THE REGÖLY-SOMOLY CHURCH RUIN AND ITS CONSERVATION IN 2025

ANDRÁS K. NÉMETH¹ – MIKLÓS RÁCZ²

Hungarian Archaeology Vol. 14 (2025) Issue 3, pp. 25–32.

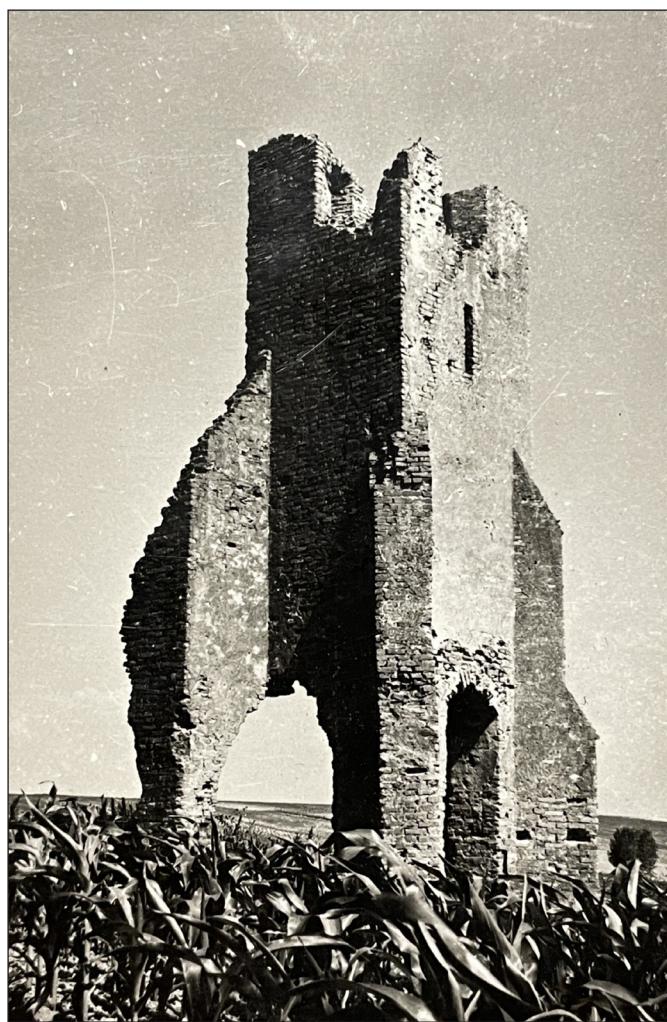
Fig. 1. The tower before the 1963 restoration
(MÉM-MDK Photo Archive 61472)

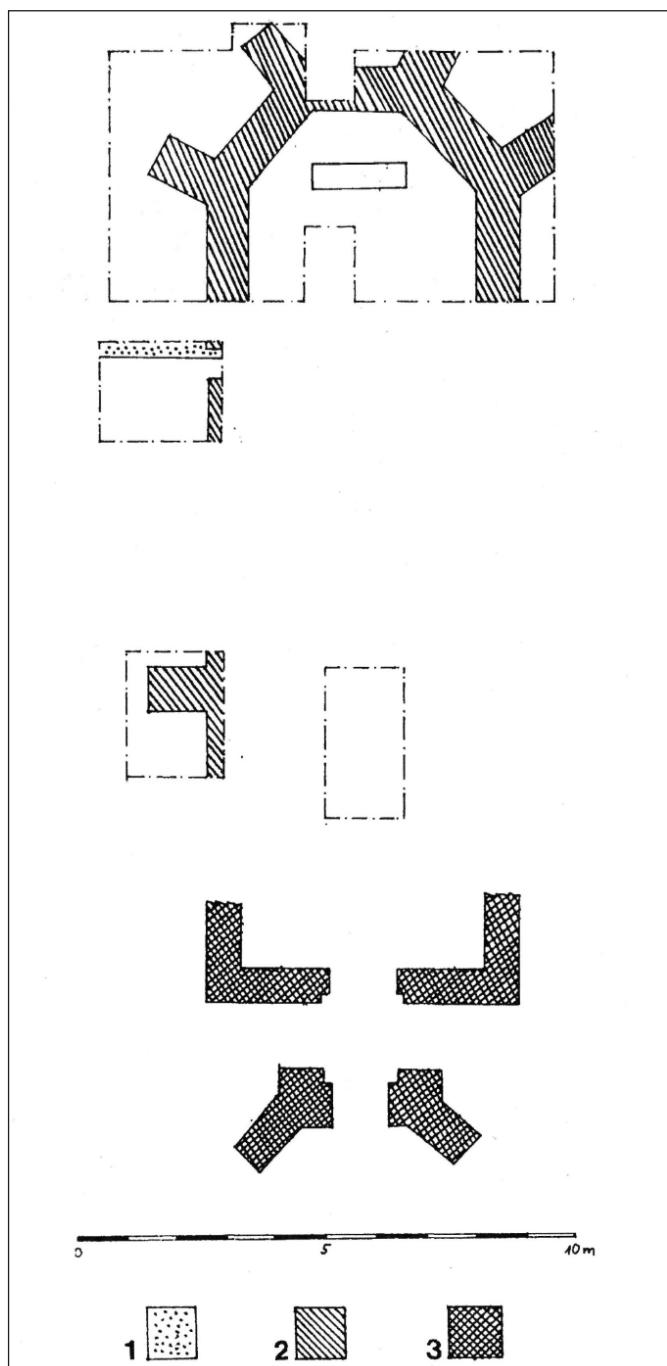
Fig. 2. Ground plan of the standing walls and the excavation, 1999. 1, Excavated foundation trench; 2, excavated walls; 3, standing walls (K. NÉMETH 2000, 170, 2. kép)

nected to it. János Gábor Ódor and András K. Németh then excavated the octagonal sanctuary, which was enclosed by three sides of an octagon and had buttresses at the corners. It was 4.75 m wide and built of brick, with a 2-metre-long altar foundation. A few courses of bricks from the sanctuary also survived. Based on the excavation results, the floor of the sanctuary was covered with tiles, its walls were decorated with painted plaster, and its windows were partially glazed. There were no signs of an earlier building period, but the painted plaster bricks built into the closing wall of the sanctuary indicate partial destruction and subsequent repair. The interior length of the church was 19.5 metres, and the nave was 5.25 metres wide, based on the wall fragments connecting to the tower. Only the removed eastern wall of the sacristy built on the north side was found (Fig. 2). Twelve graves were uncovered in the cemetery surrounding the church (K. NÉMETH 2000, 159–160; K. NÉMETH 2001).

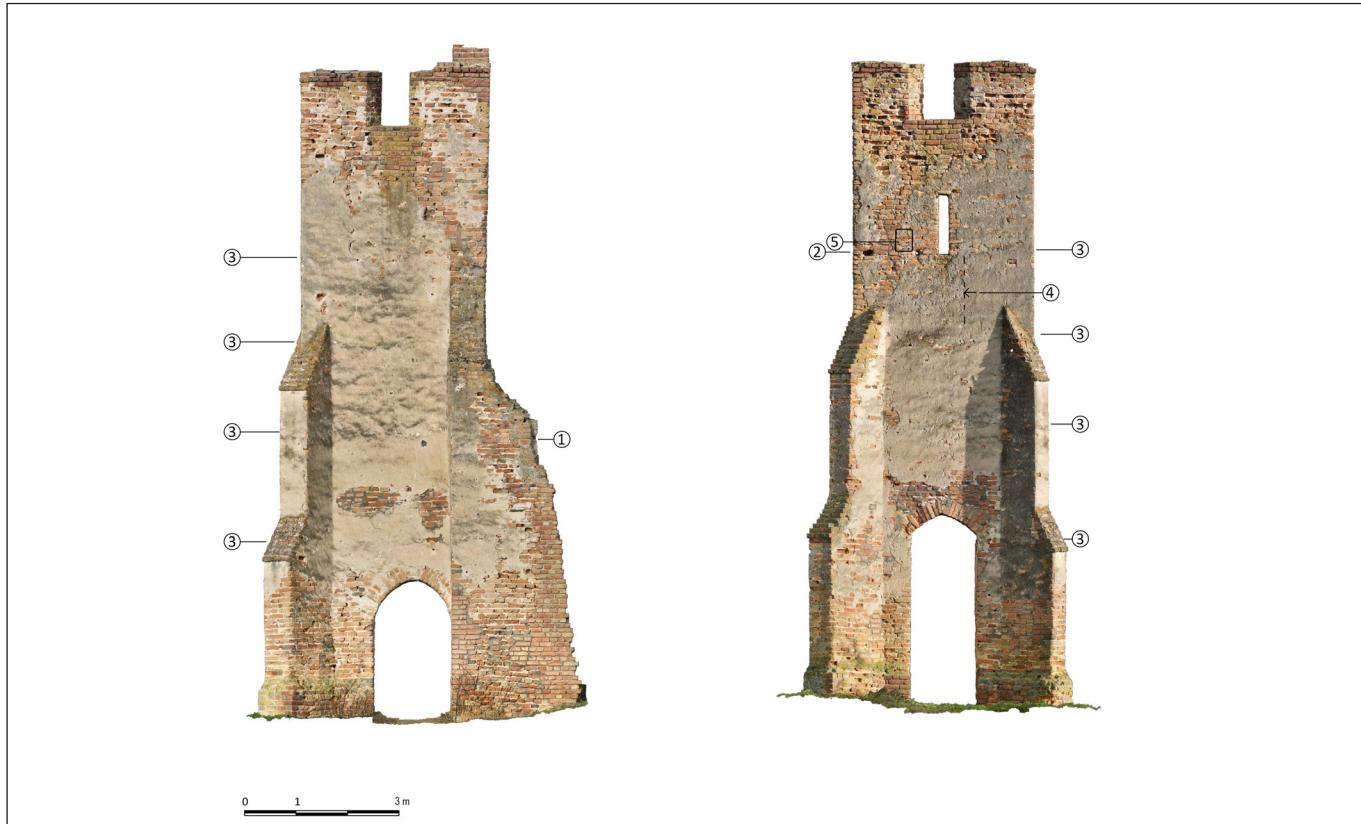
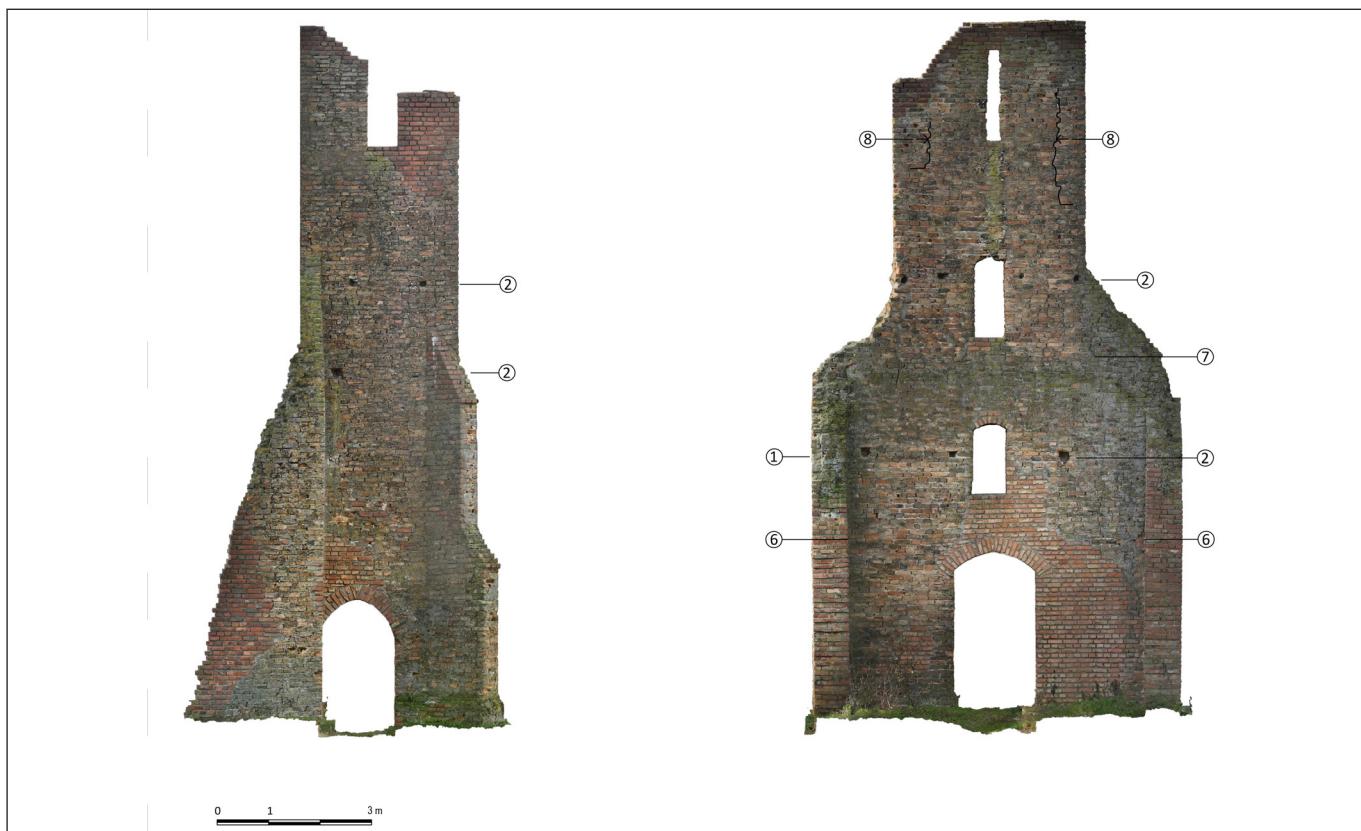
The surface of the medieval brickwork is largely well preserved and intact, but numerous damaged, fragmentary bricks were visible on the plinth sections and especially on the upper part of the tower (Fig. 3–4). The laying method of the medieval masonry, as far as it can be observed in the intact and examinable wall sections, which are generally no longer than 2 metres, is characterised by the alternation of two stretchers and one header. The characteristic bond is interrupted in many places, either by the insertion of brick fragments or by the insertion of several stretchers or headers. However, it seems that the aforementioned bond was largely followed.

Figs. 3–4. Surveys of the tower's walls, 2025 (by Kvalitron Ltd, Tibor Szappanyos – KÖZTI cPLC). 1, Detail of a window frame and a window sill; 2, beam pockets of the scaffolding; 3, construction-related horizontal gaps in the plaster; 4, position of the construction-related gap on the inner wall face; 5, large beam pocket, perhaps for a lifting mechanism, likely bricked up during construction; 6, beam nests of the gallery in the corners of the two long walls; 7, a setback – the position of the ceiling; 8, construction-related joint in the wall. Arrow indicates the direction of the extension

Rows of small beam pockets can be seen in the walls on several levels (Fig. 3–4.2), aligning with the gaps visible in the otherwise continuous plaster coating of the wall (Fig. 3–4.3).

On the western façade, at the level of the second-floor windows, there is a large opening, probably a beam pocket, which was bricked up during construction and may have served the fastening of a lifting mechanism (Fig. 4.5).

Two vertical construction joints of different heights can be observed on the inside of the west wall of the nave, approximately 1 metre below the second floor level (Fig. 3.4), and on both sides of the east outer wall of the tower, below the third floor level, indicating the multi-phase construction (Fig. 4.8). It appears that, at least in the sections between the windows, the walls were not raised evenly, but temporary gaps facilitated moving between the exterior and interior of the tower and the transporting of the (lifted) building materials.

The conservation plan designed by Bálint Kelemen (KÖZTI cPLC) based on the results of a preliminary evaluation survey included measures to repair the standing walls and reinforce the structure of the ruins. The walls were professionally cleaned and conservated; the missing parts were patched with reused bricks and a special mortar for repairs. A row or two of bricks were dismantled of previous completions of the cornice and wall stubs with horizontal closures and rebuilt; the new closure is sloped.

The cracks on the western, northern, and eastern walls of the tower, as well as the connection between the medieval wall and the 1963 addition on the northern and southern stumps and western wall of the church, were joined together using dry wall joints, i.e. by fastening 10–12 mm diameter stainless steel spiral rods in holes drilled at an angle into the wall.

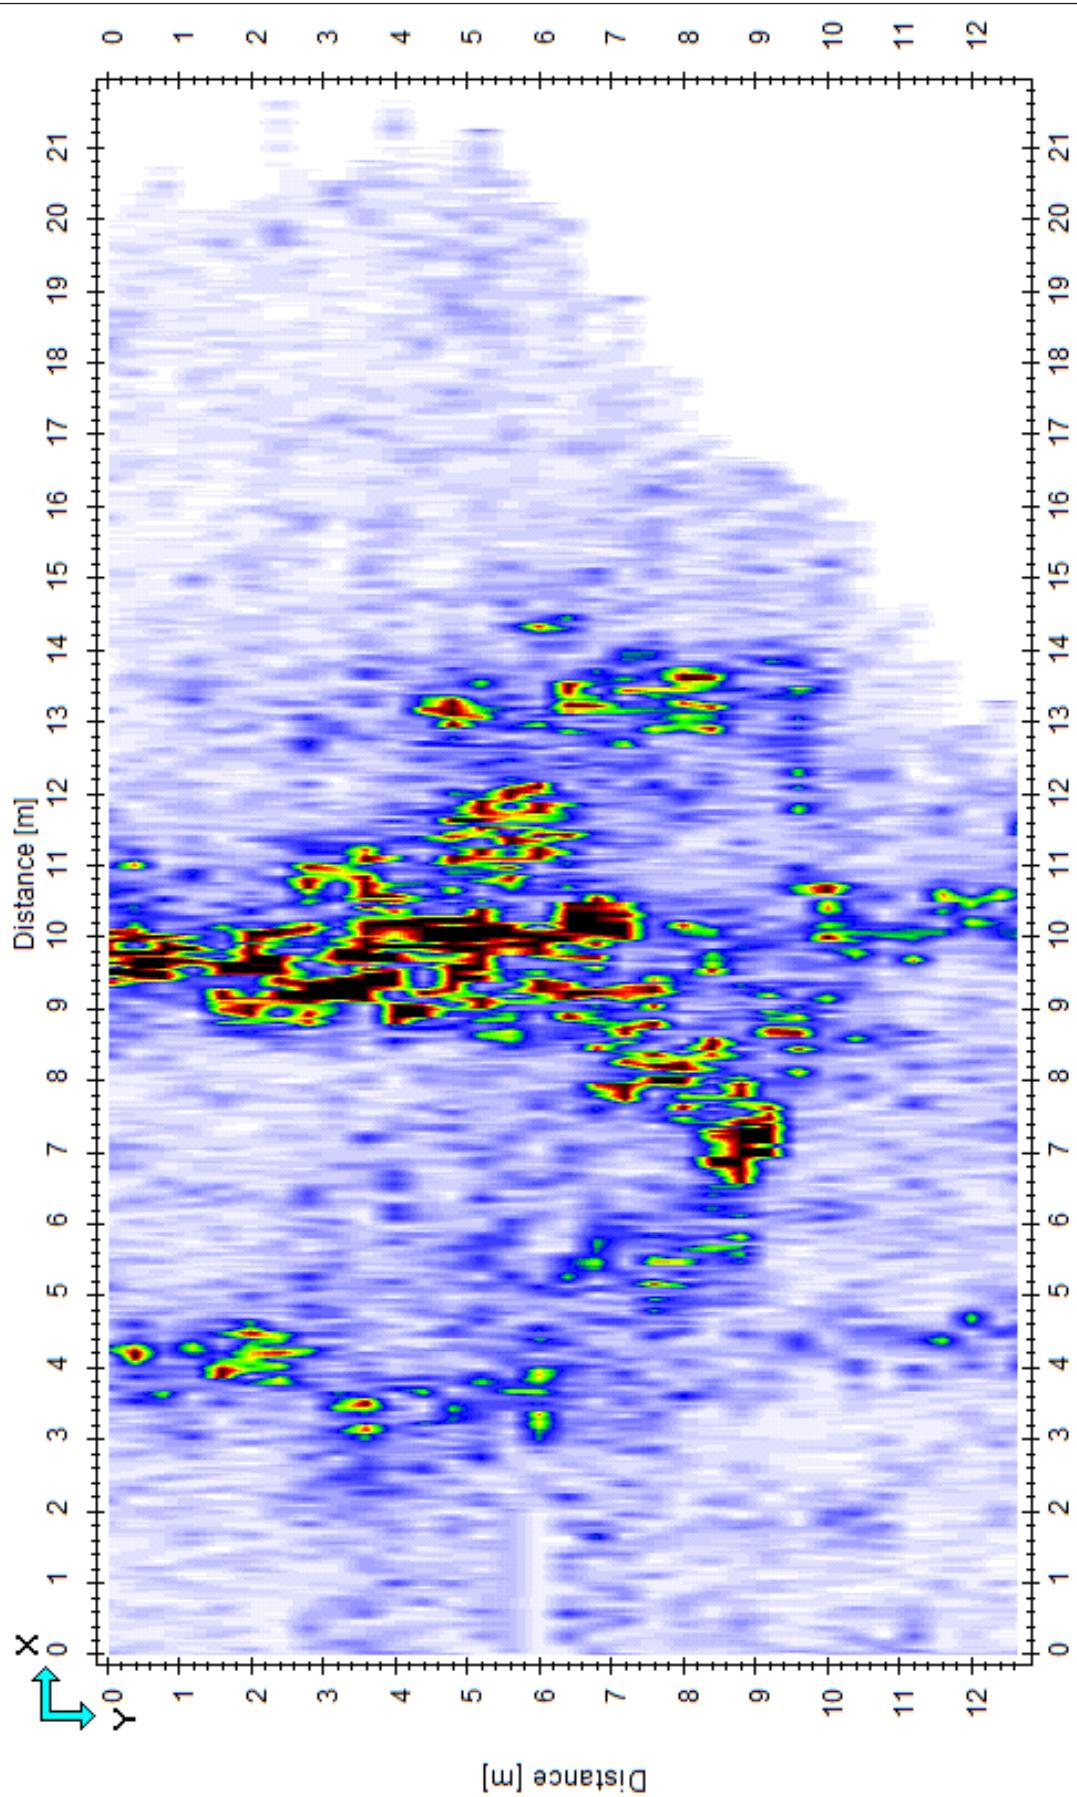
Fig. 6. Ground-penetrating radar survey of the nave (by Róbert Lóki)

At our request, Róbert Lóki conducted a ground-penetrating radar (GPR) survey on the levelled area of the church; conditions of terrain only allowed work west of the sanctuary (Fig. 6). The survey did not provide any data on the previously assumed separation between the nave and the inner plane of the sanctuary, but it did reveal that the sacristy, the extension of which was unknown, was approximately 4 metres long and 3 metres wide. Its western wall appeared as a very wide anomaly, while the northern wall appears to extend westward beyond the line of the western wall (indicating perhaps a buttress). On the survey, an approximately 3-metre-long, half-metre-wide southern protrusion, possibly the southern entrance, emerged in the eastern part of the southern nave wall. The interpretation of the arched(?) anomaly inside the nave, in line with the sacristy, remains a question (LÓKI 2025).

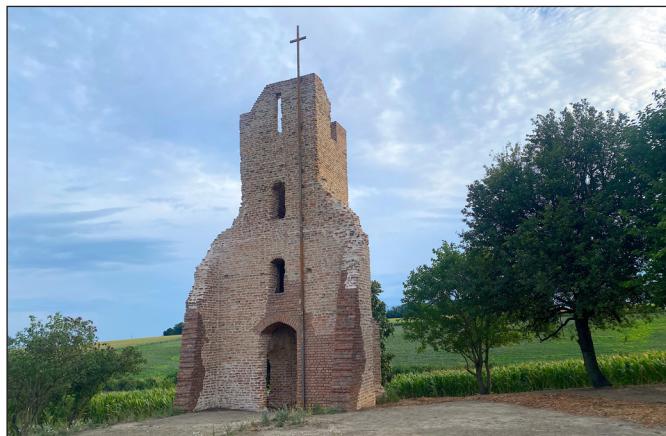
Fig. 7. The tower and its surroundings after the 2025 restoration

In addition to the conservation of the ruins, the vegetation in the area of the church was groomed, the surface of the church grounds was levelled, and the floor plan of the church, as determined by archaeological research, was marked with a flower bed (Fig. 7). As Péter Belecz, the director of the programme, put it, the basic principle of the architectural and heritage conservation programme was the technical renovation of the ruins, the preservation of the aesthetic and historical values inherent in the monument, and the preservation of the natural, harmonious relationship between the poetic ruins and the landscape. One of the special features of the ROM Váendor programme is that it not only preserves the condition of the sites involved
