## RESEARCH AND CONSERVATION OF THE VARJASKÉR RUINED CHURCH

Hungarian Archaeology Vol. 14 (2025) Issue 1, pp. 31–37.

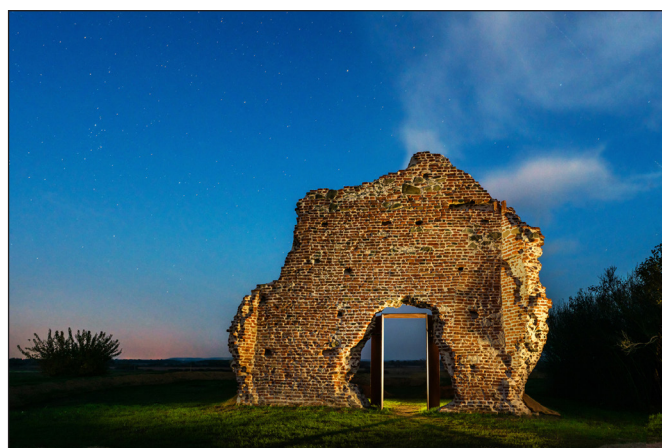
Fig. 1. The ruin church at Varjaskér after conservation (photo by Attila Gulyás, Market Építő cPLC)

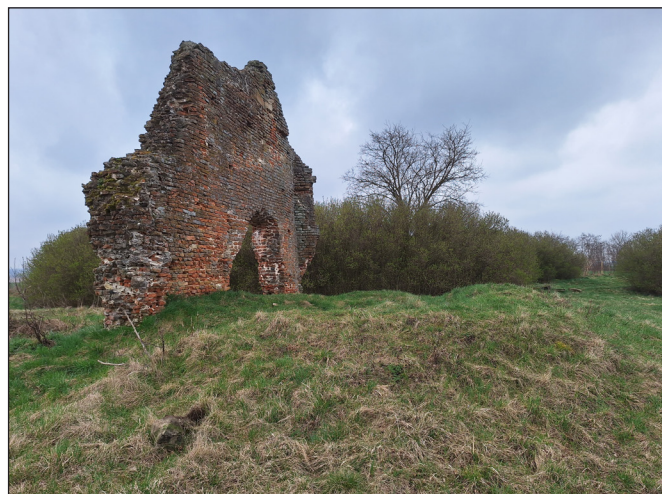
Only the western part of the rising walls of the church has survived (*Fig. 2*). It was made of bricks and some sandstone blocks. Its average thickness is 80 cm, and its height is approximately 6.5 metres. Bricks had fallen out of the wall structure, especially near ground level. Marks of erosion could be observed in its outer layer, and moss grew in places. The wall, as a whole, was compact and had good core strength, but its stability under wind load could not be proven.

Extensive brick fallout with elements indicating a former door could be observed south of the buildings' longitudinal axis on the façade. Pieces of the slanted doorframe were clearly visible on both sides under the nest of the lintel beam on the inner side, at shoulder height, and the imprint of the former bar lock beam could be seen in the northern doorframe. The stumps of two buttresses could be seen at the ends of the western wall, as well as the remains of the northern and southern walls from the east and beam nests on both sides of the wall. High up on the southern edge of the western façade, approximately at the height of the top of the former buttresses, was a deep groove, which may have nested a belt cornice that did not run completely around the building. A patch of the original plastering survived in the northern part of the eastern wall, next to the stump of a former dividing wall.

*Fig. 2. The ruin before conservation  
(photo by Bálint Kelemen, Közti cPLC)*

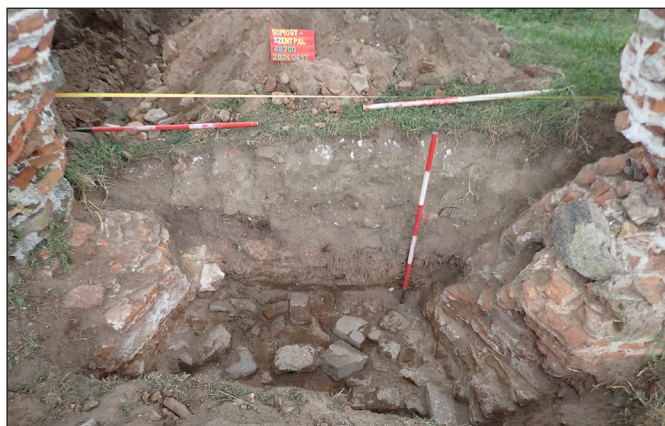
Trench 1, measuring ca.  $3 \times 1.5$  m, was marked out at the one-time western entrance (*Fig. 3*). The disturbed, 50–80 cm thick topsoil layer had to be removed from the sloping present surface first to reach the foundation wall under the door, which was unfortunately damaged by modern people scavenging for building material. A large patch of the original surface, measuring two palms, was discovered in the southern corner and marks the start of the surviving plaster layer at the foot of the wall, indicating the original level of the threshold. The wall sections next to the door were heavily damaged, but in some places, a sloping wall face, marking the entrance that widened eastward, could still be observed. This phenomenon could be followed underground, extending above the level of the threshold. The foundation was built of bricks laid in mortar, along with brick fragments and a few pieces of stone.

*Fig. 3. Excavation of the doorway  
(photo by István Molnár, Rippl-Rónai Museum)*

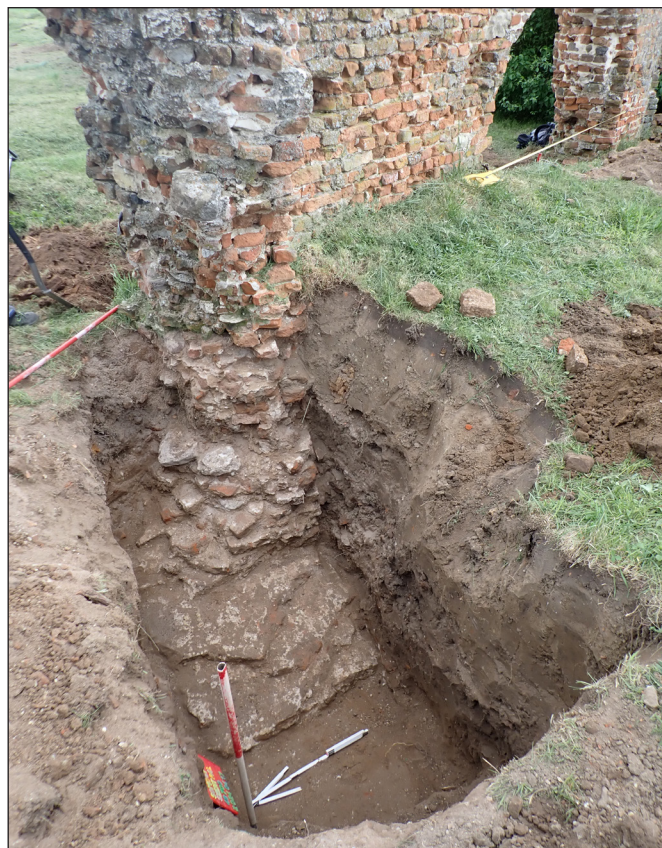
The area in front of and below the stumps of the diagonally positioned buttresses at the corners of the western wall was examined with  $2 \times 1.5$  m survey trenches (Trenches 2 and 3; *Fig. 4*). The foundations of the buttresses were mostly exploited in modern times, but it could be established from the remains that they were built at the same time as the western façade of the church, i.e. the presumed tower, using a similar technique (some stones laid between bricks set in mortar). The buttresses were 1–1.1 m long; the bottom of the northwest foundation was found a metre below the level of the threshold, and the bottom of the southwest one was 1.4 m deeper than the level of the threshold. Trench 3 also covered the foundation of the south-western corner, which was slightly less deep than that of the adjoining buttress.

*Fig. 4. Excavation of the northern buttress  
(photo by István Molnár, Rippl-Rónai Museum)*

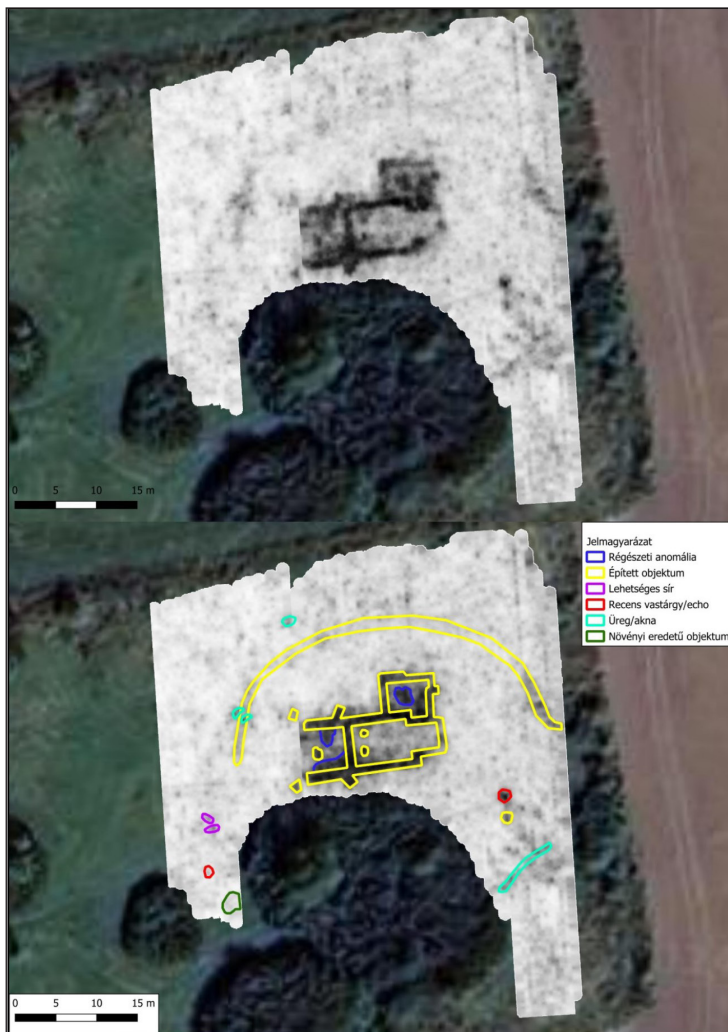
Based on the survey results, the church has at least two building phases. Based on the foundation walls, one was a typical 11 × 7 m church with a rectangular chancel with two buttresses in the western part of the nave. Additionally, the foundation of a 7 × 7 m square tower, built against the western wall of the church and reinforced with massive buttresses at the corners, is visible on the survey; the ruin that still stands today is identical to its western wall. Additionally, a large room, a sacristy or chapel, was constructed against the northern side of the chancel. The foundation levels from different periods can be clearly distinguished in the survey results: while the foundations of the early church are visible to a depth of 1.8–2 m, the foundations of the tower and the addition on the northern side can be observed about half a metre deeper, to a depth of 2.3–2.5 m. This also means that the walls of the church have been preserved in relatively good condition underground, at a depth between 0.5 and 2–2.5 m.

Despite significant visible surface anomalies west of the still-standing wall, no trace of a wall foundation was visible on the survey map, indicating that the uneven ground there is likely due to an illegal excavation pit. The northern section of the brick perimeter wall surrounding the cemetery and the church also appeared in the GPR results. The foundation of this wall is much shallower than the church wall and can only be observed to a depth of 0.5–1 m. Its eastern end turns slightly eastward, which may indicate that the entrance to the cemetery was located there. Based on the survey, there were no other buildings within the churchyard; only smaller anomalies—probably related to graves—could be identified there.

Fig. 5. GPR survey of the Varjaskér church area (-1 m depth slice map) with interpretation (by Máté Stibrányi, Munifex Ltd)

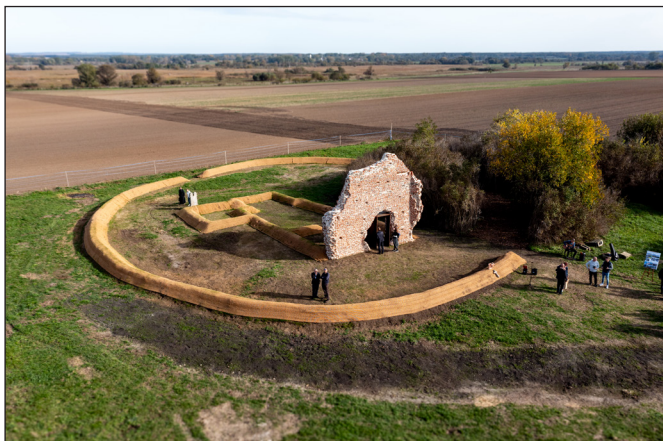
Fig. 7. The restored ruins are surrounded by mounds marking underground wall remains. The mounds will be overgrown by grass over time (© Market Építő cPLC)

The foundations of the former perimeter walls, church walls, and sacristy walls, which could be identified around the ruin based on the archaeological geophysical survey, have been marked by low earth mounds. The continuous line of the cemetery wall, running across the lilac shrubbery, is indicated by a cleared strip. The surroundings of the ruin have also been given a new lease of life: the lilac shrubs have been pruned, and the area has been graded and grassed. It is particularly interesting that during the spring and autumn equinoxes, the light of the setting sun shines through the doorway in the axis of the church to the eastern wall of the chancel (Fig. 9).

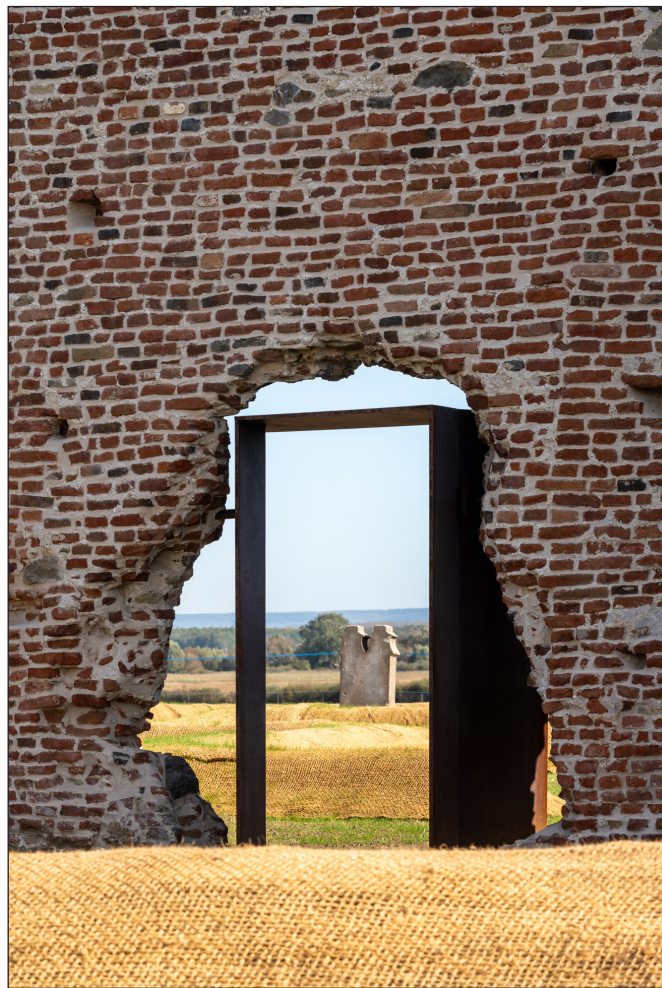
Fig. 8. Indication of the door/stabilising structure (photo by Péter Molnár, Market Építő cPLC)

cleaning the wall surface and the joints, unbuilding and rebuilding the loose wall sections, and replacing the missing patches, while preserving the natural contours of the wall with as little as possible structural and proportional additions. Only a single new structure has been built to stabilise the ruin and indicate the location and scale of the one-time church door using contemporary means. This element marks the sacred focal point of the church and serves as an information board. This door/stabilising structure has been built of a 2 cm thick corten steel sheet, the colour of which harmonises with that of the brick, while its texture resembles the heterogeneous surface of the original brick wall (Fig. 8).
