RESEARCH AND CONSERVATION OF THE CHURCH OF THE MEDIEVAL HETYE VILLAGE WITHIN THE FRAMEWORK OF THE ROM VÁNDOR (RUIN ROVER) PROGRAMME

GERE LÁSZLÓ¹ – KELEMEN BÁLINT²

Hungarian Archaeology Vol. 15 (2026) Issue 1, pp. 33–41.

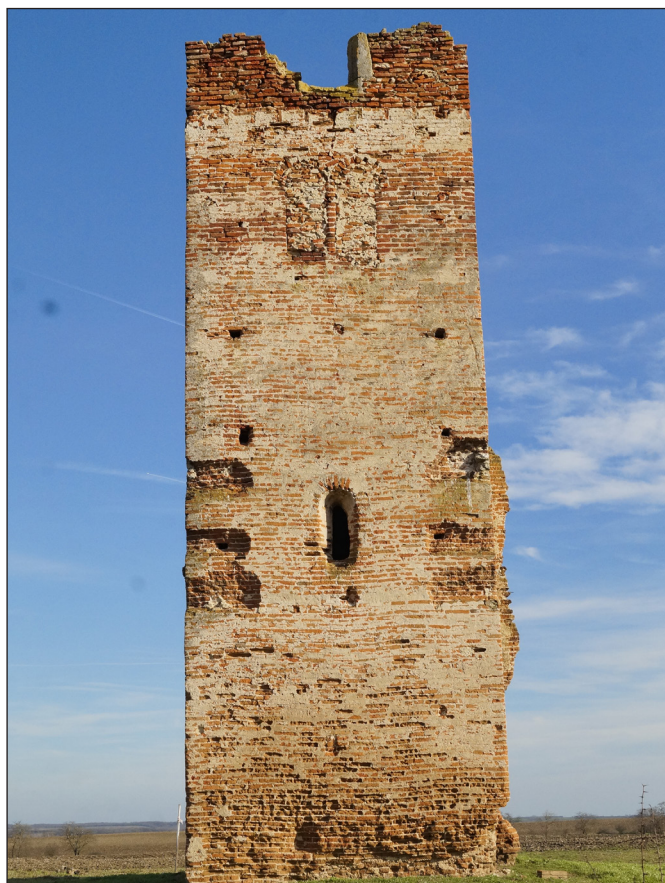
At the height of the first floor, both the south-eastern and south-western walls were perforated by a slit window widening outwards and inwards. At the height of the second floor, two twin windows could be upward extension of the tower (*Figs 1 and 2*), while the north-western wall did not have an opening (*Fig. 3*).

Fig. 1. South-western facade of the tower

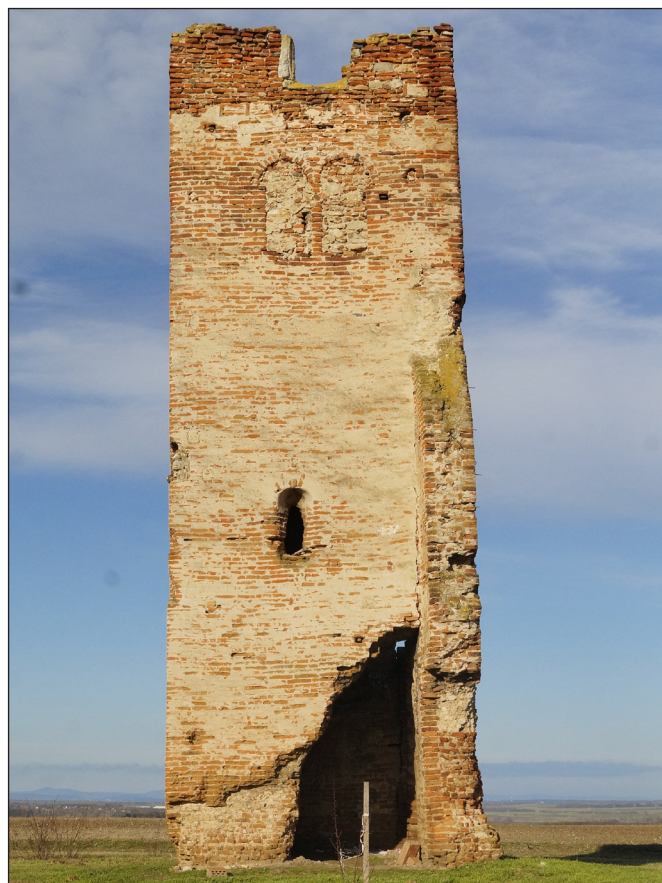
Fig. 2. South-eastern facade of the tower

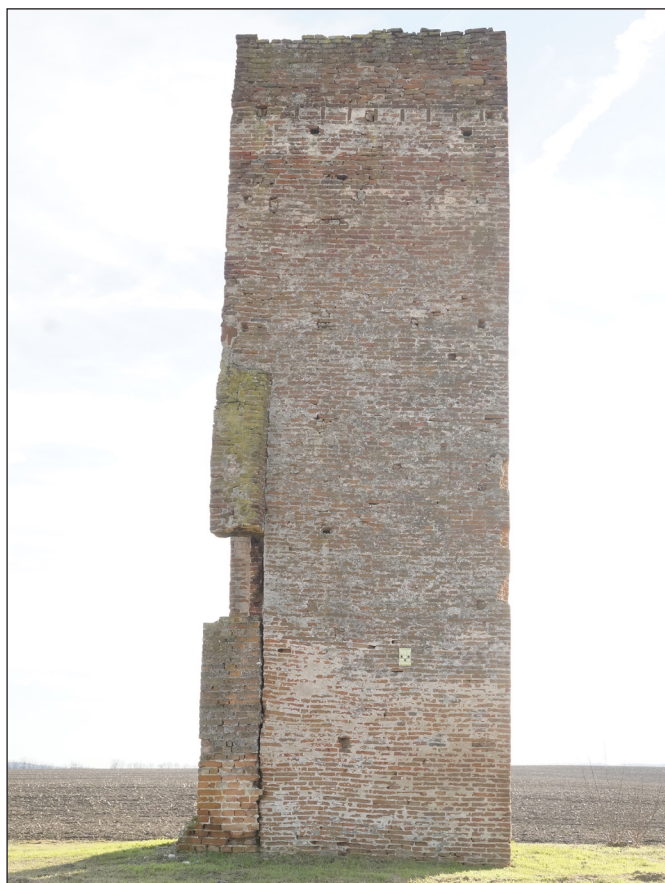
Fig. 3. North-western facade of the tower

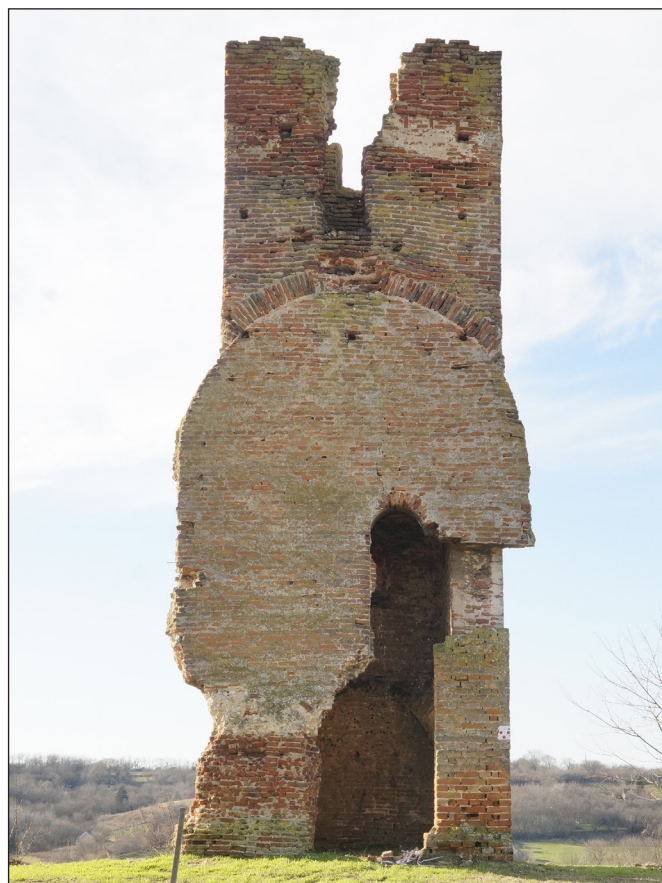
Fig. 4. North-eastern facade of the tower

The north-eastern wall of the tower also serves as the western wall of the nave (Fig. 4). The south-western wall of the nave is topped by an arch made of bricks laid upright. This arch is not a load-bearing one built for the tower; it can be detected under the tower, but it also continues towards the north-west and south-west. The wall below the arch also has a semicircular closure, even the springing can be recognised. The courses of bricks on the tower above the arch are curved, following its line, and become horizontal again after several rows. All this proves that the tower and the vault of the nave were built at the same time. The ground floor area of the tower was covered with a barrel vault ceiling that sprung from the north-western and south-eastern walls. The bricks of the vault were also connected to the south-western wall, so the vault can be drawn accurately. The barrel vault above the springing was covered with a fill of brick fragments and lime-grained yellow mortar. The vault on the top of the tower marks the place of the former vault from before the upward extension: originally, the tower was capped by a barrel vault similar to that of the ground floor room. The remains of the springing and the vault are clearly visible in the south-western wall (Fig. 12). The original height of the wall can be determined very precisely from the height of the vault, the positions of the springings, and the row of arches made from truncated bricks on the external facade.

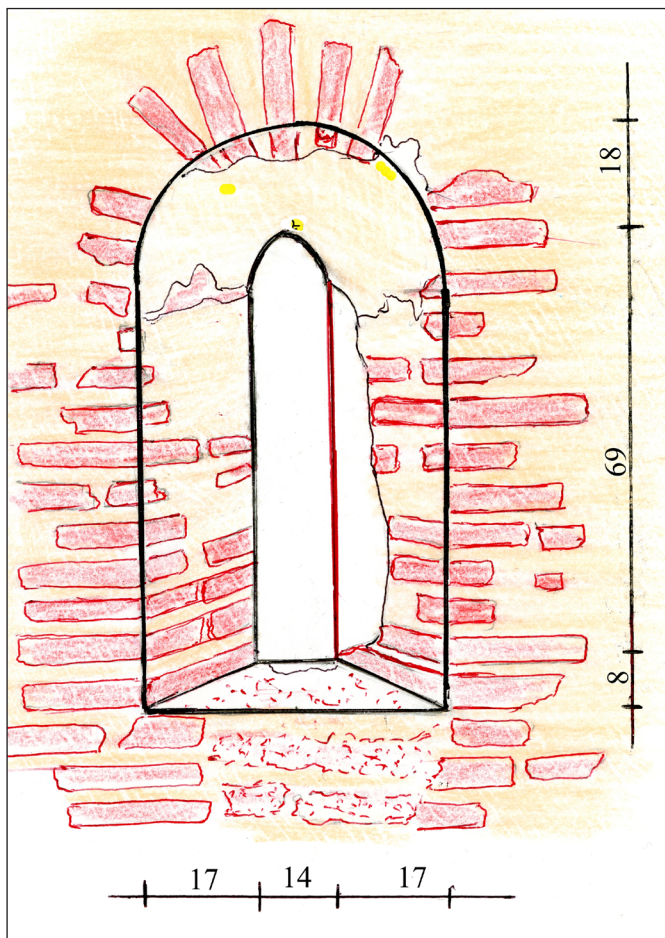
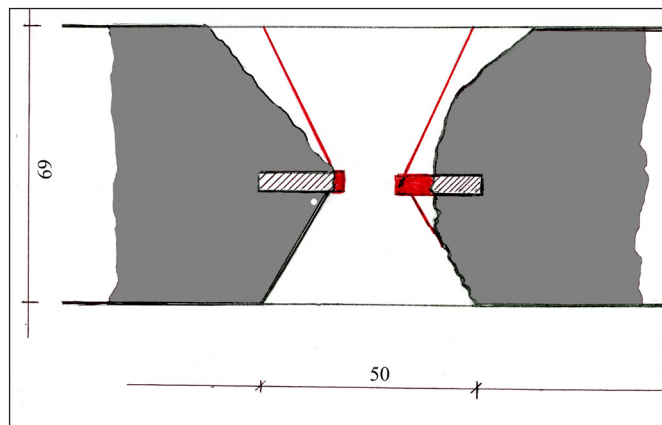
Fig. 5. Survey of the upper floor window on the south-western facade

Fig. 6. Section of the window

The inner half of the window is heavily damaged, exposing a course of bricks set on their short side in the central part of the wall core, which separated the external and internal oblique planes of the jamb and formed an internal horizontal plane between them. A wooden panel or wooden frame that covered the opening could be attached to this surface (Figs. 5 and 6).

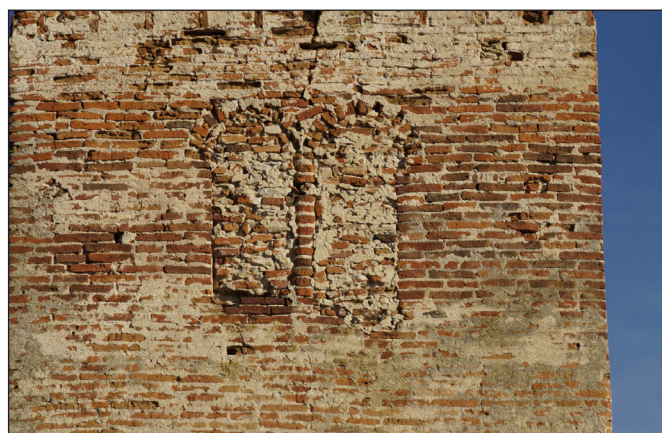
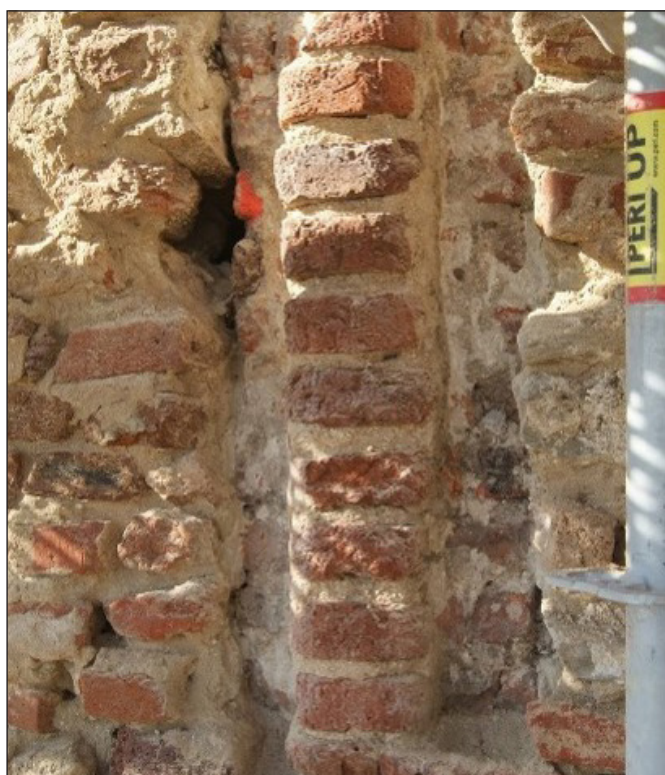
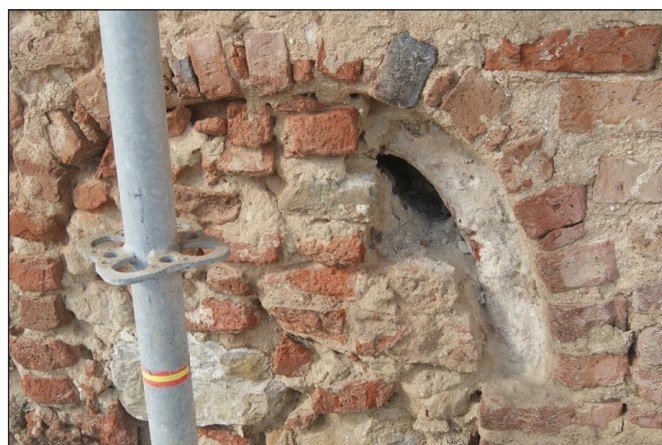
Fig. 7. External view of the second-floor window on the south-western facade

Fig. 8. Mullion after exploration

Fig. 9. Detail of the vault after research

The bricked-up twin windows on the second floor are identical in size to the ones on the first floor. On the external wall face, the two windows are separated only by a 14 cm-wide pillar, while the same pillar on the internal wall face is 25–28 cm wide. The original design of these pillars could be explored: the outer, 13–14 cm-wide front part was completed by 8 cm-wide grooves on the sides, 8 cm inward from the wall plane. An *in situ* detail of the sill has survived on the south-western façade, at the northern jamb of the northern window opening of the twin windows on the second floor (Figs. 7–9).

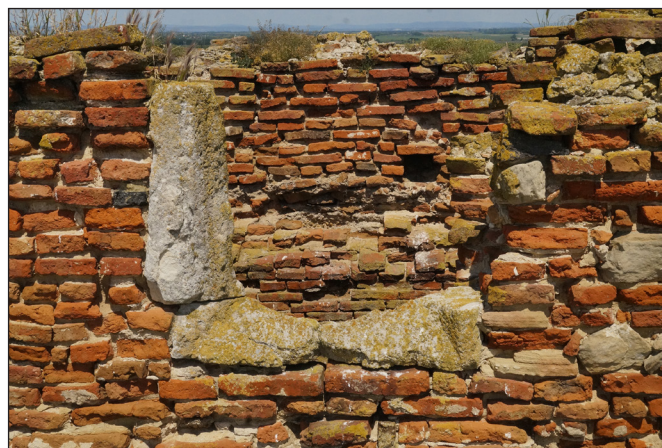
The third floor of the tower is clearly the result of a later upward extension. Here too, a large window breaks through the wall in its central axis. A fragment of one of the jambs and the sill have survived in the window opening. The sill originally sloped outwards, just like the jamb. Both stones are heavily worn and damaged. Several courses of brick have fallen out below the window sill from the nave-side part of the wall (Fig. 10).

Fig. 10. South-eastern window on the third floor before restoration

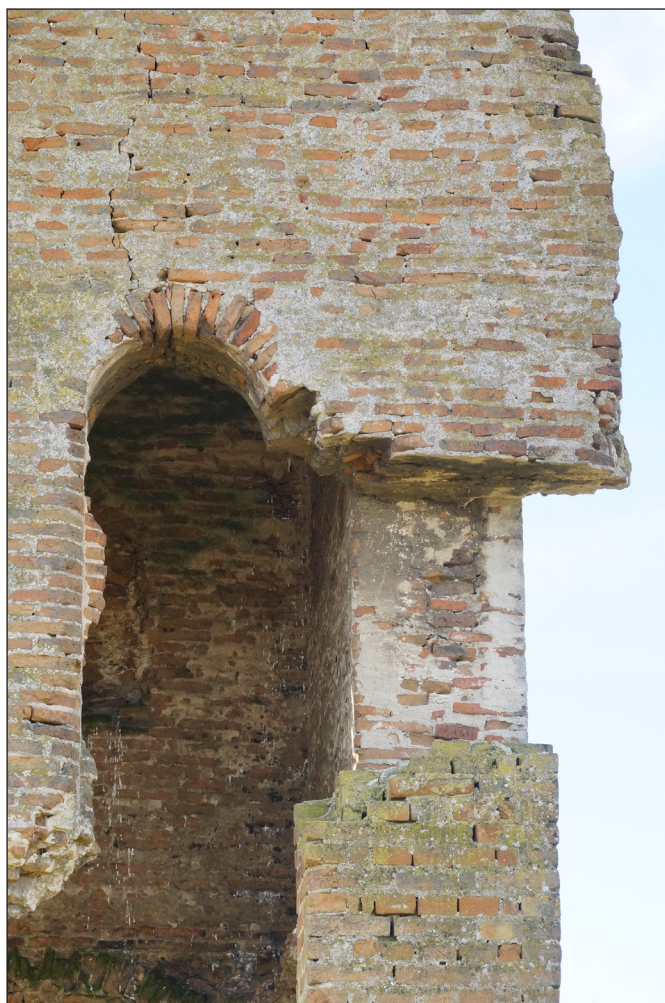
Fig. 11. Door to the gallery

Basically, the north-eastern facade has to be divided into two parts, since the lower two-thirds of the wall is actually the south-western wall of the nave, and only the upper one-third rose higher than the ridge of the roof above the nave. This was where the barrel-vaulted ground-floor room of the tower could be accessed through a door under the gallery, and the upper part of the tower could be accessed through the gallery door. The existence of the gallery is also clearly proven by the surviving springing in the southern half of the wall. The lower north-western third of the northern wall of the nave is completely missing, akin to the entire north-western half of the ground floor and part of the gallery north-west from the gallery door. Despite that, the arch and the southern jamb of the gallery door have survived. Every dimension of the door is known: the height of the jamb between the threshold and the impost is 149 cm, the arc of the opening rises to 32 cm above the impost, and the width of the door

measured at the impost is 70 cm (Fig. 11).

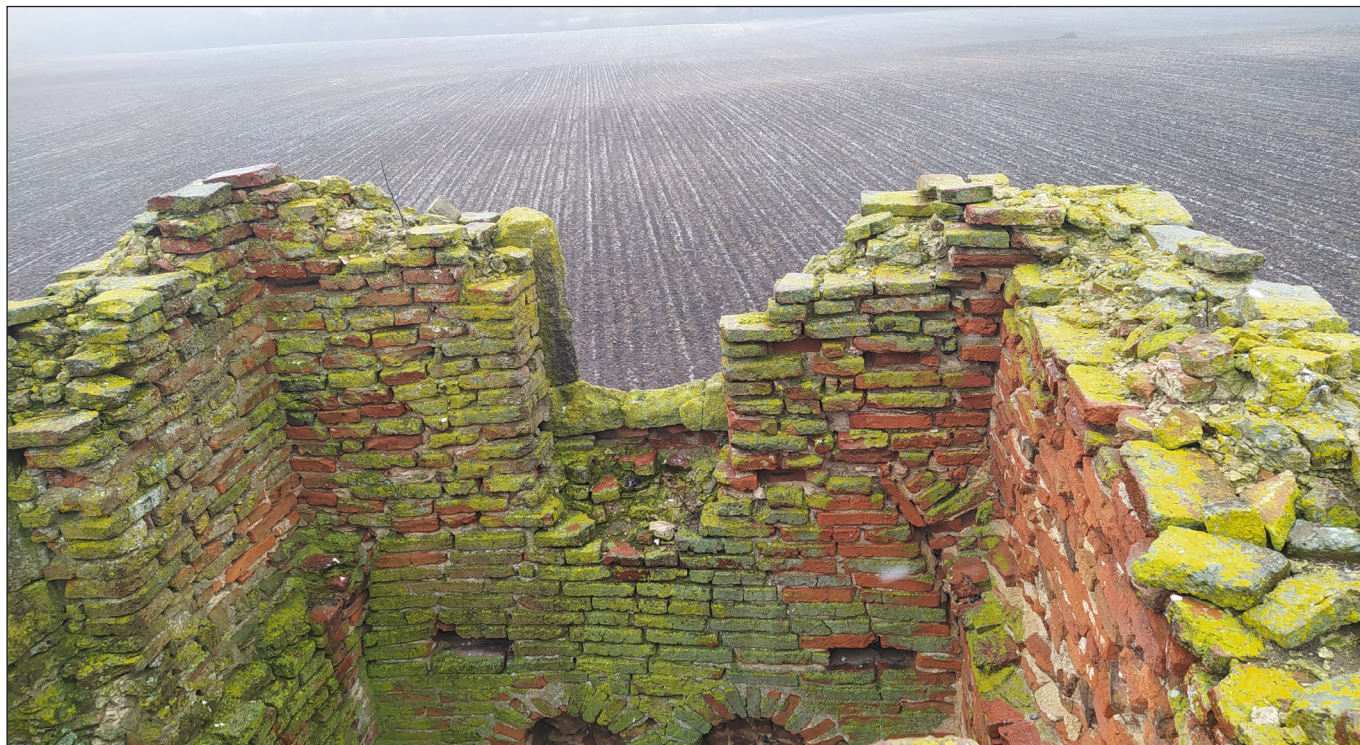
Fig. 12. Remains of the second-floor vault of the Romanesque tower

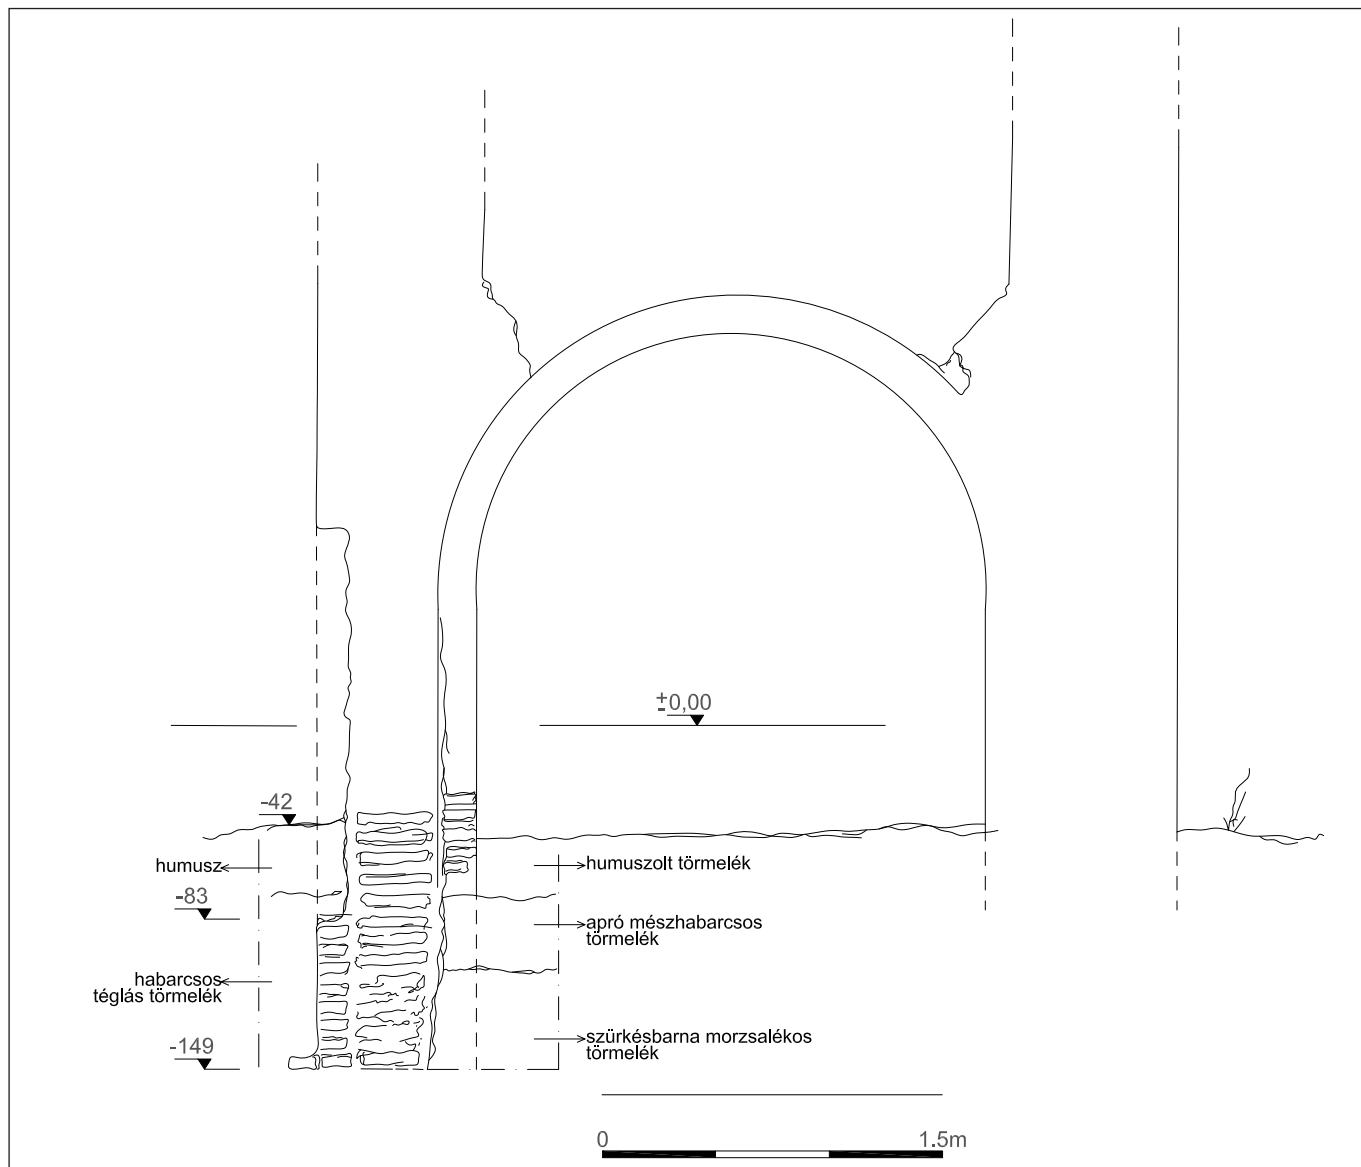
Another sondage trench was opened at the south-eastern facade of the tower in search for the foundation of the tower at the missing eastern half of the wall. Thus, we practically obtained a full profile of the southern wall and the fill next to the outer part of the wall and within the tower. Fig. 13 illustrates well that the external and internal facings, the bricks of which were arranged in a regular pattern that continued on the

Fig. 13. North–south wall section, including the foundation of the south-eastern wall

joining walls, were removed from the lower part of the wall, and practically only the wall core remained on the western side of the south-eastern wall. The outer wall face was found 40 cm below the current surface, but no features associated with a foundation could be discerned. However, as clearly visible on Fig. 13, neither the foundation of the wall or the lowermost course of bricks was exposed. Bricks and courses of bricks laid less regularly, integrated with the outer wall face but slightly protruding – indicating perhaps the start of the foundations – were found at a depth of 149 cm.

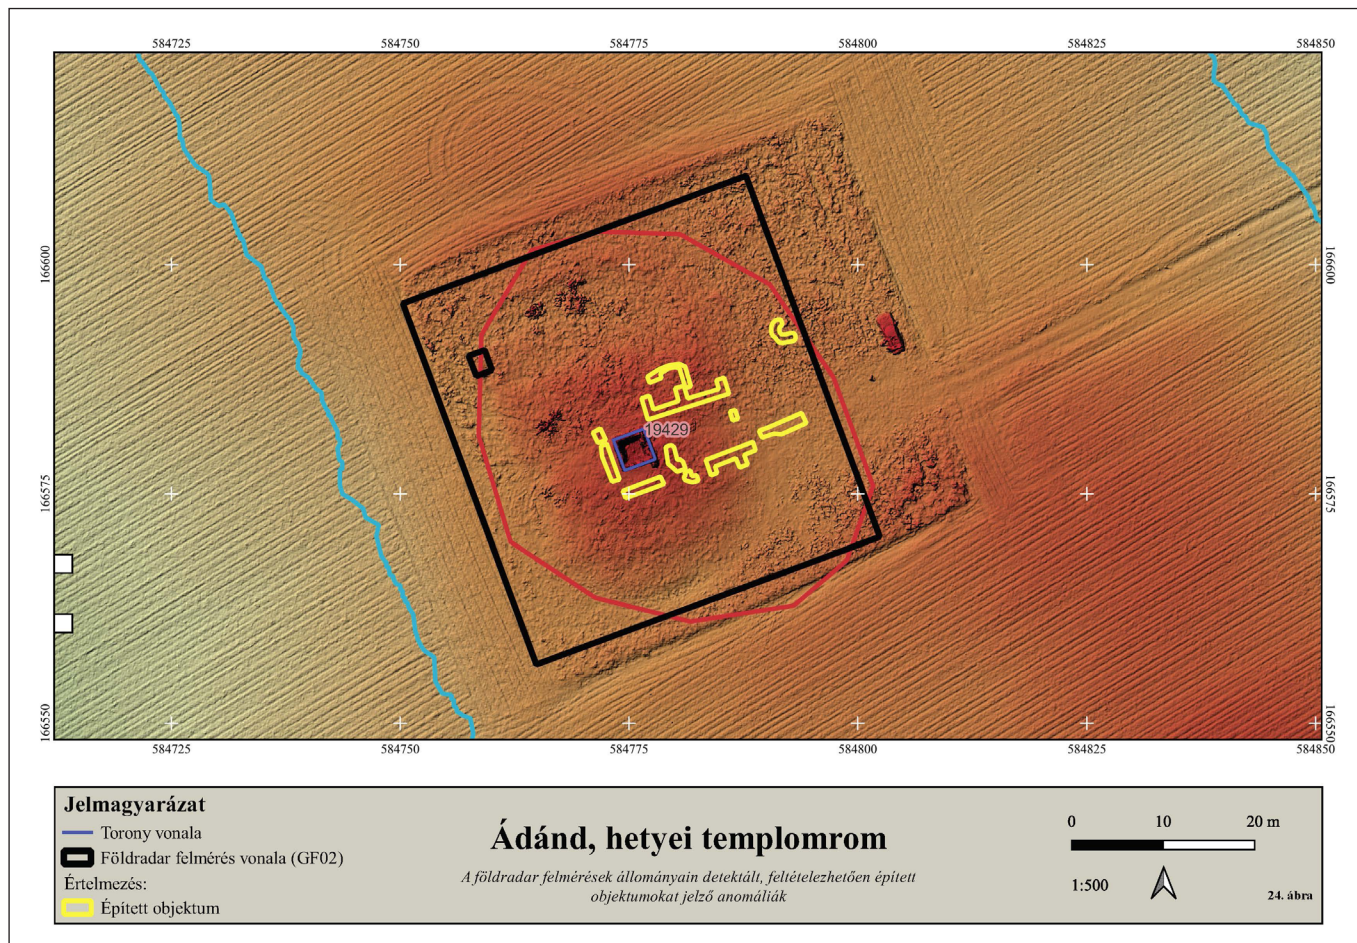
Fig. 14. Ground plan of the church as reconstructed from the georadar survey

Based on the wall remains determined by the georadar survey, the ground plan of the late Romanesque church could be reconstructed as a single-nave building with a straight-walled apse and buttresses, complete with a three-story tower located in front of the western wall (Fig. 14). According to the survey, the length of the nave is 9 m, its width is 5.8 m. The apse is 6.5 m long and 3.5 m wide. The nave and the apse together are 15.5 m long, and the total length of the church, including the tower is 19.3 m.

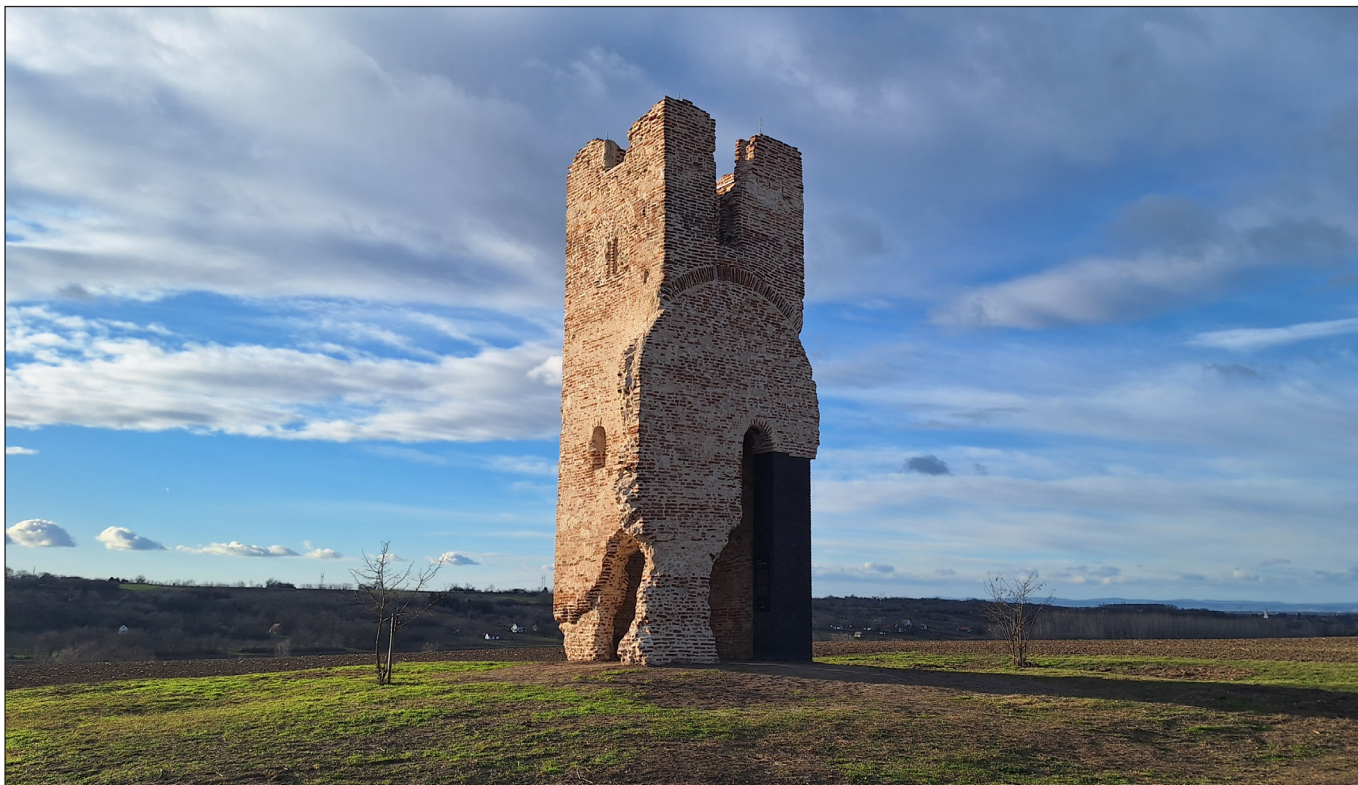
Fig. 15. The restored and conserved tower with the new corner pillar

The Ádánd church ruin is the sixth renewed monument in the ROM Vándor (Ruin Rover) programme of Market Építő cPLC, and the fifth that has been conserved based on KÖZTI's design (lead architect Bálint Kelemen). The primary goal of the intervention carried out within the framework of the programme is to protect the remaining architectural-historical monuments. The intervention at Ádánd, similarly to the other ROM Vándor projects, was minimalist, focusing on the remaining tower, and its concept was based on professional conservation and a contemporary addition designed around a single concept (Fig. 15). As the tower tilted, the north-eastern wall gradually separated from the walls joining it at a right angle; the resulting cracks were repaired with hidden, dry wall seams using stainless steel spiral rods. The tower was stabilised by injecting synthetic resin under the foundation,

and the damaged wall surfaces were conserved using professional methods. The brick pillar built in the 1940s was demolished and a supporting wall was built at the northern corner. The bottom of the tower was paved with frost-resistant clinker bricks. An anthracite grey, powder-coated steel information board was added to the new wall section on the side of the northern corner pillar facing the former wall opening, while the cassette of the ruin booklet (guestbook) was built into a bench. A small bell to be rung by anyone was mounted on the tower wall.

The newly built elements, the cladding of the northern corner pillar, the floor paving, and the bench were made of the same material: basalt-coloured, structured, combed clinker bricks, thus creating a contrast with the various original brick surfaces. All new additions (pillar, floor, bench, and information board) are limited in scale and designed to fit the monument (*Fig. 16*). The area around the ruin was graded to enhance the draining of precipitation, and it was re-grassed.

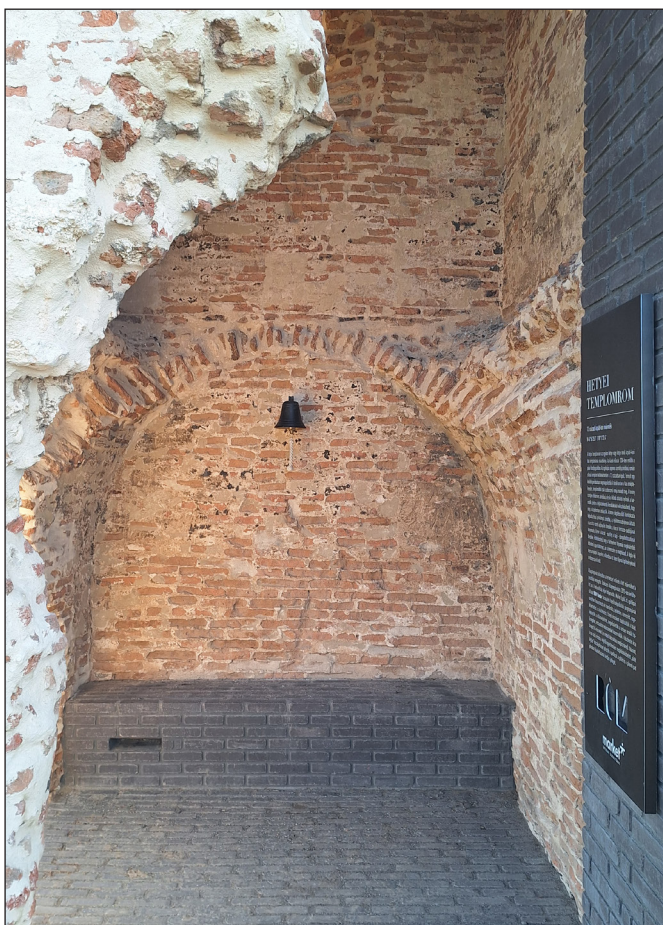
Fig. 16. Interior of the tower with a bench, a cassette for the ruin booklet, and an information board
