HUNGARIAN ARCHAEOLOGY

THE FIRST RESULTS OF THE EXCAVATION IN THE SURROUNDINGS OF ST. GEORGE'S CHAPEL IN VESZPRÉM IN 2022

Dóra Hegyi¹ – Márk Kékesi² – Virág Kristóf³ – Gergely SzoBoszlay⁴ Hungarian Archaeology Vol. 11. (2022), Issue 2, pp. 38–47. <u>https://doi.org/10.36338/ha.2022.2.5</u>

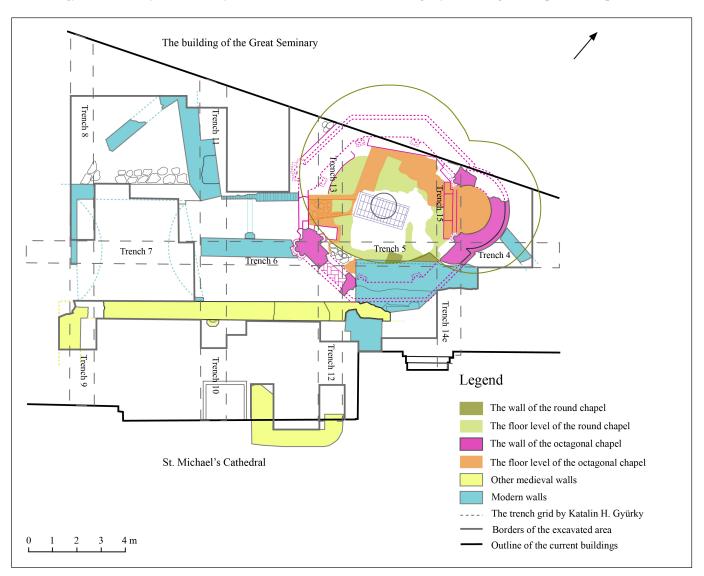
Fig. 1. Survey map of Katalin H. Gyürky's 1957 excavation, detail (clean copied by Kristóf Virág)

Previously, Katalin H. Gyürky carried out a full-scale excavation between the St. Michael Cathedral and the Great Seminary in 1957. This year, H. Gyürky took over the amateur excavation started not long before by József Hungler. Her systematic investigations were focused on the two-phase St. George's Chapel and its surroundings. The area was excavated with fifteen intersecting ditches arranged in a regular grid-like network (*Fig. 1*).⁶ Later on, in the 1970s and 1980s, Sándor Tóth and Alán Kralovánszky carried out further excavations, partially examining the area between the chapel and the cathedral (Tóth 1974, KRALOVÁNSZKY 1990). Since these investigations, no other archaeological research has taken place in the area. After the 1957 session, a protective building was erected above the ruins unearthed at the time, sheltering them for decades and enabling them to be presented to visitors. The cover was designed by Ferenc Erdei (architectural design) and Tibor Slavik (static design). Parallel with the protective building's construction, Tibor Koppány conserved the medieval ruins (ERDEI & KOPPÁNY 1966, 89–90).

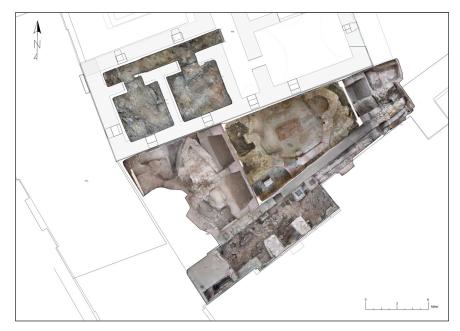
Fig. 2. Survey map of the 2022 excavation in the basement of the Great Seminary at the northern end of the Castle Hill and the vicinity of St. George's Chapel

In our excavation between the beginning of February and mid-March 2022, we divided the area of the chapel and its surroundings into five separate sections: the current remains of the chapel under the protective building; the areas east, west, and south of the protective building, respectively; and the western section of the Great Seminary's southern basement wing (*Fig. 2*).⁷ We have reached the natural rock surface at an

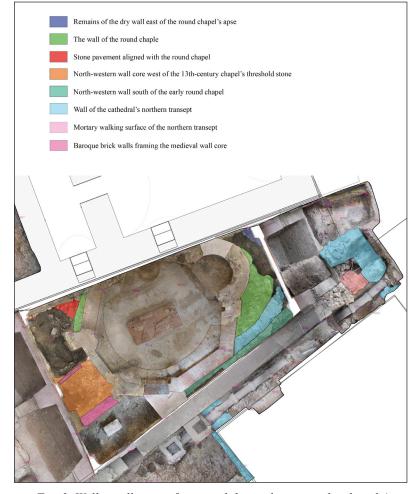
Fig. 3. Walls, walking surfaces, and their relations in the chapels' immediate surroundings as observed in the 2022 excavation

We have also uncovered a thick mortary layer southwest of the chapel, above the rocky ground, which was most probably placed down to level the terrain and serve as the base level for the rotunda. We have unearthed a burial there, east of the apse; based on their matching east-western orientation, it may also be linked to the early round chapel (*Fig. 3*).

The multi-period St. George's Chapel was in the focus of our excavation (*Fig. 3*). By summarising stratigraphic observations (including those related to wall remains), we could establish a relative chronology of

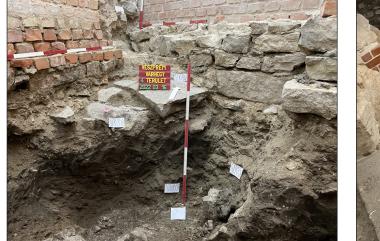
Fig. 4. Walking surface made of stone slabs, connected to the early chapel

Yet another structure could be linked to the earliest building phase. At the western intersection of the early rotunda and the southern wall of the Great Seminary, we discovered detail of a walking surface paved with large stone slabs (Fig. 4). The slabs displayed similar erosion marks suggesting that the layer may have been a walking surface, where the gaps between the tightly fitted stone slabs were filled with the same bright mortar that was used by wall structures in the earliest phase. Conclusively, this surface was built probably in the same phase as the first period of the chapel, all the more as the stone slabs were aligned with the rotunda's wall. This walking surface was cut through during

the reconstruction of the chapel in the 13th century and destroyed by the northwest pillar of the chapel's second building phase, the foundation of which comprised several reused paving slabs. The three medieval burials discovered in the area under the protective cover also cut through this early pavement. The graves' orientations matched the cathedral's, pointing slightly north-east.

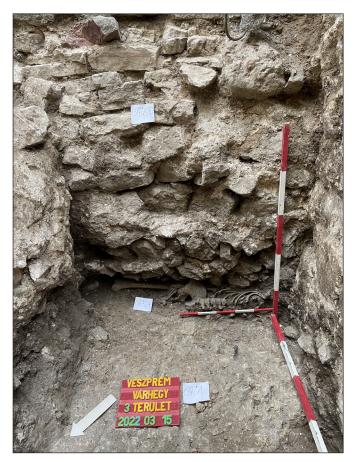
Fig. 6. Burial discovered under the foundation of the cathedral's northern wall, next to the north-western tower

The three burials found next to the northern wall of the cathedral can be connected to the early round chapel and the period preceding the 11th-century Romanesque cathedral. Compared to St. Michael's Cathedral, their orientation was more southwest/northeast. Furthermore, all of them were disturbed by later graves, the orientation of which matched the cathedral's. It is important to note that, as the burials did not contain any grave goods, a relative chronology could have only been established based on their orientations and relative positions. We must also mention yet another burial that was cut into the natural rock surface next to the exterior wall of the cathedral's northern side aisle. That grave became heavily disturbed during the construction of a Romanesque-style wall sequence connected to the western tower (*Fig. 6*).¹⁰ These

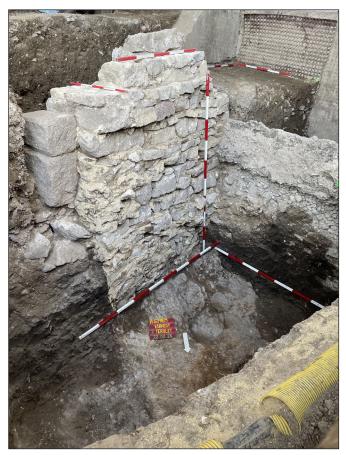
Fig. 7. Face of the medieval northern transept's outer wall and its north-eastern corner with ashlars

East of the chapel's protective roof, we have discovered the outer side of a stone wall running east-west at 10 cm below the current surface. The discovered wall section turned south in front of the eastern profile. Its corner was strengthened by large ashlars (*Fig.* 7). This L-shaped stone wall was the north-eastern corner of the Romanesque cathedral's northern transept that was shortened during later renovations. Previous piping works cut through this wall section in three places. However, despite the damage, one could still clearly determine that its eastern end runs under the north-eastern corner of the church's current transept. The unearthed wet wall section also preserved traces of the cathedral's Goth-

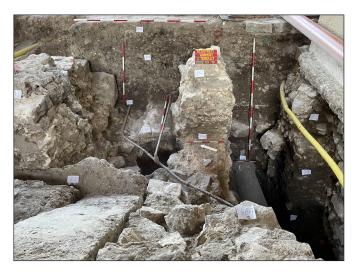
Fig. 8. Detail of the medieval northern transept's eastern wall cut through by modern utility trenches and detail of the mortary Gothic-period walking surface connecting to the wall's inner side

ic-style reconstruction around 1400, when the north-eastern corner was rebuilt and the walking level raised. Its lower part was set in white, chalky mortar, while the upper, clearly different part in more yellowish mortar. The younger, elevated, mortary walking surface was preserved in a small area along the inner side (*Fig. 8*).

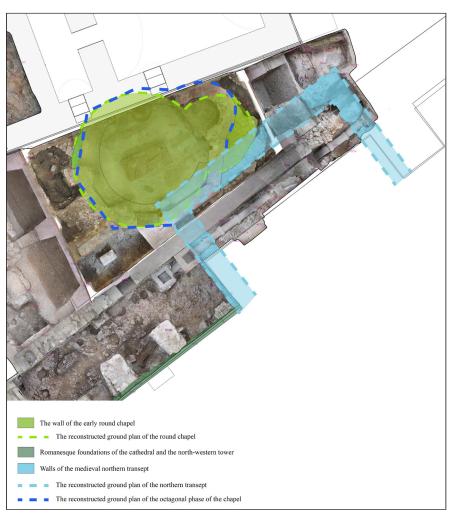
Fig. 9. Reconstruction of the medieval northern transept's position and its relations with the older and younger chapels

During the rebuilding of the chapel in the 13th century, the walls of the early round chapel were dismantled, and a new building with a polygonal floor plan was attached to the then-existing northern gable wall of the cathedral's medieval transept. The connection assumed previously between the two buildings became proven by the transept's northern wall that matched the remains of a high wall segment where the structure's southern walls should have been. That (southern) wall section was found in 1957 by Katalin H. Gyürky, who interpreted it as a modern structure. We have clarified, however, that the remains in question represent the northern gable wall of the medieval transept and, at the same time, the southern wall of the octagonal chapel (attached to the transept of the Romanesque cathedral). According to written sources, the capitular meeting was held in St. George's Chapel in 1352; that may account for the close architectural connection between the building and the cathedral (Fig. 9;

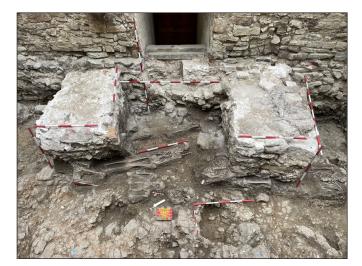
Fig. 10. Detail of the medieval cemetery next to the north wall of the cathedral, between the two unearthed Baroque-period buttresses

reconstruction phase, as displayed by 19 unearthed graves with the same orientation as the cathedral's. We do not know the precise extent of the cemetery, but no burials were found in the southwestern corner of the Great Seminary, suggesting, perhaps, that its western border was in that area. It is important to highlight, however, that we have only found the deepest graves of the cemetery in the basement of the Great Seminary, and it is possible that less deep ones were destroyed by modern construction works (*Figs. 10–11*). In the cellar, we have found a pit carved into the dolomite surface of Castle Hill. Based on the characteristics of its infill, the pit was dated to the first half of the 16th century. Later, when the Great Seminary's basement was constructed, the hill's base rock was carved in several places, and the works also disturbed the pit's upper part. The pit's infill contained several finds, including intact and fragmented stove tiles, broken pots, a Renaissance-style stone carving, several floor tiles, animal bones, and archaeobotanical remains.

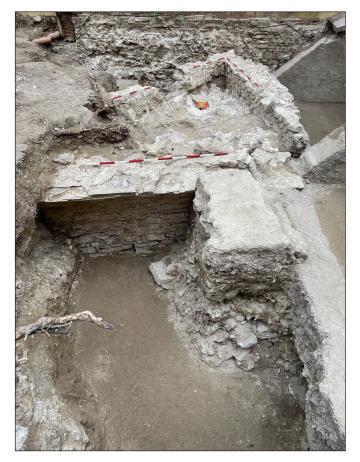
Fig. 13. Barrel vaulted room west of the chapel and the triangular building attached to its northern wall

eval chapel's western entrance, the kneewalls of which have already been found in 1957. The mortary, brick-dusted, and rammed walking surface discovered west of the chapel, containing 18th-century finds, could also be linked with that layer (*Fig. 13*). The Baroque-style baptismal font, the pedestal of which was discovered by H. Gyürky in the chapel's centre above Vetési's tomb, was also established in this phase (H. GYÜRKY 1957, 128.V.II).
