## THE AMPHITHEATRE OF AQUINCUM, NAGYSZOMBAT STREET: RECONSTRUCTIONS AND THEIR PRESENTATION

LŐRINC TIMÁR<sup>1</sup>

Hungarian Archaeology Vol. 11. (2022), Issue 3, pp. 10–15. <https://doi.org/10.36338/ha.2022.3.2>

**Keywords:** Aquincum, amphitheatre, Nagyszombat Street, reconstruction drawing

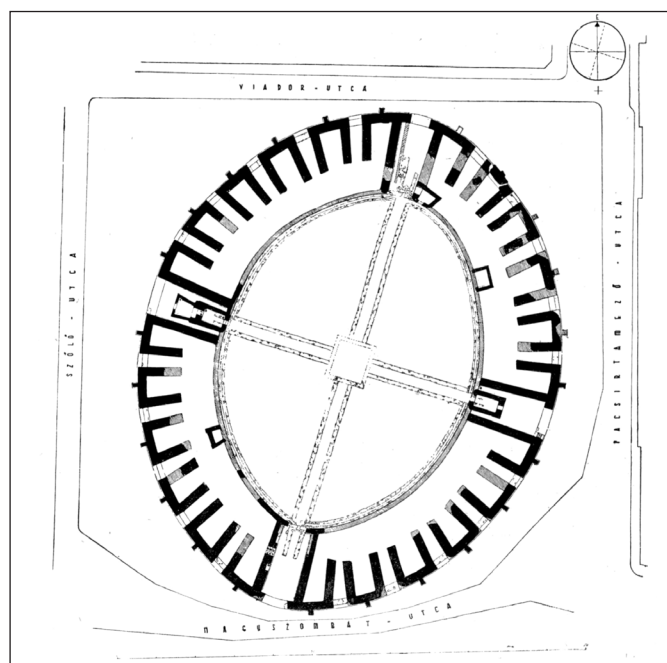
Fig. 1. Ground plan of the Nagyszombat Street amphitheatre of the military town (after GERŐ 1941, 317, Fig. 2)

The amphitheatre of the military town (Fig. 1) was excavated between 1935 and 1940 (SZILÁGYI 1956, 9), and the conservation of the ruins and a partial restoration of the building began subsequently (GERŐ 1941, 316). The amphitheatre has *opus caementicium* walls (“Roman concrete”; the wall core was built of a mixture of mortar, gravel or stones, and rubble, and faced with stones on both sides) and had a relatively simple structure (Fig. 2). The space between the ring wall surrounding the arena (A) and the external ring wall (B)

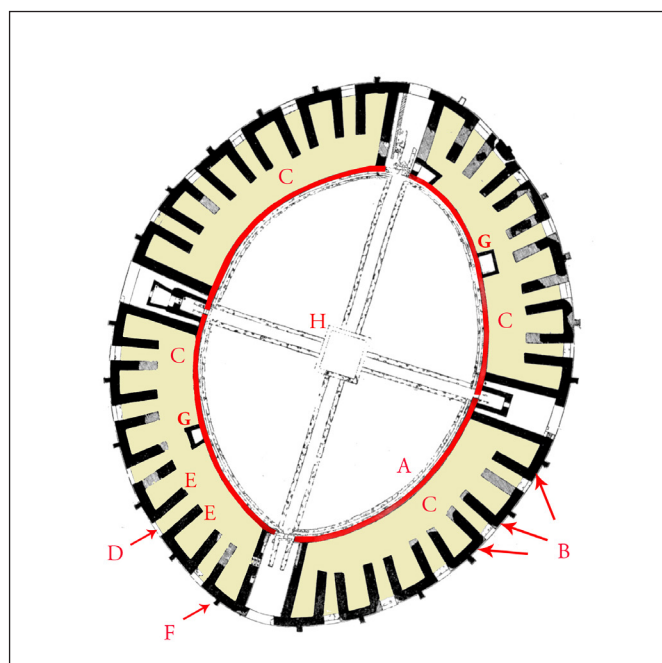
Fig. 2. Main parts of the amphitheatre (see text for legend; by L. Timár; based on Fig. 1)

was filled up with compacted soil and the gallery (C) was built on top of that. There were regular openings (D) in the external wall, lined by radial wall sections on both sides (E). According to the interpretation of the archaeologists who excavated the amphitheatre, visitors could access the seatings by taking the stairs in these openings, and the uppermost rows in the gallery for spectators were supported by the radial wall segments (GERÖ 1941, 321). There was a protruding part in the middle of each wall section in the external wall (F). Small rooms adjoined the arena (G), and an aqueduct system of considerable size (H) was also built.

As mentioned above, there was a small protruding piece of masonry in the middle of each external ring wall segment (Fig. 2, F). These were rebuilt as buttresses when the building was partly reconstructed. The published excavation photos (Fig. 5) suggest that none of these stonework segments was preserved at a height sufficient for a full reconstruction, and, with the excavation documents now lost, it cannot be decided anymore whether they were buttresses indeed or supported half-columns. It is also uncertain whether the present ground plan is complete and if there was an additional row of pillars outside the external wall. Besides, the excavations brought to light further architectural elements of the military town's amphitheatre (SZILÁGYI 1956, 13; NAGY 1943, 374), but these also proved insufficient to clarify the façade's structure. In his paper, Gerő provides a detailed description of the hypothesis he used when reconstructing the openings in the façade (GERŐ 1941, 321–322), but his assumptions lack a firm basis.

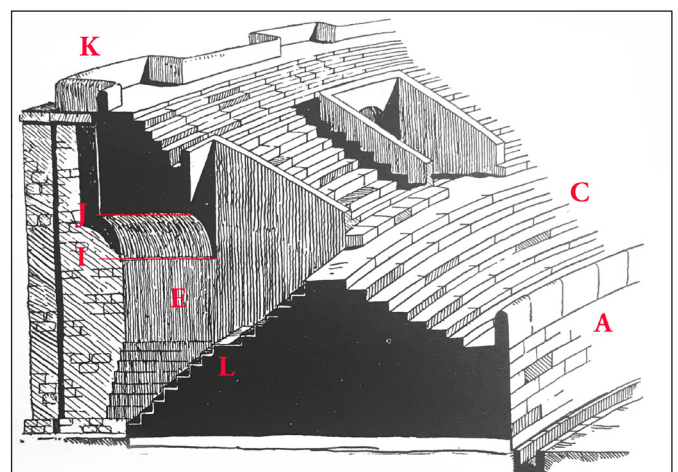
*Fig. 4. Reconstructed cross section according to János Schauschek, with the major parts highlighted (see text for legend, after SZILÁGYI 1956, 21, Fig. 12)*

All other reconstruction drawings (by János Szilágyi and János Schauschek: SZILÁGYI 1956, 21, Fig. 12; by Gyula Hajnóczy: HAJNÓCZI 1971, 189, Fig. 3; HAJNÓCZI et al. 1995, 67) are based on Gerő's hypotheses (Fig. 4). The height of the ring wall surrounding the arena (A) was more-or-less given, while the height of the external ring wall can be calculated from the inclination of the gallery (C). The steepness of the flights of stairs also depends on that of the gallery, while it also defines the height of the vault's springing<sup>3</sup> (I) (provided that the ceiling comprised of horizontal vaults, which Gerő was unable to clarify; GERŐ 1941, 322). The springing line (J) of the vault supported by the radial walls (E) could not have been higher than the row of seats on top of it, so the height of the amphitheatre's external walls is defined by the inclination of the gallery. The reconstruction drawing shows a low wall at the perimeter of the gallery (K), and it was assumed that the rows of seats continued above the flights of stairs. Therefore, the headroom above the stairs is more-or-less limited. Upon reconstructing the building's cross-section, a problem arose: as the steep gallery could only be accessed through a similarly steep staircase, the headroom above the stairs would not have been sufficient. The reconstructions solved this problem by inserting different-size landings (L) into the entrance staircase. The amphitheatre's 1940s reconstruction became a cornerstone for all later interpretations.

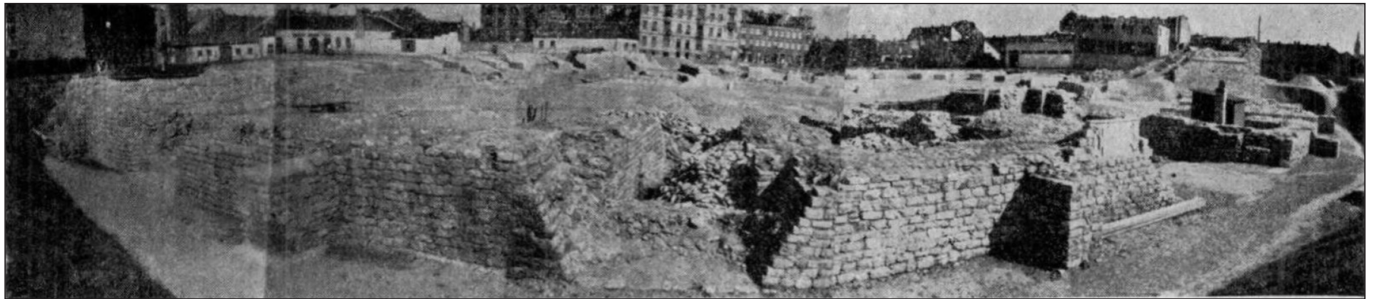
*Fig. 5. The “best preserved quarter”, panorama photo compiled of several images (GERŐ 1941, 318, Fig. 3). A protruding stonework segment is visible in the foreground, probably in its restored state. The relief on the wall behind it is thought to feature the building inscription of the amphitheatre, discovered in 1927 during the construction of a house at 8 Viador Street (currently in the collection of the Aquincum Museum, inv. no. 63.10.28; a copy is on display in the underpass at Flórián Square)*

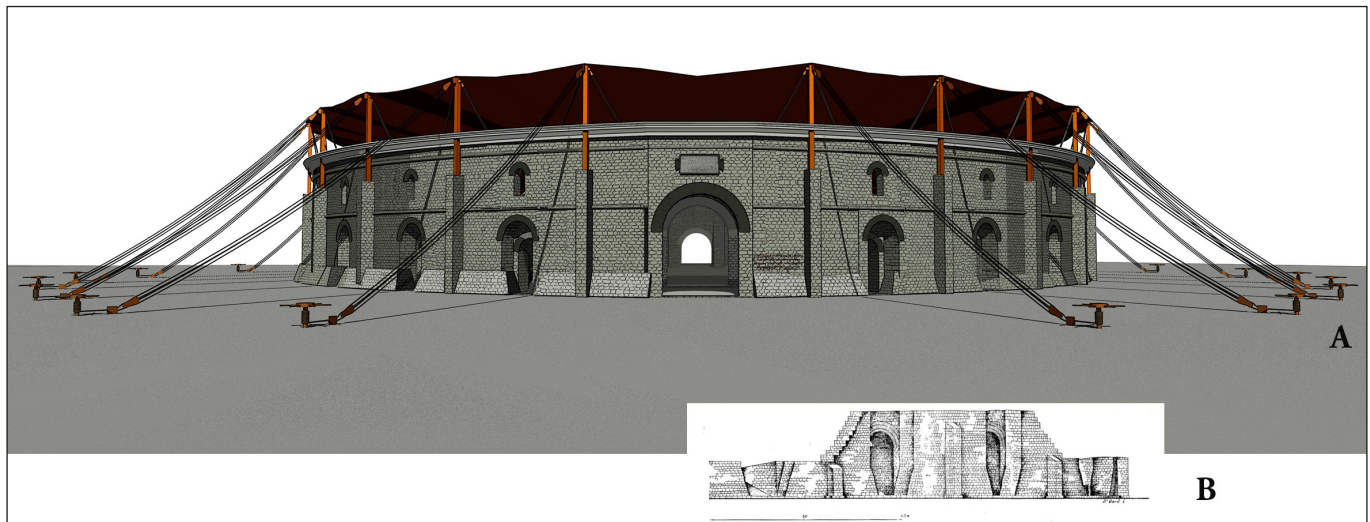
Fig. 6. The reconstruction shown on the boards (A – by L. Timár) and a drawing of the currently visible, restored building part (B – by L. Gerő, GERŐ 1941, 322, Fig. 10)

The reconstruction built based on Gerő's hypothesis represents the smallest possible building volume. In our opinion, it cannot be excluded that the amphitheatre in the military town was much more massive and big, with a steeper gallery for spectators, higher façade openings, and rising barrel vaults above the flights of stairs.<sup>4</sup> However, the building had to be presented on the information boards in a way that corresponds the existing, conserved ruins (Fig. 6). Therefore, we had to find a compromise to not to confuse the visi-

In the displayed reconstruction drawings, the façade of the amphitheatre has two stories and is much higher than in the earlier versions. It should be noted that the façades of amphitheatres were not uniform (see, e.g., the comparison between the amphitheatre in El Jem and the one in Verona: WILSON JONES 2000, 15–16, Fig. 0.23). In our current understanding, the Nagyszombat Street amphitheatre, of relatively simple structure and modest ornamentation, is unlikely to have had a façade adhering to the classical proportions defined by the Roman orders of architecture, as this was only typical for buildings with their façades ornated with (half-)columns.

The only vault that was rebuilt is the one above a flight of stairs. This was partly due to financial reasons, and partly because László Gerő was unable to say anything certain about the arches on the external walls (GERŐ 1941, 322, see also footnote). However, the reconstruction drawings display these hypothetical external arches, and windows were also added above the ground floor openings to visualize the height of the building. The walls in the drawings have small, thin cordons and cornices. In line with earlier interpretations, the protruding pieces of masonry were presented as buttresses and supports for the awning (*velarium*) that covered the gallery for spectators.

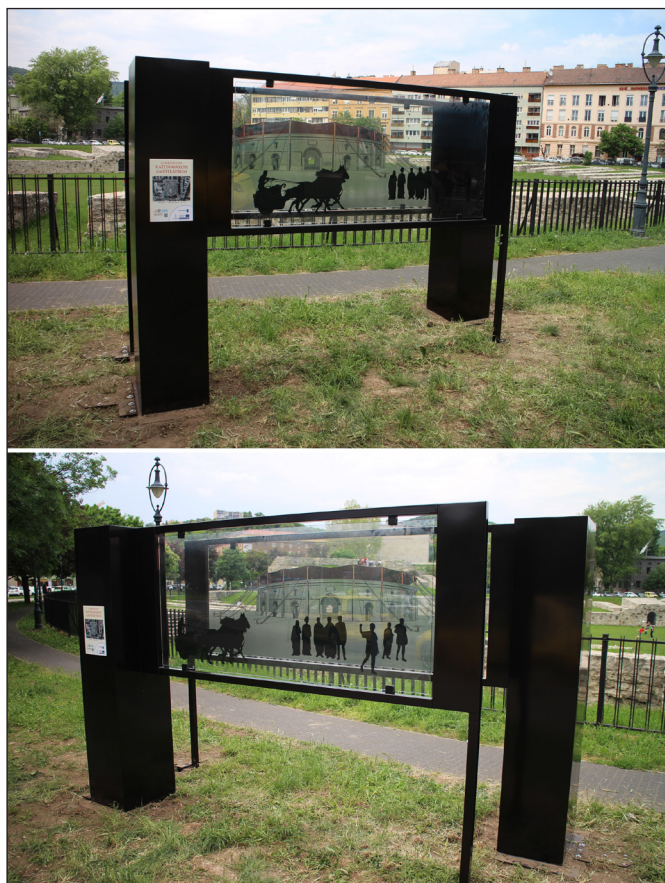
Fig. 7. Board A1-A2 from two different angles  
(by L. Timár)

Board A1-A2 has been installed beside the amphitheatre close to Pacsirtamező Road. The board consists of two large glass panels (90×200 cm and 90×240 cm in size, respectively). One of them shows silhouettes, the other a possible reconstruction of the amphitheatre. The two panels are 60 cm far from each other, so that they give the passer-by the illusion of movement, a bit like the once-popular floaty pens of the '70s and '80s. The amphitheatre is depicted with 120° field of view, facing the entrance that leads into the arena. Thus, a person passing by the image, viewing it from any angle has the impression of looking at the entrance from the front. Winches for setting up and extending the *velarium* have been drawn around the building. Their presence is mere speculation, but it was necessary to fill the space around the building (the amphitheatre itself takes up only ca. two-thirds of the image so that the necessary field of view can be applied). In fact, the representation has three layers: on the first panel, there are silhouettes, on the second, the drawing of the amphitheatre, and the third layer is the background itself, the built environment only dimly seen through the glass panels. As the viewer passes by the installation, the three layers 'move' in relation to each other, creating an almost holographic illusion (Fig. 7).

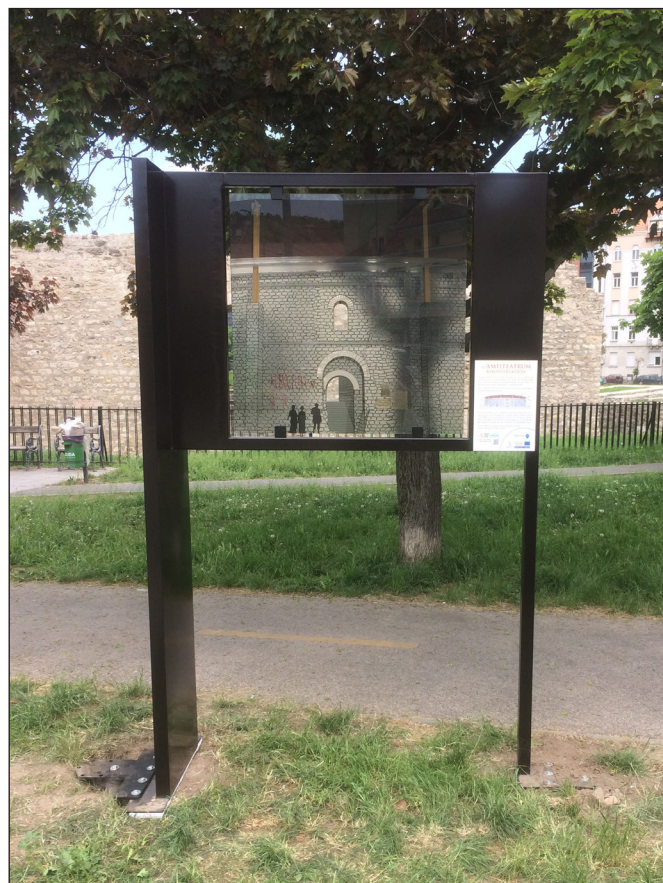
Fig. 8. The reconstruction drawing on Board A3  
(by L. Zimár)

Board A3 is installed on the corner near the Square of the Katyń Martyrs, and shows the reconstruction of the building part that stands right in front of the board. The drawing is to be viewed together with the actual ruins, similarly to the installation at Heidendor in Carnuntum (Austria). There is, however, a significant difference between the two sites: the remains of Carnuntum stand isolated in a field, without modern structures around it, and the whole complex is visible from one spot.

Unfortunately, in the case of the Nagyszombat Street amphitheatre, the possible locations to install the board – and the viewpoint – were limited. The position of the sidewalk, the bike lane, the fire hydrant, and the associated pipelines, and the lines of underground cables all had to be taken into consideration. The board was fixed in place with soil screws, and only during the first installation attempt did we realise that there was rubble in the ground, which made it impossible to set it at the selected location. Therefore, we had to move the board to a place where one of the trees in front of the amphitheatre obstructs the view. The reconstruction drawing had to be adapted to this situation. The panel is transparent and shows the reconstruction of a flight of stairs right in front of the board. The proportions are visualized by human silhouettes, Roman graffiti and posters (Fig. 8).

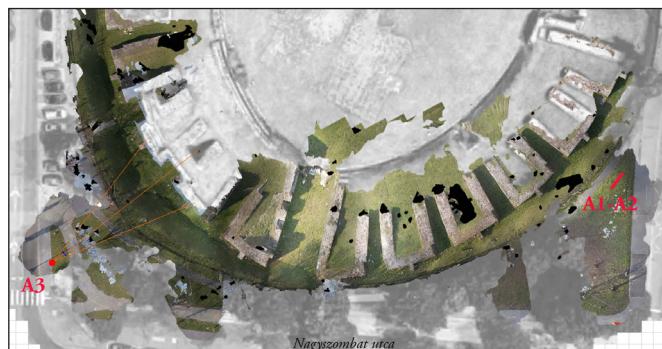
Fig. 9. The photogrammetric survey (colour) and the Google Maps photo of the site (greyscale) superimposed, with the viewpoint of Board A3 (red dot) and the wall segment shown in the reconstruction drawing (by L. Timár)

We aimed to produce drawings that are not ‘sterile’ or purely technical; at the same time, it was important to communicate that the reconstructions do not represent past reality but only an abstract image of it. The reconstruction and cross-section drawings were relatively easy to create, because the ground plan had been published and online aerial photos made it possible to build a more-or-less accurate CAD model that served as the reconstruction’s basis. However, a thorough site survey was also necessary; only thus could the reconstruction drawing be made to complete the actual ruins when viewed together. In this case, it was sufficient to prepare a photogrammetry-based model to clarify details of the ground plan (Fig. 9). As mentioned above, the position of the board had to be changed during installment and it also had to be turned slightly due to unforeseen factors, but, thanks to the survey we made at the site, these changes were not difficult to implement.
