MONUMENT CONSERVATION AND EXCAVATION OF THE ROSSZTEPLOM CHURCH IN TÖK, 2022

Hungarian Archaeology Vol. 11. (2022) Issue 4, pp. 79–83. <https://doi.org/10.36338/ha.2022.4.6>

Keywords: Tök, ruin church, excavation, community archaeology, reconstruction

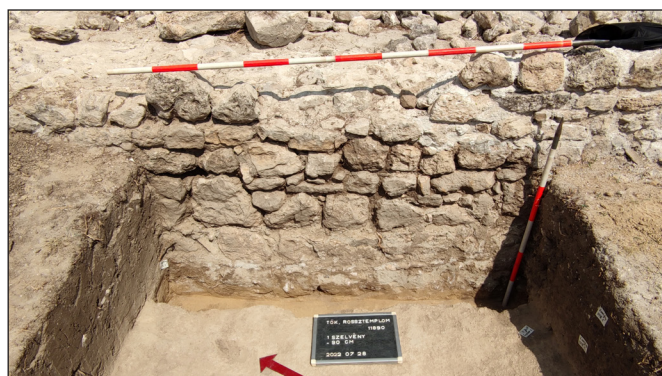
Fig. 3. The western wall in Trench 1, excavated to the bottom of its foundation (photo by Tibor Ákos Rácz)

The date was not legible on it anymore, but it was identified as a counterfeit coin imitating the type ÉH 766 (issued in 1564–1608). The yellowish, clayey subsoil was reached at a depth of 50–60 cm. We cleaned the ruined wall with a high pressure water gun and found that it was relatively easy to distinguish between the foundation and the wall itself, as the outer side of the foundation was also mortared. The overground parts of the nave's western end had been completely destroyed, but the underground part of the wall could be traced to a depth of 30–40 cm, under which we have found the 20 cm thick foundation set directly on the subsoil. This means, the floor level in the Árpadian Age on this side of the wall was 30–40 cm deeper than the present-day ground level. This observation corresponds to the stratigraphy of the trench, where the border of the two, clearly different observed layers was found in the same depth. The topmost layer (S-1) consisted of greyish brown humus admixed with rubble and mortar. Under that, we have distinguished a homogenous dense light greyish brown humus fill layer (S-2) with no rubble that yielded only a single human bone; it was identified as the Árpadian Age humus layer. The foundation trench (S-4) could also be traced along the foundation wall, deepening from the fill layer some 20 cm more; in summary, the foundation of the wall was 40 cm deep relative to the medieval ground level. Nothing suggested that an entrance had ever existed on the west side of the church.

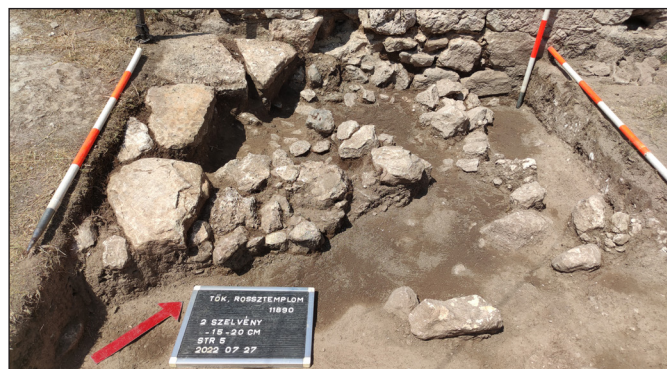
Fig. 4. Rubble of a collapsed wall section in Trench 2 (photo by Tibor Ákos Rácz)

The second trench was positioned next to the southern wall in order to clarify if there was an additional construction associated with the entrance there. The top 30–40 cm was identical with S-1 in Trench 1. Underneath, a layer containing the stones from a major collapsed wall section (S-5) was observed; it contained stones without any recognizable arrangement or connection. The layer also comprised a few pottery sherds, some animal bones, and perhaps human bones as well. A new layer started under the rubble, at a depth of 40 cm; it was a greyish brown fill with only a few stones (S-10) and somewhat more medieval ceramic fragments than the one above. Under the wall rubble at the southern entrance we discovered the remains of a foundation that protruded ca. 50 cm from the wall and served as a reinforcement of the entrance (S-14); this feature could be traced from the level of the rubble down to the yellowish subsoil. In the same section, under the foundation, we could also trace a narrow north to south foundation trench. In summary, we discovered the foundation of the south entrance in the second trench but nothing indicating a portico.

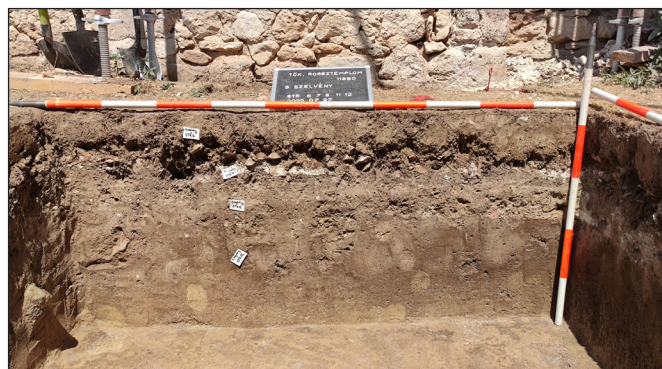
Fig. 5. Stratigraphic sequence in Trench 3 (photo by Tibor Ákos Rácz)

Trench 3 was positioned inside the nave, close to the sanctuary. The aim here was to clarify the stratigraphy of the church's interior. The position of the trench was partly defined by the scaffolding around the walls that prevented us from excavating at their feet and the building material piled up beside them, which made other parts of the church interior inaccessible. The trench was positioned in a more-or less clear area in the centre of the nave in a way to make sure that it intersects all potential important burials in the axis of the nave near the sanctuary. We found several distinct layers and a large pit. The topmost 5–10 cm was modern humus (S-6) that deposited after the first monument conservation works in 2000, when slabs had been laid in the topmost layer to create a paved pathway. The soil layer rich in gravel under S-6, observed throughout the whole trench, was a result of ground levelling during the same conservation works. It must have been created to protect the historical layers underneath, and consisted of stones that do not occur in the area naturally. The

first historical stratum was a 20–30 cm thick sandy, grey humus layer with rubble (S-8). A coin from the time of Béla IV (counterfeit of type ÉH 218, issued around 1242–1270) was found at the border between layers S-7 and S-8, while the bottom of layer S-8 featured patches of brick rubble and lime (S-11): this was the construction layer of the church. S-12 under that was a homogenous light brown humus layer that yielded no finds except for a few bone fragments in secondary position, brought there by burrowing animals. In Trench 3, the profiles proved to be the most useful in clarifying the stratigraphy of the church interior: S-8 corresponded to the medieval period of the church, while S-11 was connected with its construction.
