## EXCAVATION OF A LATE MEDIEVAL VINEYARD CELLAR IN THE TAMÁSI FOREST

Hungarian Archaeology Vol. 14 (2025) Issue 2, pp. 23–32. <https://doi.org/10.36338/ha.2025.2.3>

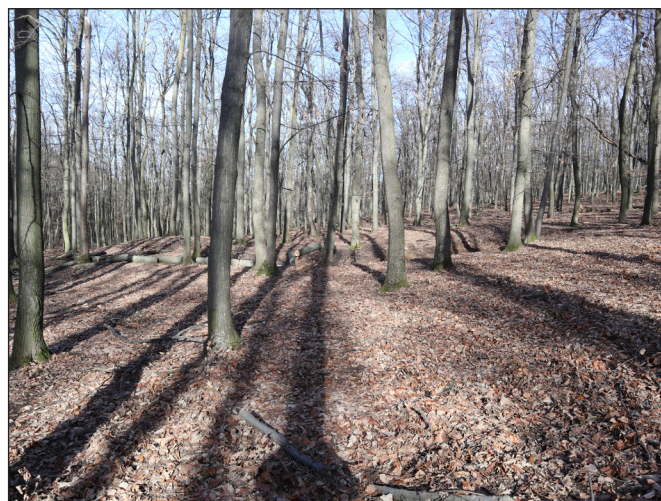
Fig. 1. The cellar and the terrace in front of its entrance preceding the excavation (photo: András K. Németh)

The location of these buildings, which are built into the ground to a greater or lesser extent at the bottom, side or edge of sloping hillsides, is indicated by surface depressions, which in the case of the excavated cellar measure approximately 15×7 metres. In front of the cellar entrances, depending on the steepness of the slope, there is usually a terrace formed from the earth excavated during their construction (Fig. 1). Their function and age of destruction can be determined from the metal finds collected from the collapsed rooms and, in particular, from those collected from the terraces, using a metal detector. Based on the few coins found, the cellars (i.e., cellar buildings) were used in the second half of the 15th and the first half of the 16th century, up to the Ottoman occupation in the 1540s.

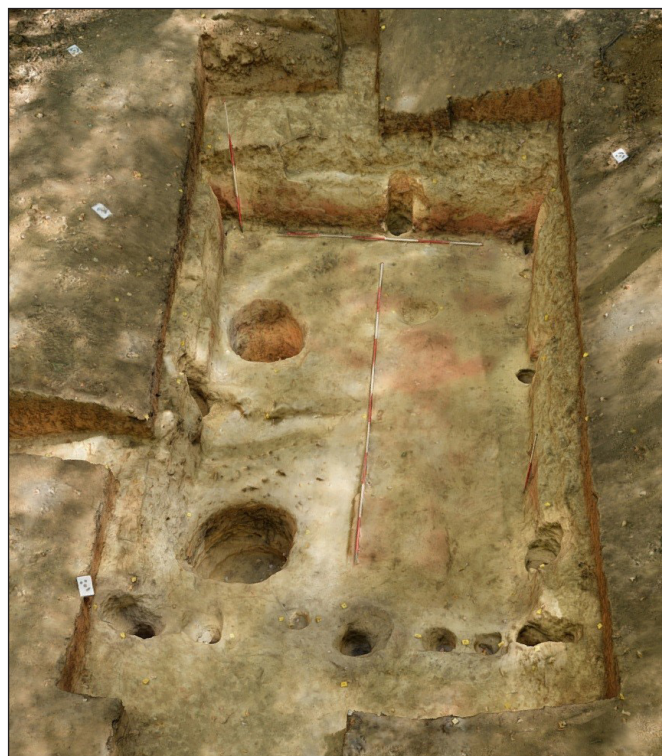
Fig. 3. Photogrammetric survey of the cellar (prepared by Norbert Sandó, Pazirik Informatics Informatikai Ltd.)

the rear wall). Its walls were half buried in the ground, and those rising above ground were of a construction of pile and wattle and daub (Figs. 3–5). The cellar consisted of a single room, with no evidence of internal divisions. Its entrance opened from the valley on the western side, where the wall of the building was sunk about 50 cm into the ground, then cut into the ground more and more towards the east, with its eastern wall formed by a vertical loess bank at a height of 1.5 metres. On its two long sides, we uncovered three large post holes, each with an average diameter of 30–40 cm (range: 25–42 cm) and an average depth of 60 cm (extreme values: 34–62 cm), and in the middle of its shorter sides, we discovered the location of two ears supporting the structure, the dimensions of which on the eastern side matched those of the side holes, while the entrance (western) branch ear, with a diameter of 60–70 cm and a depth of 76 cm, stood out from the other post holes. At the bottom of the post holes, in some places we found the remains of charred posts, which had been buried by falling debris and thus had not burned completely. The density of the pile holes on the western side suggests a wattle-and-daub wall fence (in pit 1, next to the entrance, we also observed the charred remains of a similar wattle-and-daub wall fence among the collapsed pieces of clay plasters), while the sparse distribution of pile holes on the longitudinal side suggests a plastered reed wall (cf. PÁLÓCZI HORVÁTH, 2005), which is also supported by the distribution of the plaster remains. At the base of the eastern wall, we observed traces of a 2 cm thick layer of mud plaster on a small area, with a palm-sized square grid pattern scratched into it (Fig. 6).

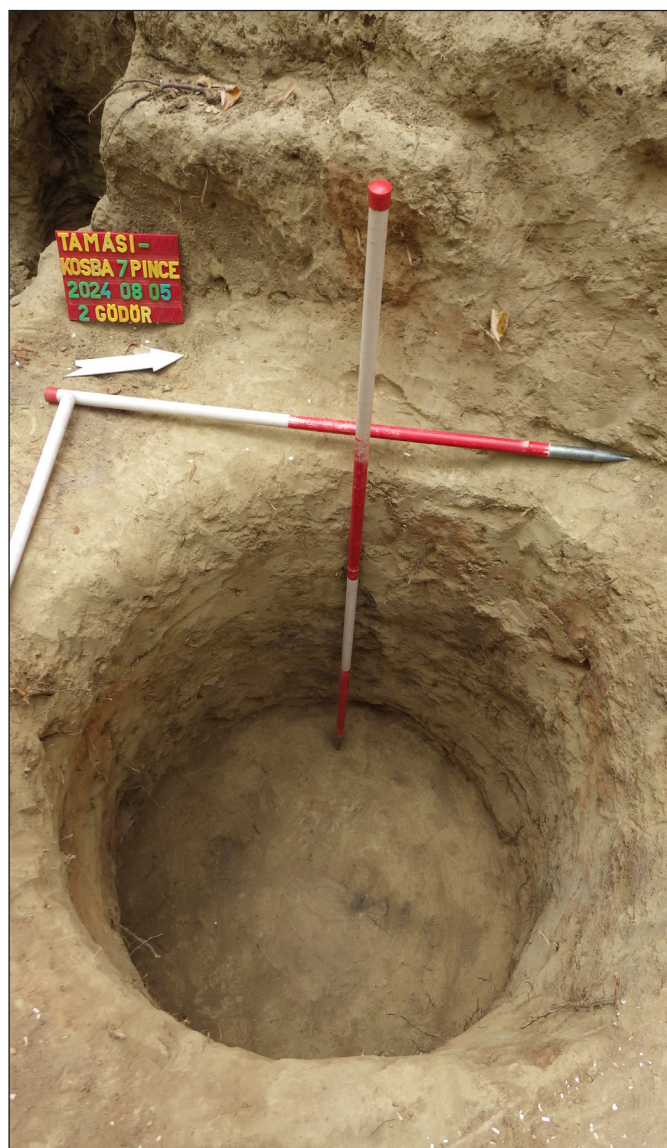
Fig. 7. The second pit (photo: András K. Németh)

Inside the building, directly along the northern wall, we uncovered two larger, roughly circular pits with vertical walls and flat bottoms, 110 and 130 cm in diameter and 120 and 150 cm deep, respectively (Fig. 7), which, based on the large amount of charred clay plaster residue found in them, were still in use when the building was destroyed. It would be logical to consider that these were grain pits, but caution is advised due to their characteristic narrowing mouths, burnt walls, and lack of burnt seeds (NOVÁKI, 1983). The pits were probably once covered with a wooden lid: there is a similar solution in a 20th-century cellar in Szenna (MÁTÉ, 2021, 101, Fig. 18).

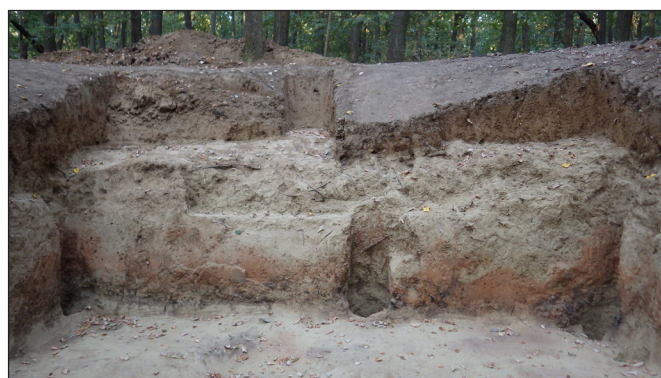
Fig. 8. Wall niche in the rear wall of the cellar (photo: András K. Németh)

A niche approximately 280 cm long and 20–25 cm wide was cut into the rear wall of the building at chest height (Fig. 8). In its considerable length and narrowness it is different from similar niches often

found at the end of today's cellars, but I cannot interpret it as anything other than a storage space.

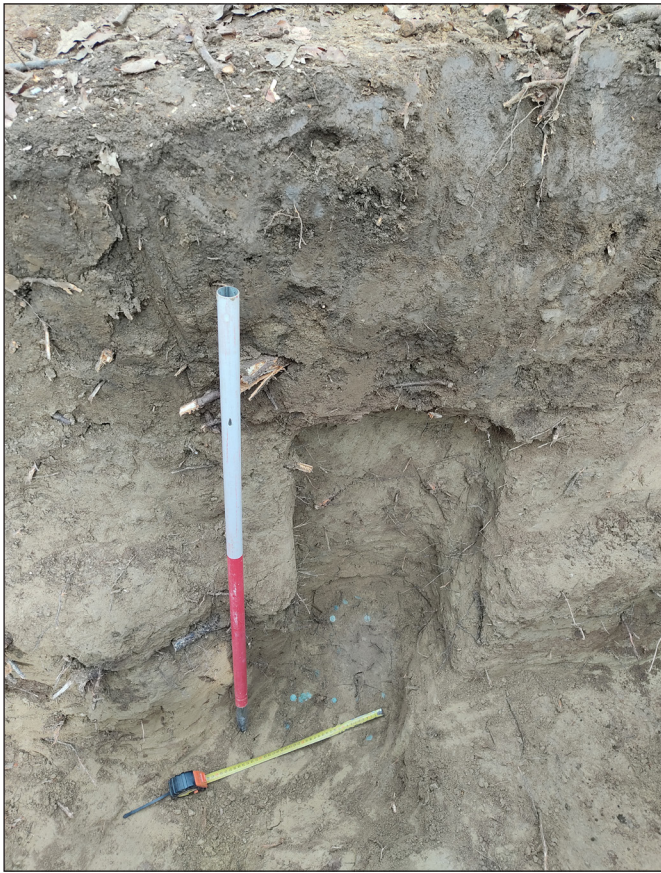
Fig. 9. Coin find in the pit of the middle pile on the north side (photo: András K. Németh)

The excavation was prompted by the discovery of coins, the first few of which were found during a metal detector instrumental survey in the dent in the cellar. The core of the coin hoard was found in the lower part of the central pile hole on the northern (longitudinal) side (Fig. 9). The find may have been placed in some kind of organic material at the base of a pile. The pile had perhaps become loose and some pieces may have come to the surface over the centuries, because the roots of the tree grew above it, or due to erosion and animal disturbance. The 730 finds consist of 564 Hungarian and 166 Austrian silver coins, mostly Ferdinand I denars and Austrian pfennigs, which, based on the closing date, were left in the ground in 1541. Despite the closing date, the destruction of the building can be dated to a few years later, to the time of the Ottoman military campaign of 1543 or the Ottoman conquest of the region in 1545.

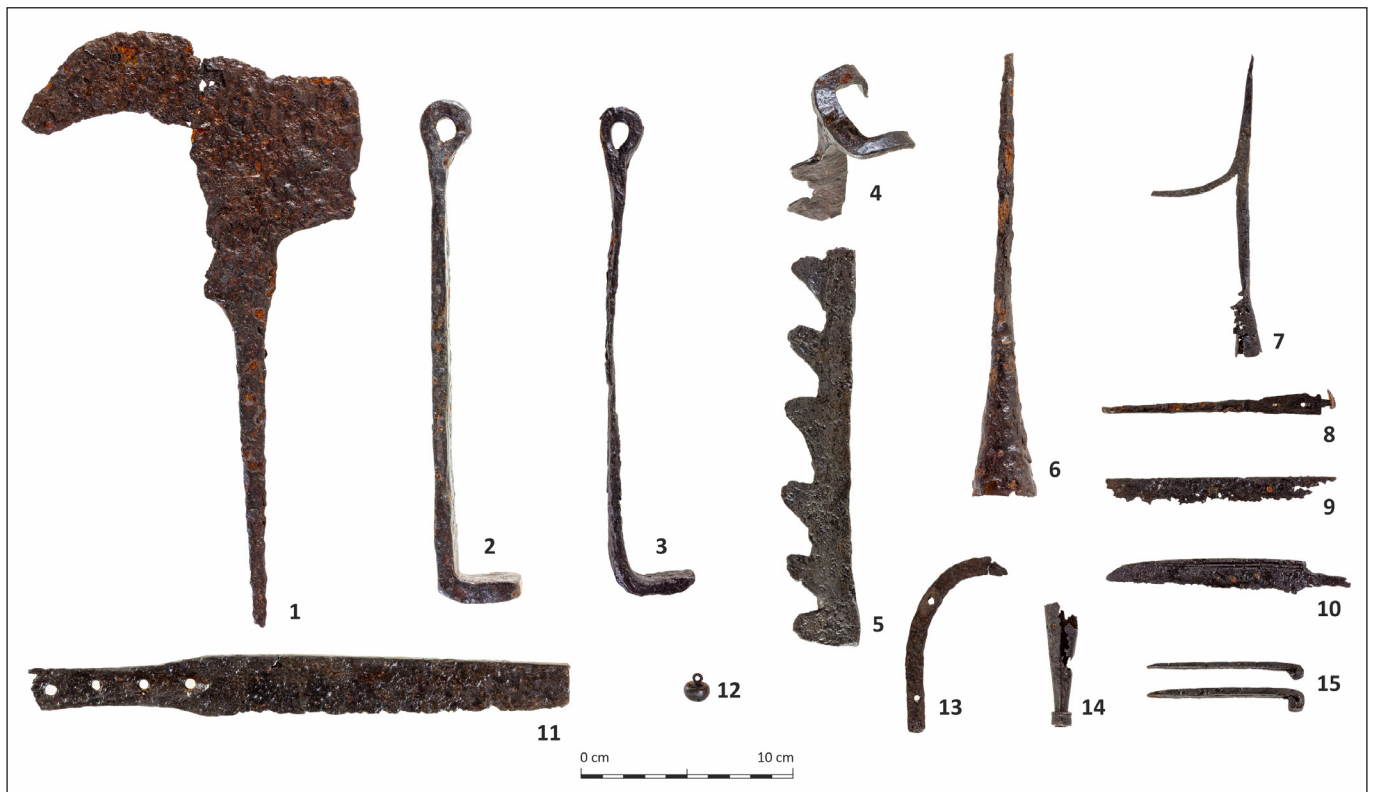
Fig. 10. Selection of finds from the cellar (photo: Tamás Retkes, image editing: László Vicze)

Before the excavation, an axe-shaped hatchet-style grape vine pruning knife (Fig. 10.1) was found in the recess of the cellar, and on the terrace in front of the entrance, an iron puller (Fig. 10.3), a fragment of a cauldron hook (Fig. 10.4), a spearhead (Fig. 10.6), a fragmentary peasant knife (Fig.

10.11), a knife blade, a boot jack (Fig. 10.13), a button with a loop (Fig. 10.12), and two peculiar L-shaped nails with flattened ends (Fig. 10.15). During the excavation, we found the other half of the cauldron hook (Fig. 10.5), a hay hook (Fig. 10.7), an eating fork (Fig. 10.8), and several fragments of knives with flat handles (Fig. 10.9) in the rubble of the building. Only a few iron nails were found. It is clear that not only tools used in viticulture but other agricultural tools, implements and utensils were also found in the building and on the terrace in front of it, the function of which I will return to.
