## THE “GLASS CHURCH” IN THE PILIS MOUNTAINS The Long and Complex History of an Árpád Period Village Church

JÓZSEF LASZLOVSZKY<sup>1</sup> – DÓRA MÉRAI<sup>2</sup> – BEATRIX SZABÓ<sup>3</sup> – MÁRIA VARGHA<sup>4</sup>

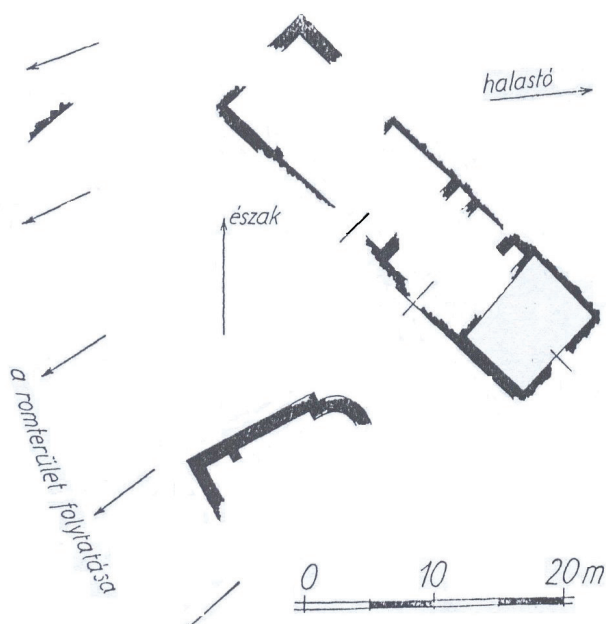
Fig. 2a: Ground plan drawn by László Krompecher after his excavations. Krompecher, László: *A pilisi apátság romjainak fellelése*. *Technika. A Magyar Mérnökök Lapja* 15 (1934), fig. 31

the Middle Ages a number of monastic communities lived in the Pilis Mountains. As the ruins at the Pomáz site cover a more or less rectangular area, reminiscent of the wings of a monastic complex at first glance, researchers first attempted to identify their exact function along these lines. László Krompecher, a professor at the Technical University in Budapest started to deal with the site in 1927, and based on the ground plan he reconstructed from the visible ruins he determined it was the Cistercian abbey of Pilis.<sup>6</sup> From the following year on he carried out excavations as well that unfortunately did not exactly correspond to professional standards. He published a new, different ground plan in a second paper about the excavations (Fig. 2a). This drawing represents a small, single aisled church with a semi-circular apse, and an oblong building located to the northeast, the orientation of which was conspicuously not in line with that of the church.<sup>7</sup>

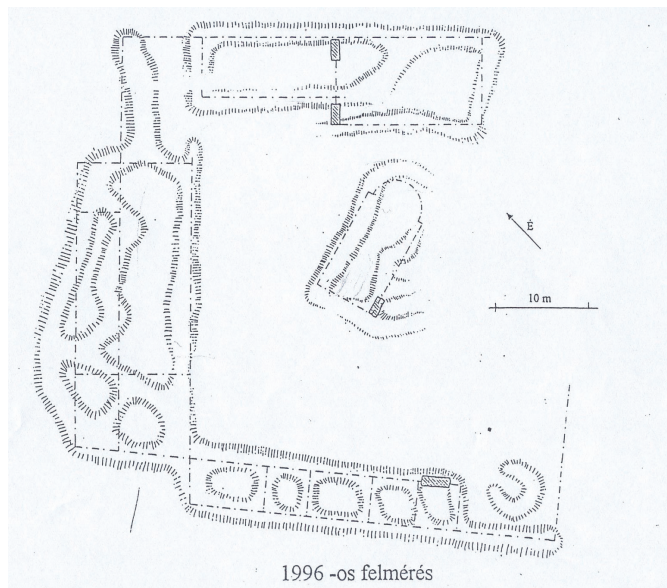
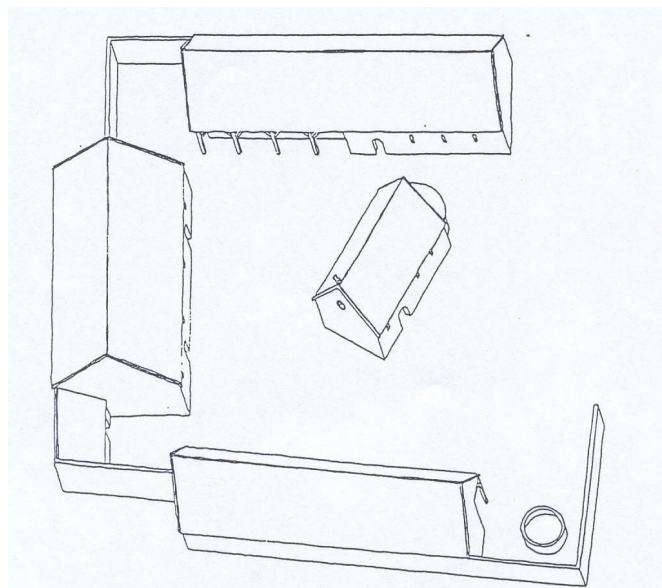
Fig. 3: Ruins visible on the surface in the mid-1990s (survey by Bálint Ásztai and Beatrix Szabó)

New research started with a survey of the surface features and the above-ground remains of the buildings. In the mid-90's the architectural students Bálint Ásztai and Beatrix Szabó investigated the complex.<sup>17</sup> Their survey confirmed Krompecher's observations concerning the difference between the orientation of the church and that of the three wings (*Fig. 3*). This suggested that the structures were not constructed at the

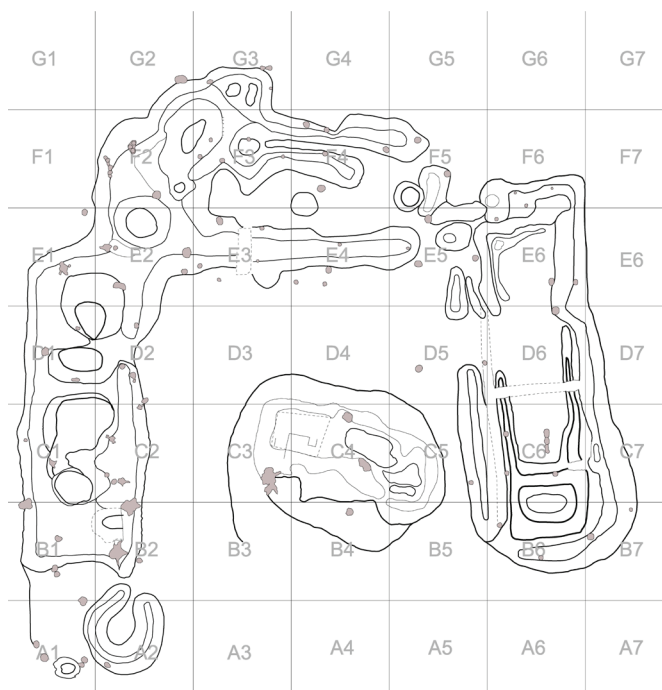
Fig. 4: Survey of the microrelief phenomena. The three wings and the church in the middle, marking the surface traces of the walls covered by earth and the earlier test trenches and disturbances (Dóra Mérai, Beatrix Szabó and László Ferenczy, 2011)

The remains of the church were covered by a meter and a half of thick stone debris, in which we could clearly distinguish Krompercher's excavation trenches (Fig. 4). It was discovered that he only opened these above the walls, tracing their line, but fortunately he stopped at the level where the ground plan could be identified – at the top of the remains – and thus he did not destroy the entire stratigraphic context. We unearthed the ashlar-built walls of the church, which survived on the western side to a height of about 100-120 cm measured from the original building ground level. (Fig. 5). In the area of the sanctuary, however, only the first row of ashlars was preserved, or in some places only the foundations (Fig. 6).

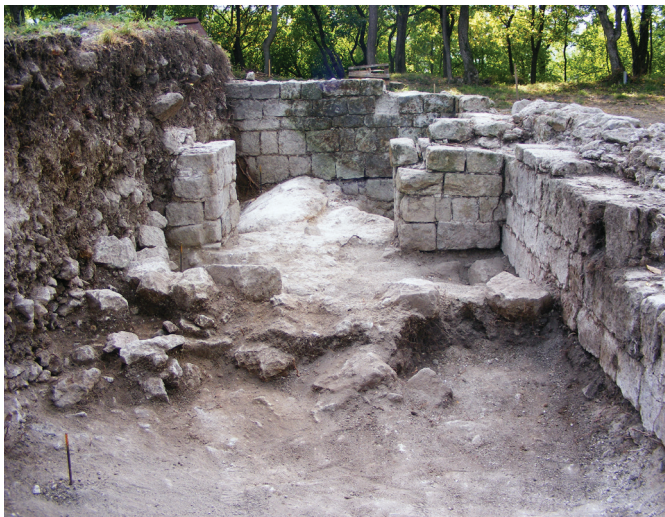
*Fig. 5: Northeastern corner of the church during the excavation. The remains of the pillar protruding from the northern wall and the one in the middle built from ashlar (2011)*

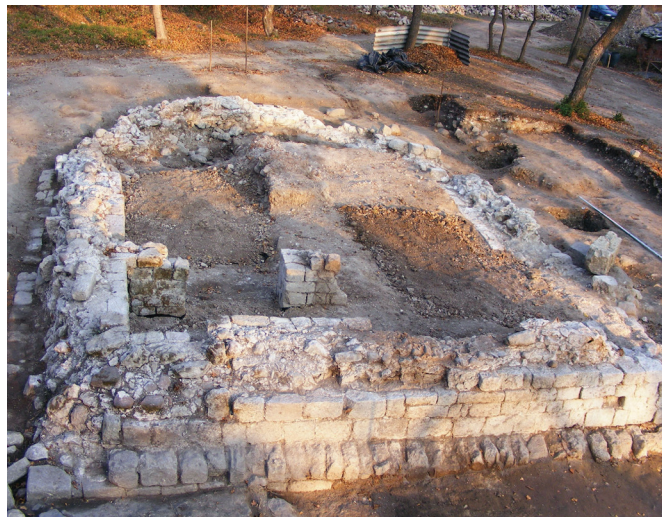
*Fig. 6: Excavated remains of the church (2011)*

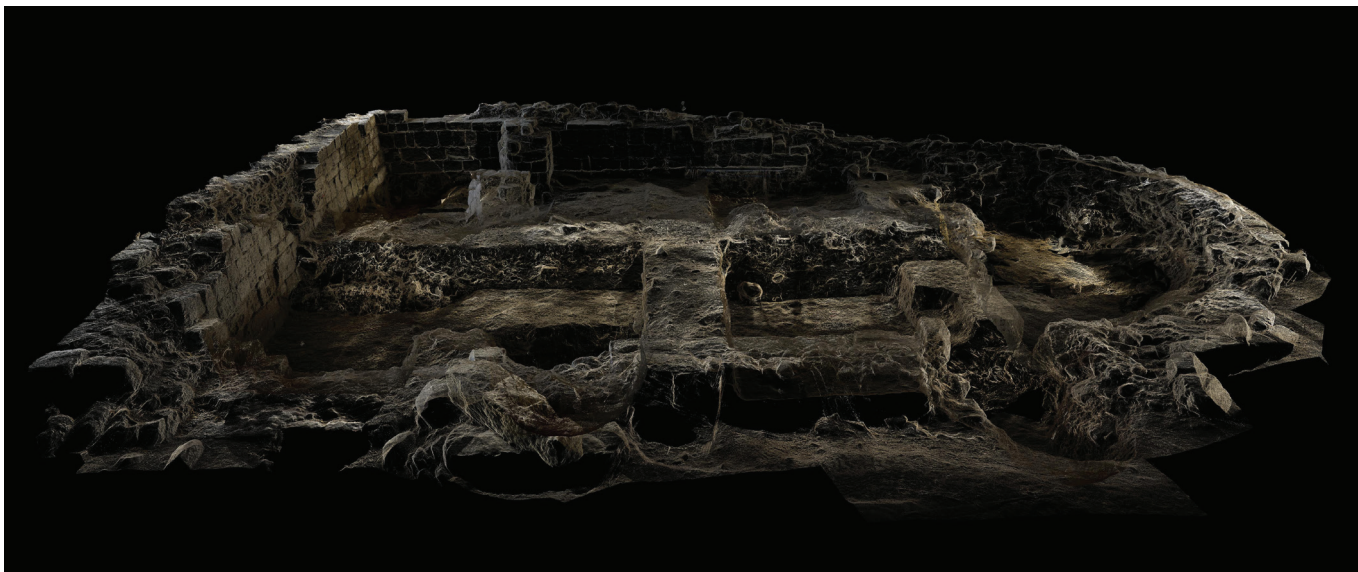
*Fig. 7: Survey of the church with a laser scanner. The building as seen from the southern side during the excavation (SZIME 3D AR project)*

We employed a variety of documentation methods during and after the excavation. In addition to the traditional architectural-archaeological survey (a stone-by-stone drawing corrected and measured with a total station), the church and the finds were scanned with a laser scanner<sup>18</sup> (Fig. 7), and we also used drones during the photo documentation of the buildings. All these will contribute to a detailed analysis of the structural and architectural characteristics of the church, and the complex stratigraphy of the site.

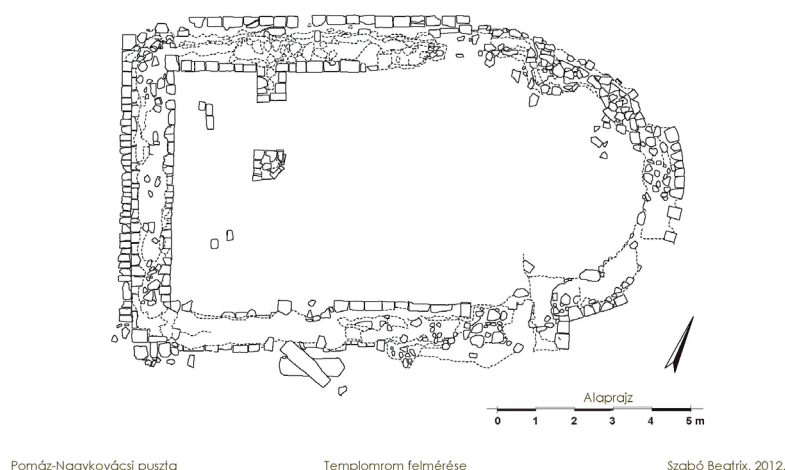
*Fig. 8: Ground plan of the excavated church using traditional surveying techniques (survey by Beatrix Szabó)*

The small (14x7 m), single-nave church was oriented towards the east, with some degree of deviation towards the northeast (Fig. 8). The semi-circular

apse was almost as wide as the nave. The entrance of the church was located on the southern side. The approximately 80 cm high remains of a rectangular pillar running perpendicular to the principal axis of the church were discovered in the middle of the western third of the nave. Two more pillars were attached to the southern and northern walls respectively, both along the same axis. Only the northern half of the central pillar has been preserved; its southern part and the pillar on the southern wall have survived only in their foundations. The eastern side of the central pillar was formed with a round-arched niche. These suggest that the church was built with some sort of a western gallery, but there is no information to reconstruct its upper structure.

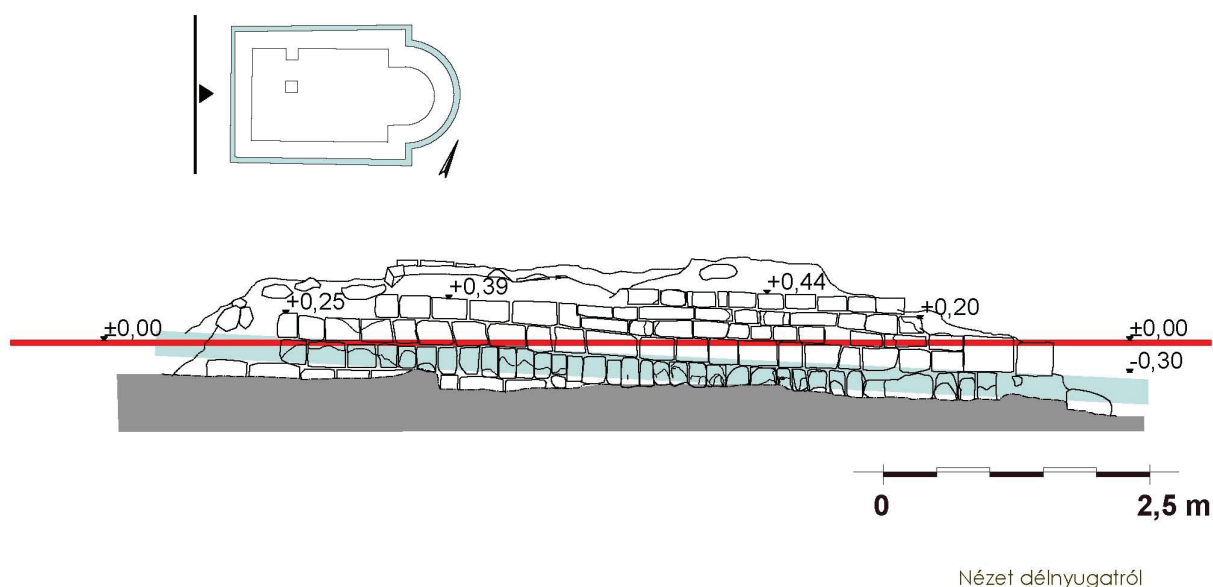
Fig. 10: The western wall of the church displaying the ashlar rows following the sloping ground level and the method of eliminating the divergence (survey by Beatrix Szabó)
