## INVESTMENTS FOR TOURISTIC PURPOSES AT ARCHAEOLOGICAL SITES AND HISTORICAL MONUMENTS

DÓRA HEGYI – ZSÓFIA NÁDAI

### RESEARCH ON THE WESTERN TOWN WALL IN SÁROSPATAK

### RESEARCH IN THE PARK OF THE WENCKHEIM CASTLE IN SZABADKÍGYÓS

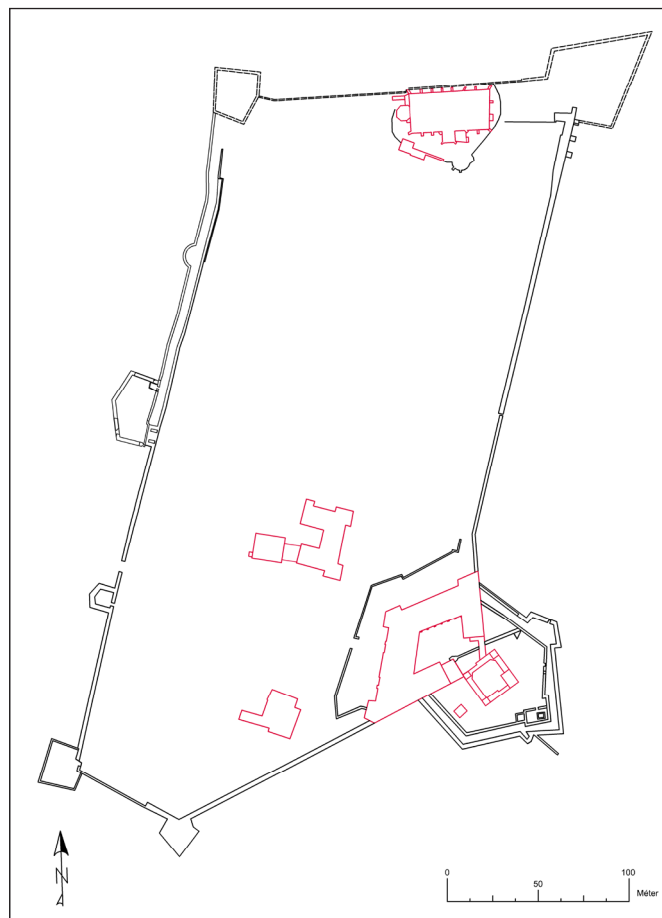
Fig. 1. Ground plan of the town

The settlement is situated on the right bank of the Bodrog Stream. This piece of land came into the possession of Péter Perényi in 1526, who then had the castle, the town walls, and the bastions built between 1534 and 1541.<sup>2</sup> In the 17<sup>th</sup> century the town was in the ownership of the Rákóczi family, and this period is seen as a second heyday, when large-scale constructions and modernization started, and the castle and the fortifications were enlarged. However, in 1702 the Habsburg Chamber ordered the castle to be blown up and made useless. The 18<sup>th</sup>-19<sup>th</sup>-century owners of the complex transformed the Red Tower and the castle wings into a romantic-style aristocratic mansion, and their environment into a landscape park. The moat around the walls was filled up; its line is perceptible today on the western side (NOVÁKI – SÁRKÖZI – FELD 2007, 102; 104–105) (Fig. 1).

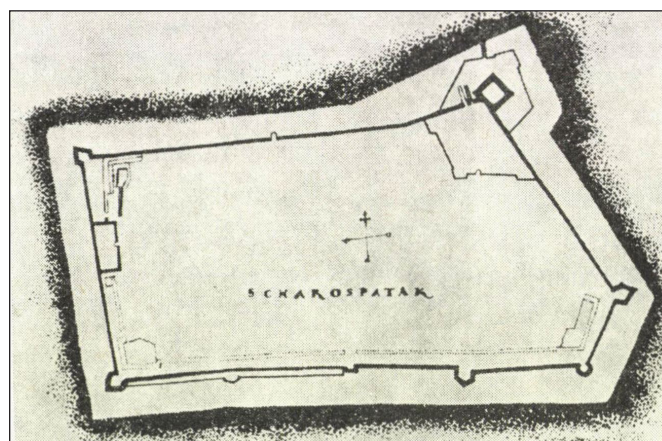
Fig. 2. Exploratory trenches in the area of the western town wall and the Lion Bastion

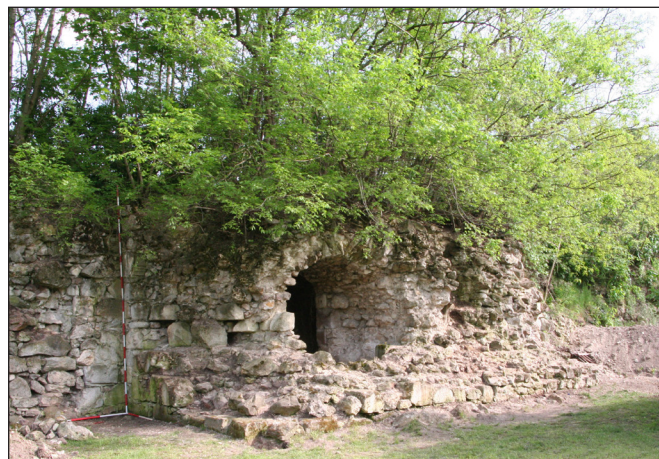
Fig. 5. The bastion built in the Perényi period, the predecessor of the Lion Bastion, viewed from the northwest

1. The western town wall, built in the Perényi period, represents the earliest building phase. The Perényi-period bastion and the western town wall are separated: the ashlar overlay that fortified the bastion's walls does not continue on the town wall (Figs 5-6).
2. In the next phase, the zwinger was built on the western side of the Perényi-period bastion.

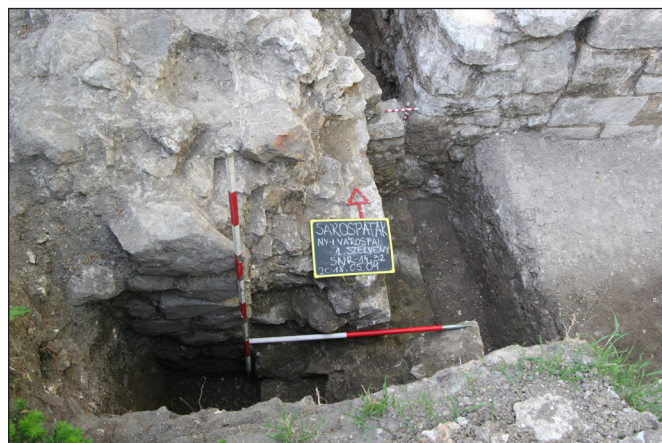
Fig. 7. The meeting point of the Lion Bastion and the zwinger, with the fourth loophole

According to Angelini’s documentation, the zwinger continued north of the Perényi-period bastion in a corner, widening the space between the two defensive walls. The excavation revealed that the zwinger continues on the southern side of the Perényi-period bastion in a similar projection; however, it is still uncertain how the northern and southern segments of the zwinger relate to each other. Research so far suggests that the zwinger’s southern part was finished earlier than its northern half, and the latter was adjoined to the southwestern corner of the bastion by a loophole, which thus became the fourth opening in the lower row of the already existing loopholes. This loophole later opened to the interior of the Lion Bastion; however, at the time when the zwinger was constructed, this part of the building was still on the outside of the town fortifications. Later a niche was created in front of this fourth loophole in order to make it useable (Fig. 7).

3. Thereafter, in the next phase, the Lion Bastion was erected, adjoining the southern projection of the zwinger. As seen in the 18<sup>th</sup>-century documentation, the Lion Bastion abutted on the zwinger’s wall and not on the western town wall. The zwinger was partly dismantled when the bastion was built; however, the above-mentioned fourth loophole was neither destroyed nor walled up.

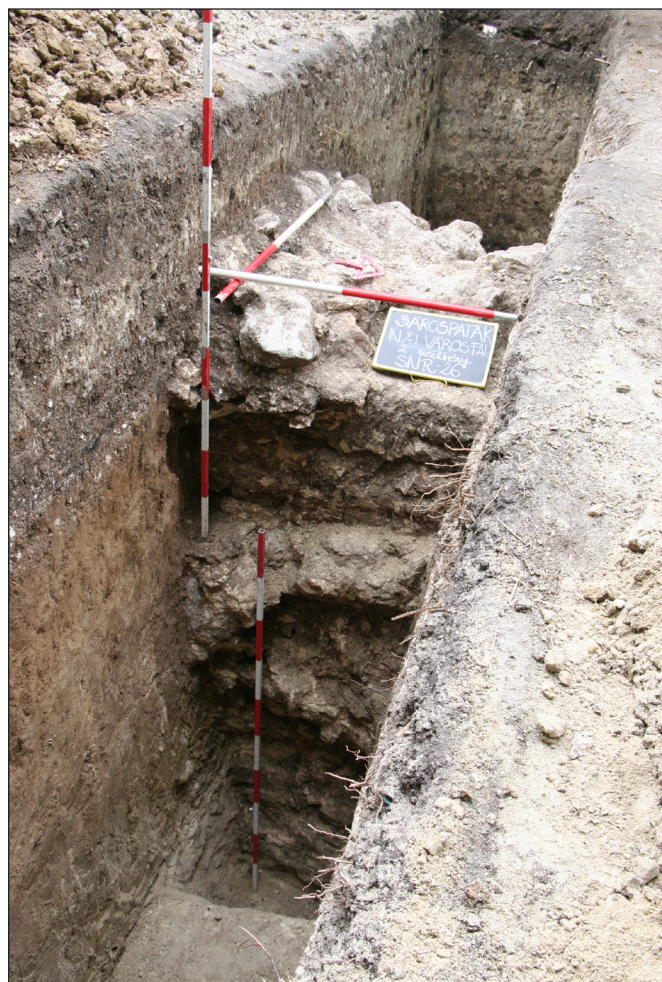
Fig. 8. The zwinger wall north of the Lion Bastion

The zwinger wall was investigated further at two locations north of the Lion Bastion. The space between the two walls became narrower towards the north (Fig. 8). It was observed in both trenches that the external surface of the wall was tiered; it cannot be excluded that this is a trace of deliberate dismantling. In a depth of 1.5 m there was a homogenous, brown, clayey fill that slanted westwards, in the direction of the once existing moat. The internal surface of the zwinger walls, however, was even, and the excavated wall segments showed that it was almost vertical. In the southern trench it was possible to explore the zwinger in a depth of ca. 3 m; the top 2.5 m was a homogenous, brown clay fill that yielded no artifacts. Underneath this a white, limey, friable layer was present, which was mixed with pebbles at places. This may be interpreted as the historical floor level of the zwinger (Fig. 9), but more research is needed to validate this argument, as the southern segments formerly excavated by Katalin Dankó failed to resolve this question. Our excavation team cut this layer in a half-meter-long section in the lee of the external wall in order to find the bottom of the wall foundation. This, however, could not be accomplished: when the friable, marly upper layer was removed, a white rock surface came to light, which was identified as a natural, undisturbed subsoil surface.

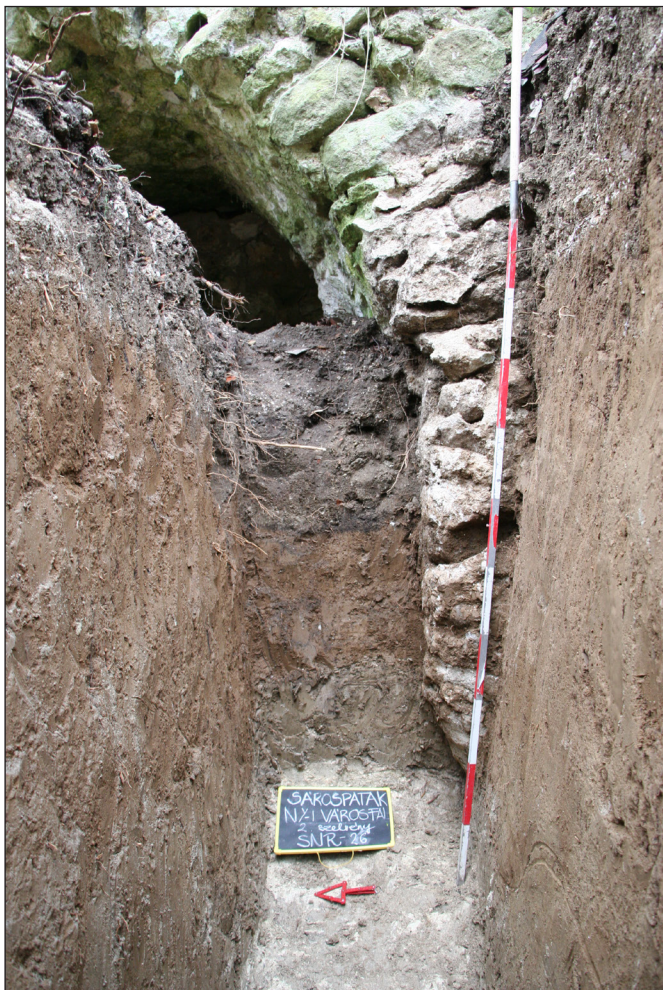
Fig. 9. The white rock surface north of the Lion Bastion

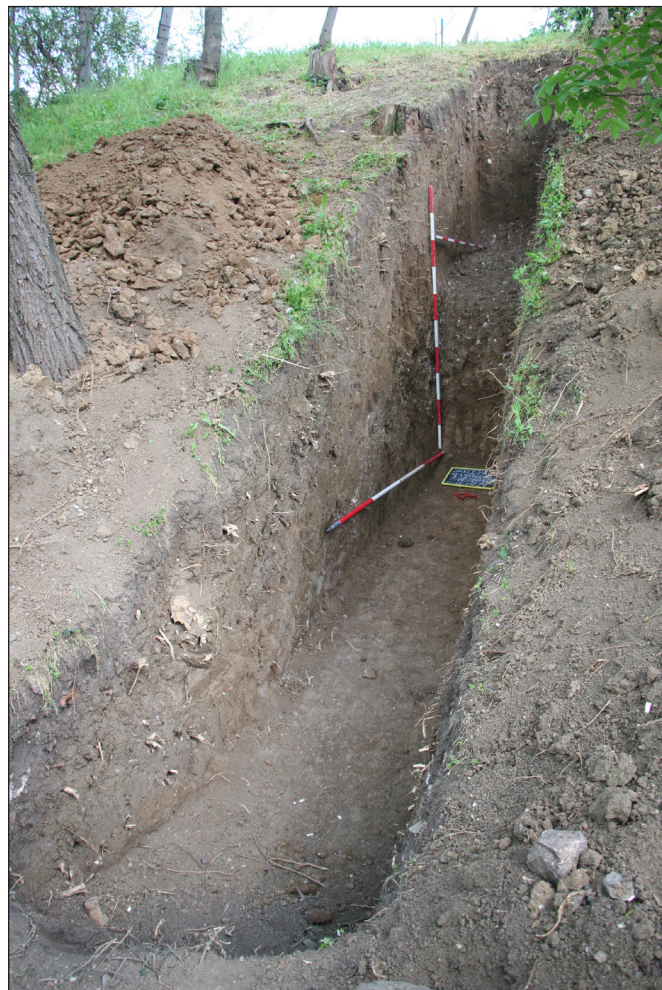
Fig. 10. The section of the cannon hill

Two further exploratory trenches were dug within the western town wall to explore the structure of the cannon hill, its relation to the western town wall, and the hypothesized road between the two. Unfortunately, modern disturbances and the heavy ruination of the wall top hampered our observations. The structure of the cannon hill could partly be explored. The uppermost, 15–20 cm thick layer of humus yielded a considerable number of artifacts. Under this there was a harder, yellowish brown, clayey layer, from which

a few objects were recovered. Underneath the latter, a grayish brown, limey, and very dense layer of soil came to light on top of another brown, very hard, clayey layer. These two lowermost layers must belong to the historical structure of the cannon hill; they yielded a few 17<sup>th</sup>-18<sup>th</sup>-century pottery fragments (*Fig. 10*).

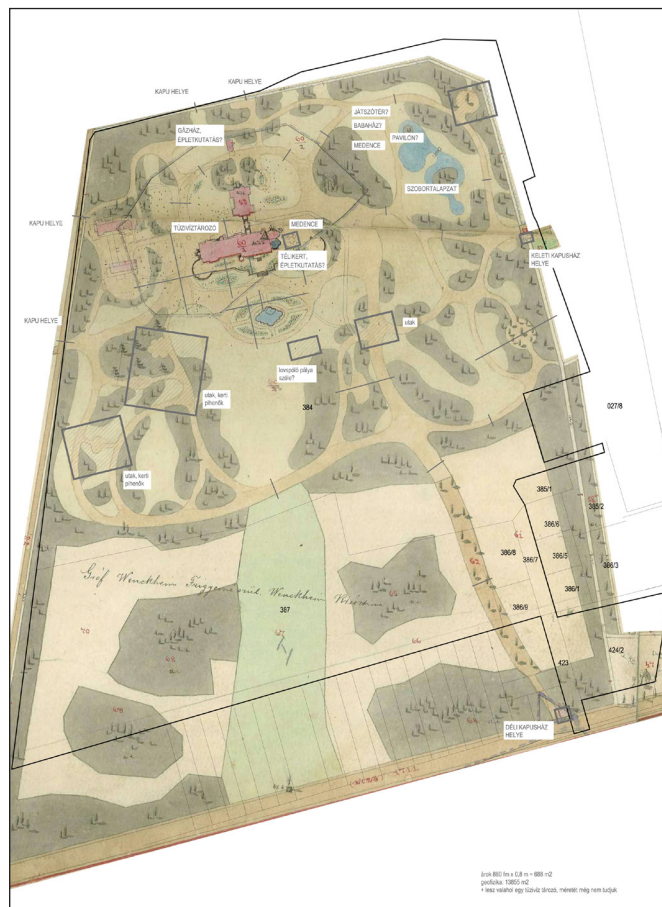
Fig. 12. Identified elements of the garden in the 1883 cadastral map (by Ágnes Bechtold, based on MOL S79 No. 0216/0459, 0467, <http://www.archivportal.arcanum.hu/kataszter/>) [kapu helye = location of the gate; gázház = gas house; játszóter = playground; babaház = doll-house; pavilion = pavilion; szobortalapzat = plinth of a statue; télikert = greenhouse; medence = basin; utak, kerti pihenők = pathways and resting places; lovaspólopályaszéle = edge of the polo field; keleti kapusház helye = location of the eastern gatehouse; déli kapusház helye = location of the southern gatehouse]

The castle park was created in the 1870s in the deliberately archaic, historical landscape style typical for that period. It was certainly finished by 1883, because it is shown in draft drawings by Gyula Dolesch, made in preparation for cadastral maps (Fig. 12). Exotic tree species, such as sweet chestnut, hybrid planes, gingko, pond cypress, and large-leaved linden were planted in the already existing oak woodland.

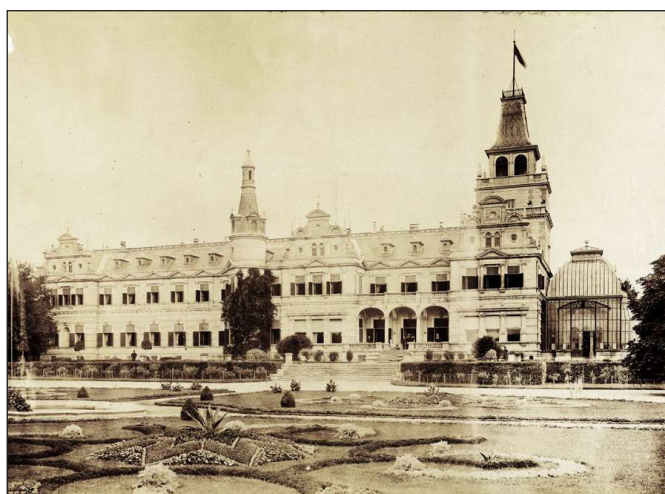
Fig. 13. The Wenckheim Castle, photo by György Klösz, 1895-1899 (Source: Fortepan 83296 / HU BFL XV.19.d.1.11.204)

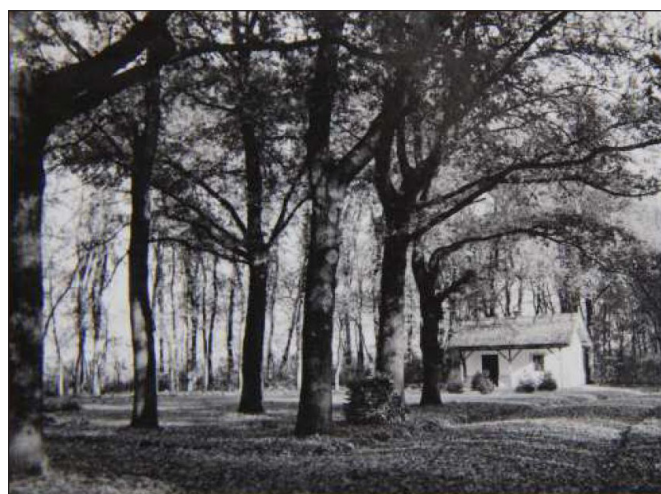
Fig. 14. The doll-house in Szabadkígyós, viewed from the south (photo in the private collection of János Tuska, 1940s [Bechtold 2017, Fig. 108])

Frigyes and Krisztina Wenckheim had built a swimming pool, a training field, and a so-called doll-house for their seven children. The latter building stood in a visual range from the castle, next to the road that led northwards. This small, bipartite brick construction copied a peasant house with a porch and a thatch roof (Fig. 14). Later a polo field and a tennis court were established as well, and Dénes Szigfrid Wenckheim (1921-1943), the grandson of Frigyes and Krisztina, had built a landing strip and a hangar for aircrafts.

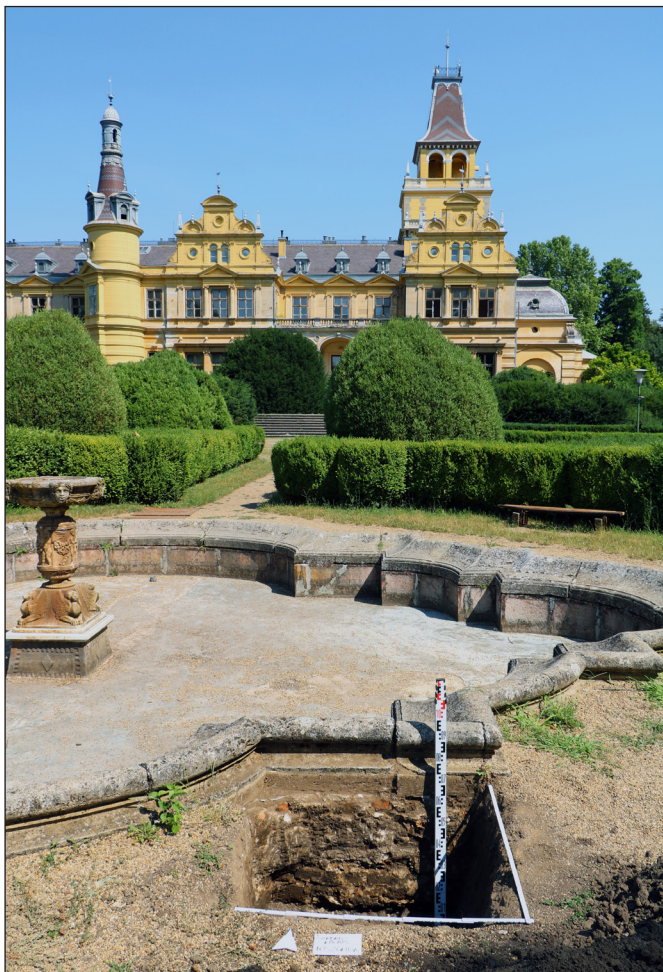
Fig. 16. Foundation of the southern great basin and its transposed fountain

reconstruction targeted this area. This survey primarily aimed to locate sites already known from historical documents (Fig. 15), and to examine their built structure and foundations. Built features of the pleasure ground, i.e., the foundation of the central basin, the pathways, and the stone jar foundations around the garden, were brought to light. A flight of stairs leading to and a retaining wall around the terrace, and the foundation of another, smaller stone basin was also explored in the castle's near vicinity (Fig. 16).

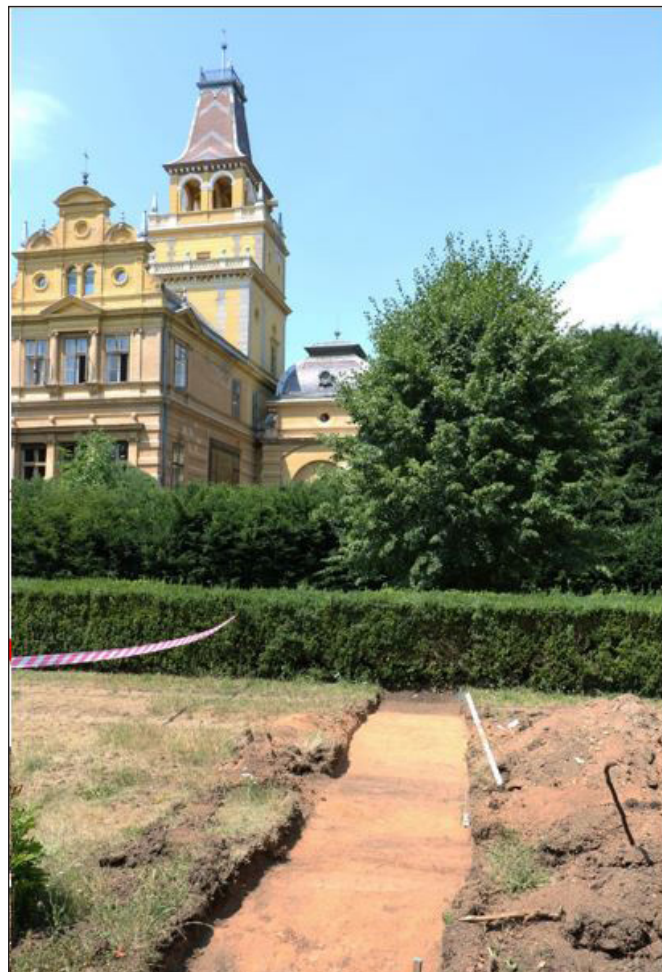
Fig. 17. Foundation of the pathway in front of the castle's southern façade

Concerning the garden pathways, we observed that only the main routes running to the four gates were supported by artificially made structures (Fig. 17). Their track could be reconstructed. The remaining pathways, however, were hardly perceptible; at places, not even their gravel surface was preserved. These must have been simple, small dirt roads with an elevated stripe of lawn on the two sides. The edges of the polo field were damaged by the running track of the later training field, while the tennis court was partly destroyed by the waterworks that was established here later.

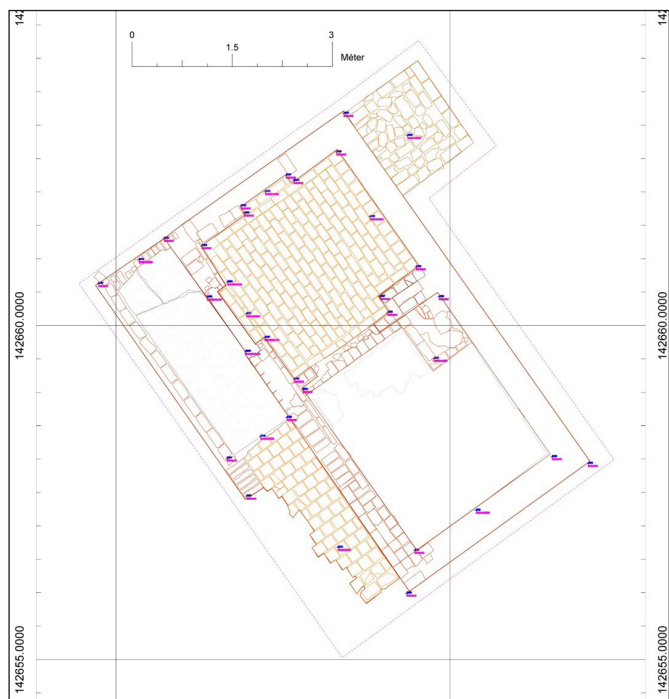
Fig. 18. Georeferenced overview of the doll-house in Szabadkígyós (by Péter Szökrön, Dóra Hegyi, and Zsófia Náda)

A single 1940s photograph is known of the doll-house, probably built in the early 20th century. The building was demolished in the 1970s. When the rubble was removed, a bipartite brick house, oriented from northwest to southeast and equipped with a patio, came to light (Fig. 18). The timber-supported patio, covered in bricks, ran along the western wall. The northern room of the building also had a brick floor. A niche window was found in the northern wall of this room. The southern room could be accessed from the other room through a relatively large opening. The original floor of the southern room was not preserved; its window opened to the patio. At the northeastern end of the dividing wall between the two rooms there was a heating structure with a chimney that projected into both rooms. After 1945 the part of the patio that was parallel to the northern room was transformed into a narrow hallway and its floor was covered in cement. A small, rectangular storage building was also added east of the northern corner of the doll-house (Fig. 19).

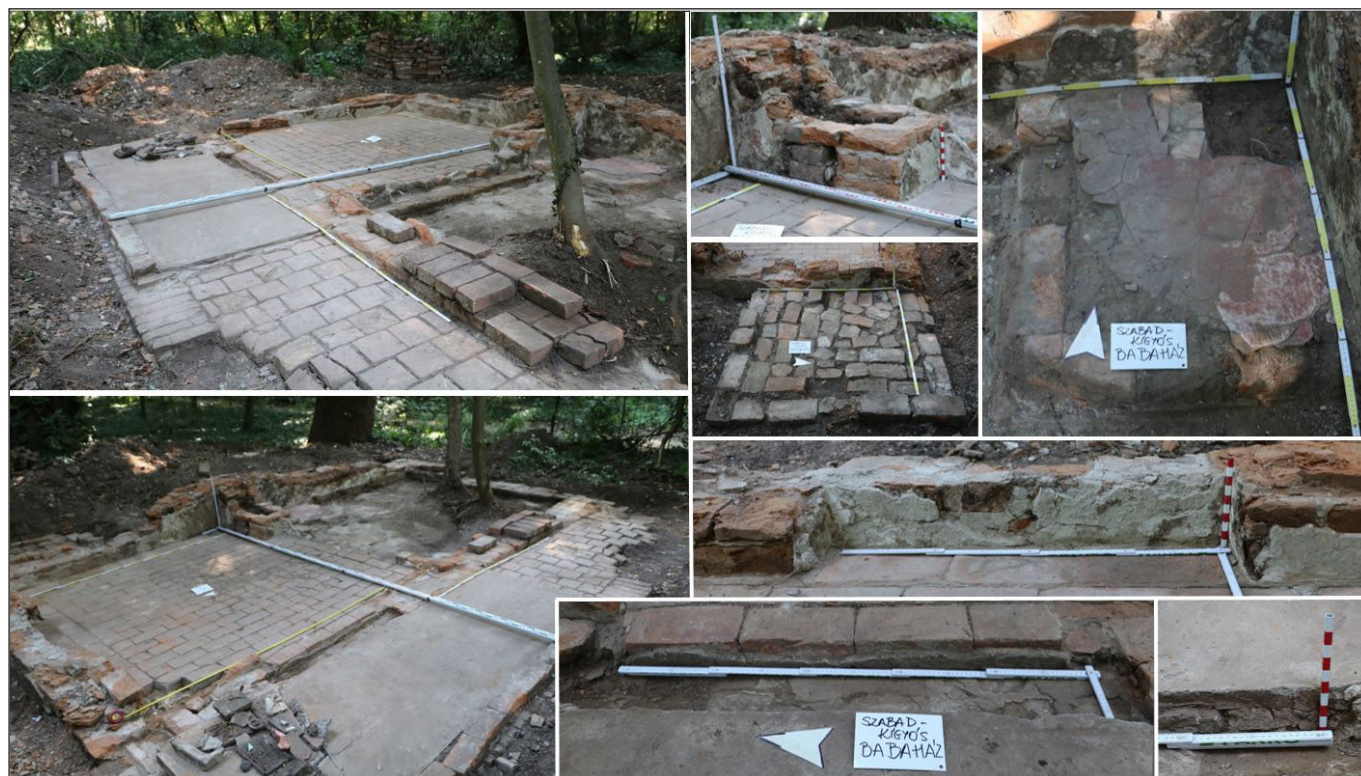
Fig. 19. Details of the excavated doll-house

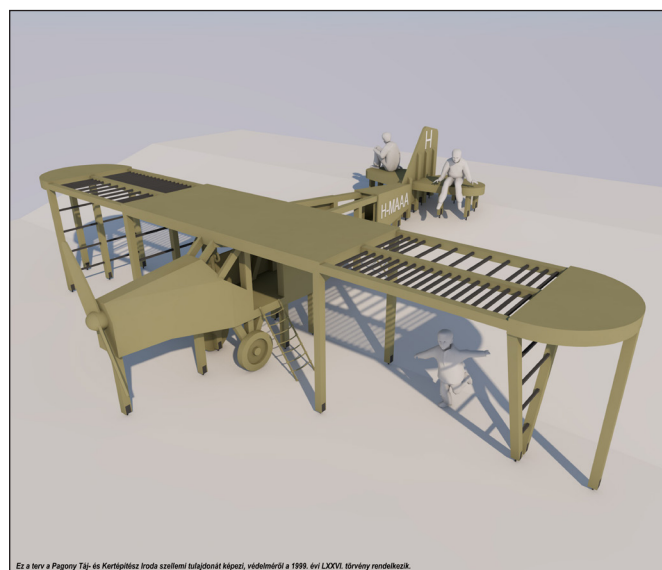
Fig. 20. Toys planned for the playground: doll-house (Pagony Tájépítész Iroda)

Fig. 21. Toys planned for the playground: jungle-gym in the shape of an aircraft (Pagony Tájépítész Iroda)

The plans for the park’s reconstruction were developed by Ágnes Herczeg (Pagony Tájépítész Iroda, ‘Pagony’ Landscape Building Office). The park was renovated in three phases; first the castle’s immediate environment was reconstructed. The garden pathways were rebuilt according to the hierarchy suggested by research, partly as gravel-walks and partly as simple dirt roads. Substructures of the built heritage, such as retaining walls, flights of stairs, basins, and garden fountains, will be re-made as copies of the originals. In addition to the reconstructed features there will be a playground in the northeastern part of the garden, with special toys referring to the history of the Wenckheim family. A timber house will be erected next to the original foundations of the doll-house; this will not copy the original but rather give an idea about it. Another interesting element of the planned playground is a jungle-gym in the shape of an aircraft, aiming to remind visitors of Dénes Szigfrid Wenckheim as a passionate pilot (Figs 20-21).
