ARCHAEOLOGICAL RESEARCH OF THE OTTOMAN PALACE IN SZOLNOK

RÓBERT KERTÉSZ¹ – BALÁZS SZÓKE²Hungarian Archaeology Vol. 13. (2024) Issue 2, pp. 44–59. <https://doi.org/10.36338/ha.2024.2.3>

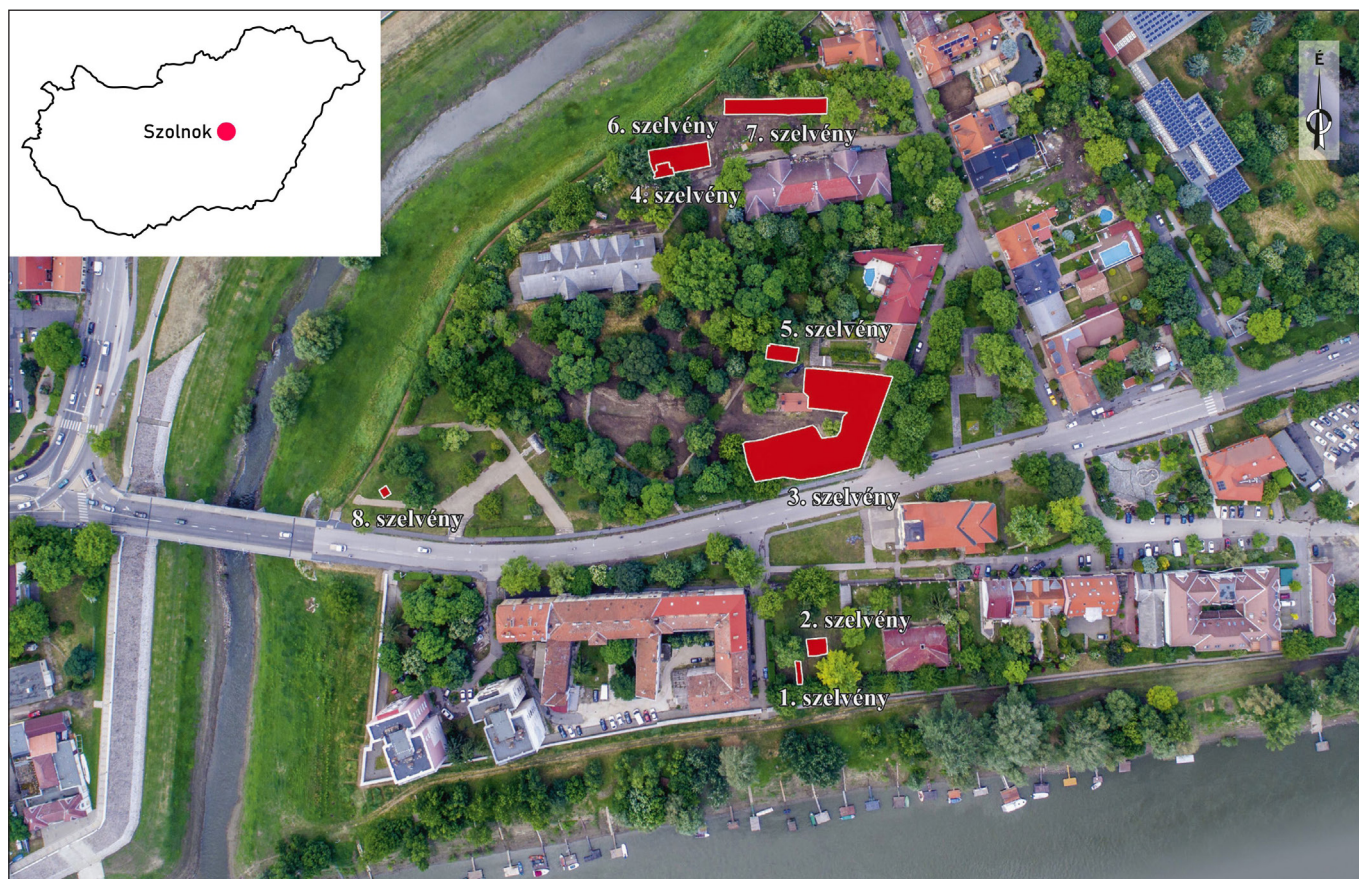
Fig. 1. Bird's view of the Castle Island in Szolnok, bordered by the Tisza River in the south and the Zagyva in the north and west, with the position of Trenches 1–8 unearthed in 2017–2019 (drone photo by Z. Lescsiszki, 2018; graphics by S. Horváth; after KERTÉSZ 2021, 107, Fig. 103)

The large, rectangular, and likely two-storey building constructed with a characteristic Ottoman-Balkan technique was unearthed in Trench 3, opened at the centre of the palisade fort (*Fig. 1*). The other large, north-south oriented, rectangular building next to its northern side was identified as a barracks (*Fig. 2.1*). It had been erected short before the fort was captured (KERTÉSZ 2019, 12; 2021, 312–322, 324–330, 332, 335, Figs. 343–363, 339–344, Figs. 365–370, 348–374, Figs. 373–401, 379–388, 391, 393–400, Figs. 407–430, 404, 512–519, Figs. 531–543, 537; KERTÉSZ *et al.* 2021, 36; 2024). The roughly west-east oriented building presented here was built by Ottomans from its foundations (*Figs. 2.2, 3*); that and the barracks, almost at a right angle to its axis, formed an L-shaped complex (*Fig. 2.1–2*). Despite only the northwestern part of the building could be investigated in an area covering about 40% of its remains, we could establish that is consisted of two wings (KERTÉSZ 2019, 12; 2021, 537; KERTÉSZ *et al.* 2021, 36; 2024).

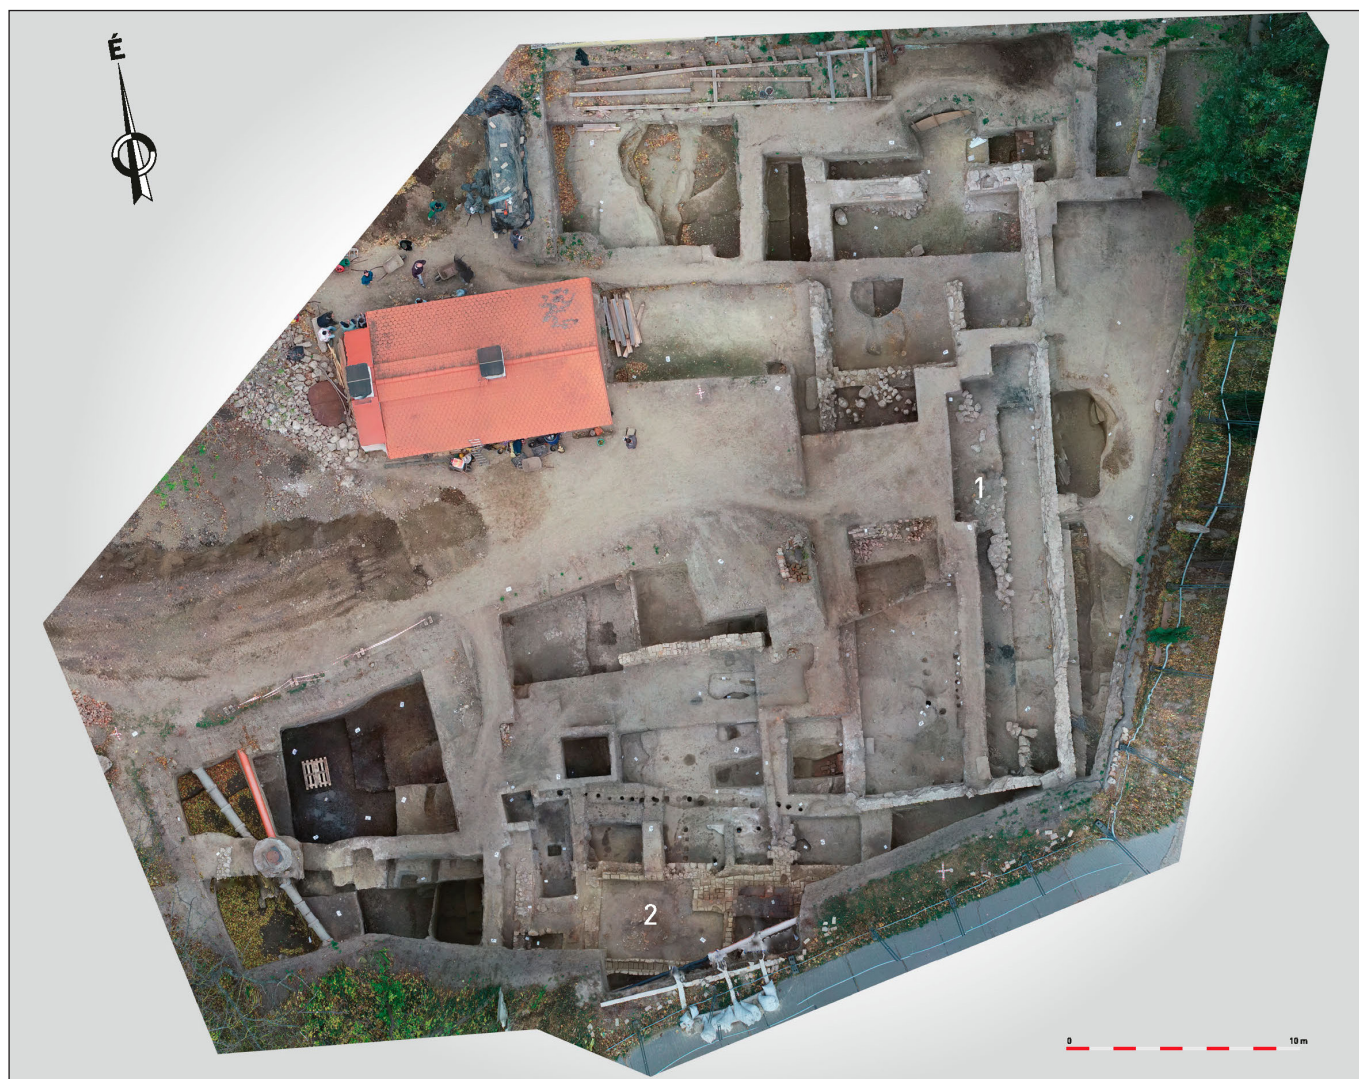
Fig. 2. Two Ottoman Period buildings in Trench 3 in Szolnok Castle. 1, barracks; 2, Ottoman palace (ortophoto by Pazirik Ltd, 2018; after KERTÉSZ 2021, 400, Fig. 430)

The size, two-wing structure, solutions applied in its construction, materials used, find context, and unique find material suggest that the building was the residence of the actual *sanjak-bey* (*sancakbeyi*) (KERTÉSZ 2021, 541). There are buildings with a similar status known from the territory of the Ottoman Empire: for example, the *pasha's* palace erected in the 17th century at the Castle Hill in Buda (PAPP 2013, 168) and the Bosnian *pashas'* palace in Travnik between 1684 and 1850 (KREŠEVLJAKOVIC 1956, 15–16). Sometimes after the death of a *pasha*, the next official received from the treasury a part of his wealth, including his house (FODOR 2002, 223). The barracks next to the palace (the other excavated building, mentioned above) probably housed the military escort of the *mirliva* (*sanjak-bey*) (Fig. 2.1; KERTÉSZ 2021, 543).

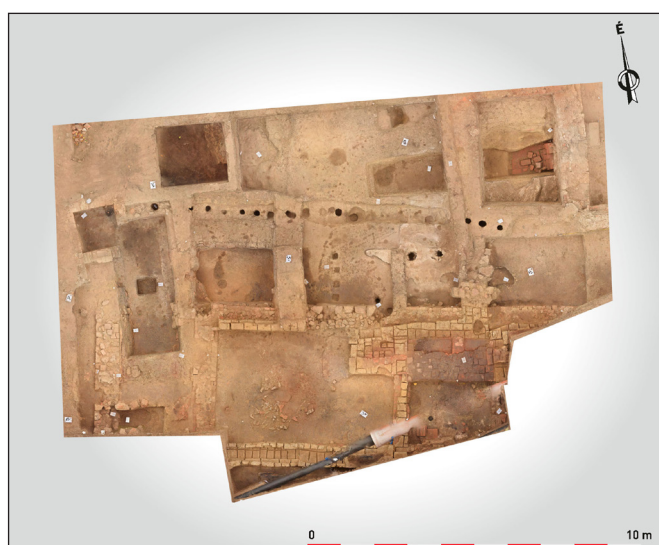
Fig. 3. Partially unearthed Ottoman palace in the southern zone of Trench 3. Szolnok Castle, second half of the 16th century–1685/1687 (ortophoto by Pazirik Ltd, 2018; after KERTÉSZ 2021, 526, Fig. 549)

The ground floor likely consisted of four rooms in the second half of the 16th century (Fig. 4) and eight from the late 1590s to about 1685/1687 (Fig. 12). Altogether seven of these were investigated in the excavation, five in the northern wing and two in the southern (KERTÉSZ 2021, 541). The function of two small rooms in the western part of the northern wing remained unchanged throughout this period (Figs. 3, 4.1–2, 12.1–2). The niche in the north-western corner had a wooden plank flooring (Figs. 3,

4.1, 12.1, 13), while the one south of it housed a cesspit connected directly to the toilet on the upper floor (Figs. 3, 4.2, 12.2, 14; KERTÉSZ 2021, 538, 553, Figs. 559, 579).

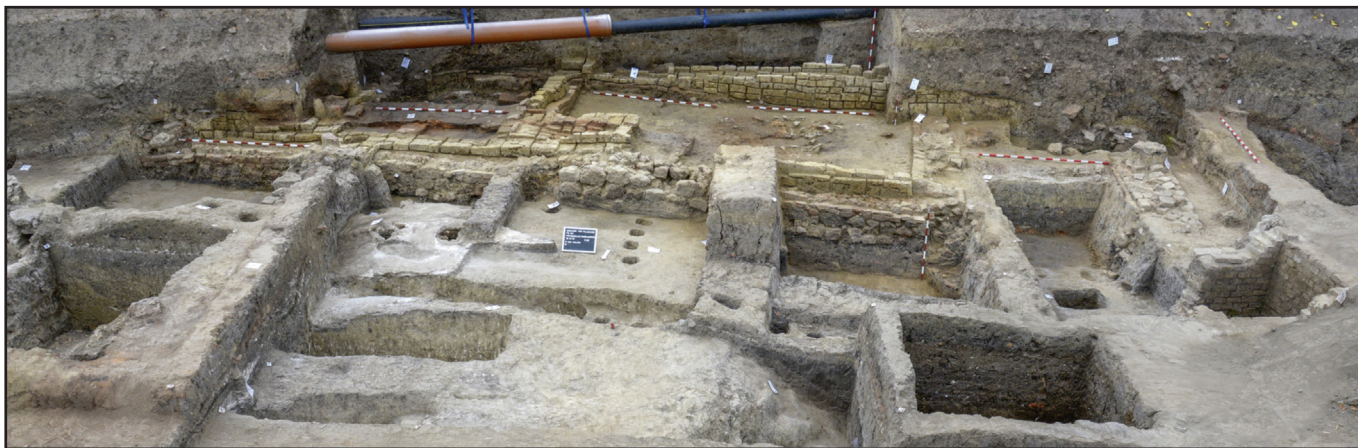
In the Genç ağa house in Tekirdağ the toilet (*hela*) opening from the *sofa* on the upper floor had another small niche, an air vent (*havalık*) on its northern side (Figs. 15–16; ELDEM 1984, 74). Based on this analogy, the northwestern part of the upper floor in the palace in Szolnok was likely also divided in two, a

northern *havalık* and a southern *hela* (Fig. 17.1–2). The division of the rooms on the ground floor must have matched the upper floor (Fig. 17, III): the two adjoining rooms were divided by a post-framed wall (Figs. 4, II, 12, II), the imprint of which in the floor could be clearly discerned in the excavation (Fig. 13). Based on the analogy of the Genç ağa house (Fig. 15), both could be entered from the western room of the southern wing (Figs. 4.6, 12.6), opening from the inner courtyard, whenever it was necessary (for emptying the cesspit).

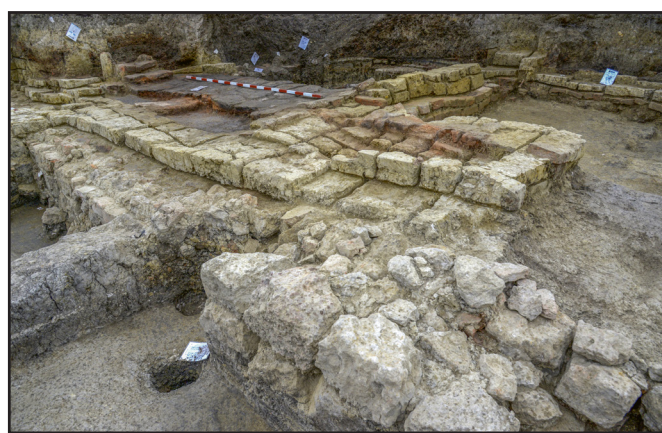
Figs. 5–6. Unearthed sections of the foundations and clay brick walls of the palace. Szolnok Castle, Trench 3 (photo by K. Kozma, 2018; after KERTÉSZ 2021, 534–535, 542, Figs. 556 and 566)

former branch of the Zagyva River, only filled up in the autumn of 1550 (KERTÉSZ 2014, 9, Fig. 3, 11–13; 2021, 61–66, Figs. 58–60, 122). This practically excludes the possibility that a major building persisted there for a longer period because the fill layers could not get compacted enough in the short time between the filling and the supposed constructing of the palace to provide a stable ground for an edifice with such a weight; thus, had the palace been built there, it would have sunken and collapsed in a short time, as it happened in the area of the castle before the Ottoman occupation (KERTÉSZ 2021, 403–410, Figs. 433–442; KERTÉSZ *et al.* 2024). This mistake was also made, even if only to a lesser extent, during the construction of the palace: the western ca. third of the building, including the two joined small rooms or niches (Figs. 4.1–2, 12.1–2), the next room to the south (Figs. 4.6, 12.6), the western half of the next room (Figs. 4.3, 12.3), and the western edge of the sofa (Figs. 4.7, 12.7), was built on top of the moat of the former comes's fort, filled up shortly earlier; accordingly, this part sunk visibly with time (Fig. 5).

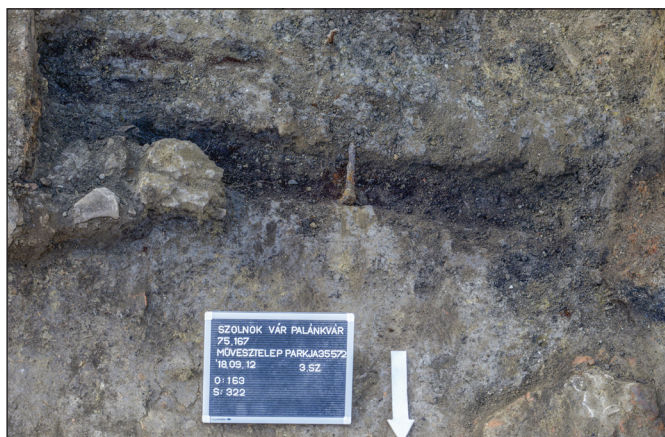
Fig. 7. Crushed bricks and stones set in clay to reinforce the foundations of the building from the outside and the imprint of a wooden beam pierced by an iron nail. Szolnok Castle, Trench 3, Ottoman palace (photo by K. Kozma, 2018; after KERTÉSZ 2021, 544, Fig. 568)

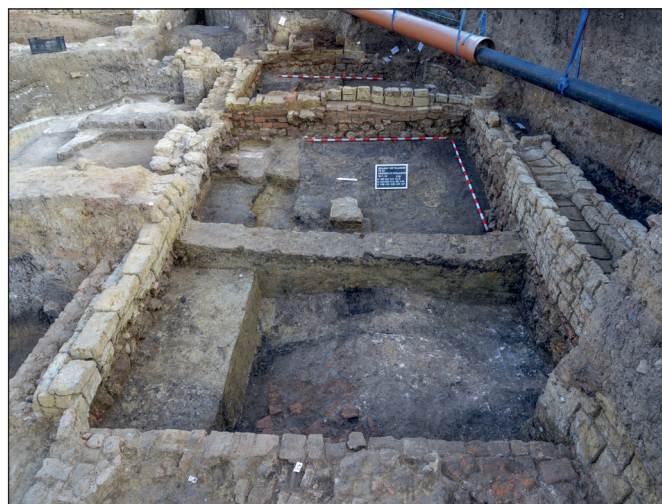
Fig. 8. Clayey fill inside the palace. Szolnok Castle, Trench 3 (photo by K. Kozma, 2018; after KERTÉSZ 2021, 545, Fig. 570)

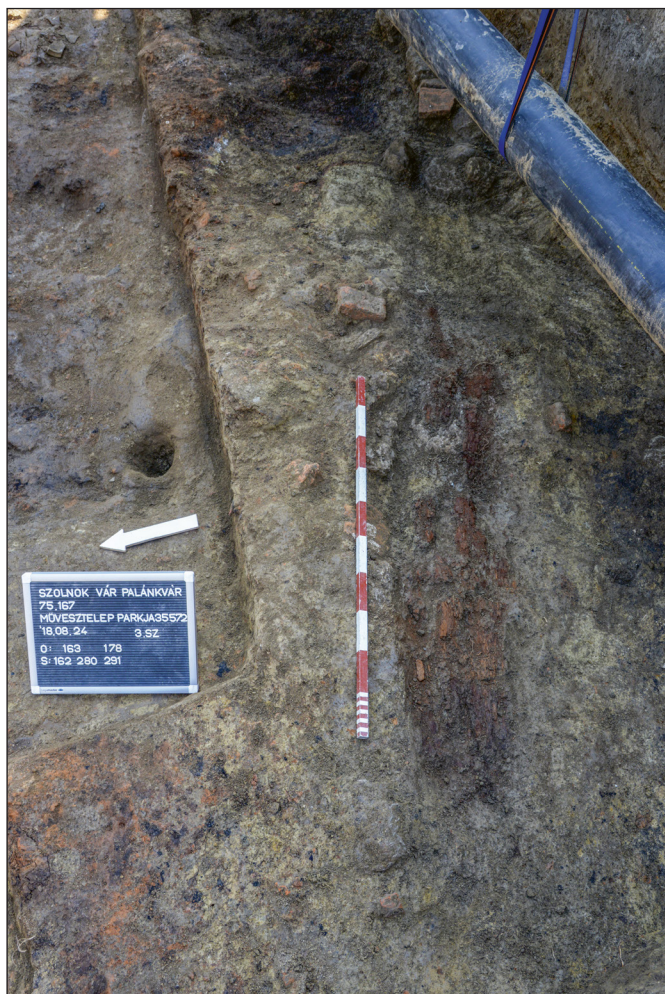
Fig. 9. Remains of the sill beam of the main dividing wall, dividing the palace into a northern and a southern wing. Szolnok Castle, Trench 3 (photo by K. Kozma, 2018; after KERTÉSZ 2021, 546, Fig. 571)

The external walls and the main dividing wall (separating the wings) in the axis of the building were 70 cm thick, while the lesser dividing walls were only 30 cm thick (*Fig. 4*). The external walls and the main dividing walls were braced with a beam structure (*Fig. 9*), the gaps of which were filled with unfired clay

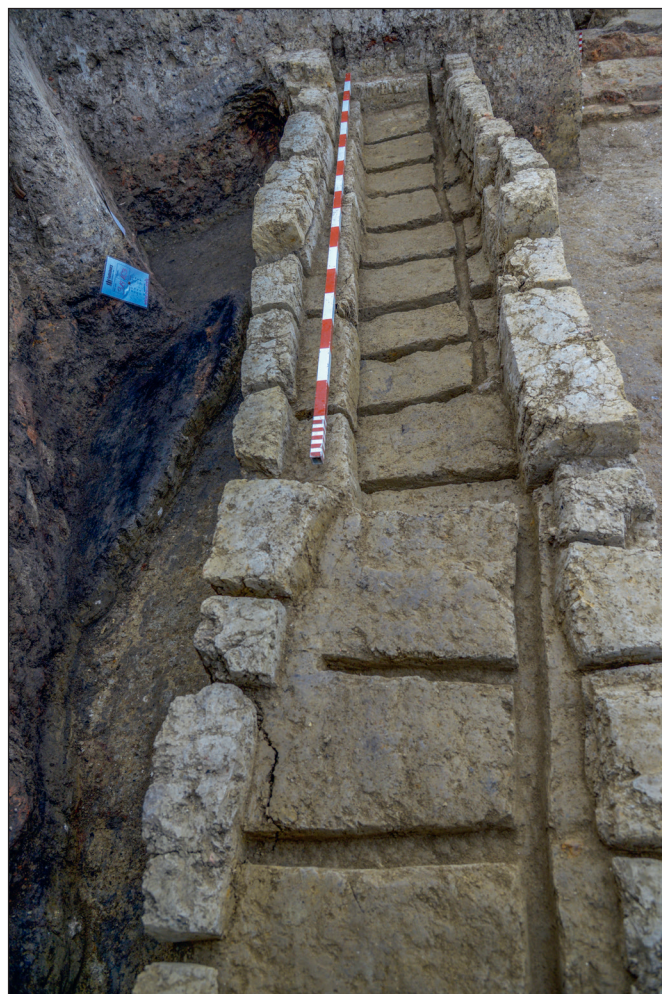
Fig. 10. Imprint of a completely decayed wooden beam in the core of the main dividing wall, made of unfired clay bricks Szolnok Castle, Trench 3, Ottoman palace (photo by K. Kozma, 2018; after KERTÉSZ 2021, 549, Fig. 574)

bricks (*ciğ tuğla*) and both wall faces were plastered (Fig. 10). During the excavation, we could identify the bonding material, a clay substance of somewhat different colour than the clay bricks, between the bricks (Fig. 11). The joints of the two wall faces and in the upper course of bricks were prepared to document their layout and the wall structure (Figs. 3–6, 8, 10–11; KERTÉSZ 2021, 546–549, Figs. 571–574).

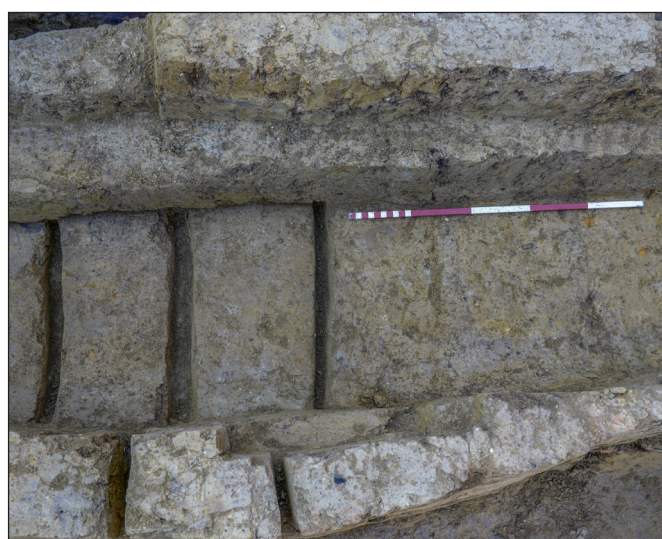
Fig. 11. Clay bricks of the main dividing wall, cleaned and ready to be removed; the bonding material (also clayey) is a shade different. Szolnok Castle, Trench 3, Ottoman palace (photo by K. Kozma, 2018; after KERTÉSZ 2021, 548, Fig. 573)

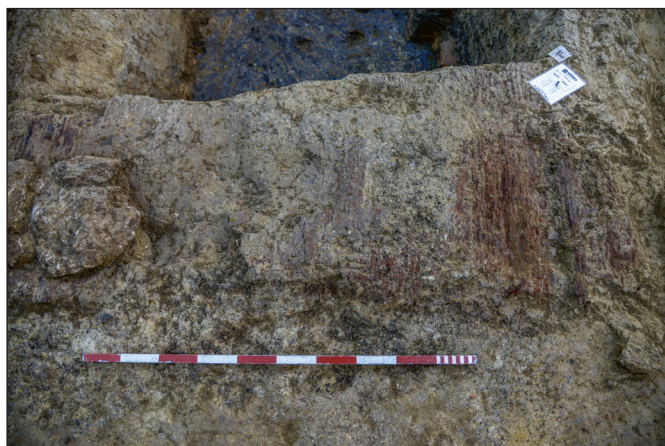
Fig. 13. Detail of the wooden plank flooring of Room 1 in the northwestern corner of the palace and the remains of its southern, post-framed. Szolnok Castle, Trench 3 (photo by K. Kozma, 2018; after KERTÉSZ 2021, 538, Fig. 559)

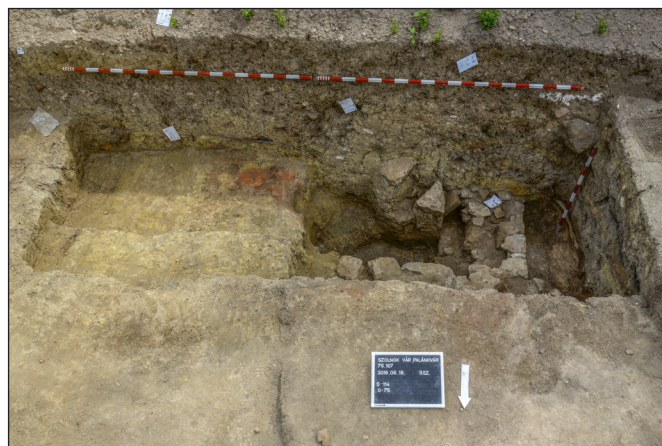
Fig. 14. Profile of the cesspit by the wall at the western edge of the northern wing of the Ottoman palace. Szolnok Castle, Trench 3 (photo by K. Kozma, 2018; after KERTÉSZ 2021, 553, Fig. 579)

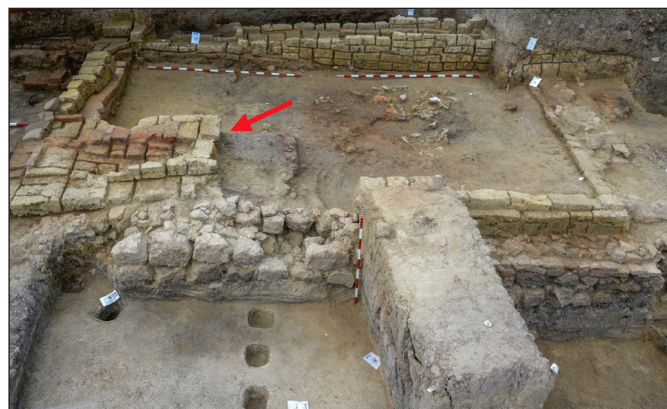
Fig. 18. Western room in the northern wing of the Ottoman palace; it was heated by a tile stove (marked by an arrow) from the late 1590s to 1685/1687. Szolnok Castle, Trench 3 (photo by K. Kozma, 2018; after KERTÉSZ 2021, 554, Fig. 580)

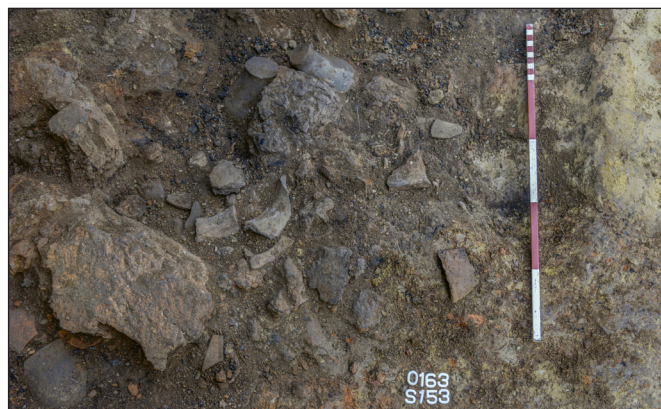
Fig. 19. Debris of the tile stove in the western room of the northern wing; it was demolished and levelled after the recapturing of the fort in 1685. Szolnok Castle, Trench 3, Ottoman palace, period: 1685/1687 (photo by K. Kozma, 2018; after KERTÉSZ 2021, 555, Fig. 583)

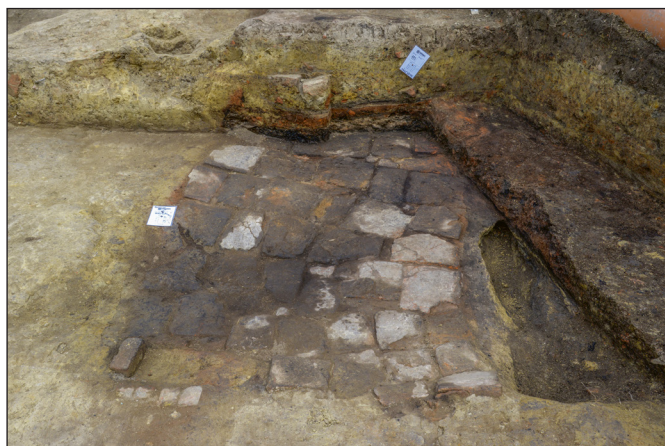
Fig. 20. The open fireplace of the kitchen (*mutfak*). Szolnok Castle, Trench 3, Ottoman palace, building phase: late 1590s–1685/1687 (photo by K. Kozma, 2018; after KERTÉSZ 2021, 556, Fig. 584)

fireplace paved with diverse size bricks set in clay, also established in the late 1590s (Figs. 3, 5–6, 12.4, VI, 20). This room was clearly a kitchen (*mutfak*) The last room in this wing is a large one (Figs. 3, 4.5) with another tile stove, only the western edge of which could be excavated, in its northwestern corner (Fig. 12.5, V). The tile stoves in the two rooms on the two sides of the kitchen opened directly to the open fireplace (Figs. 3, 5–6, 12, IV–VI, 18, 20–21), proving that the two heated rooms were smoke-free living rooms (*oda*) at least from the mid-1590s. Only the western, the one with the wooden plank flooring, be excavated entirely (Figs. 3, 5, 12.3, 18). Likely to enhance the stability of the structure, the planks were nailed to the joists beneath them; the remains of the nails were found when the room was unearthed (KERTÉSZ 2021, 554–557, Figs. 580–581, 583–584, 586).

Following the siege, the function of the palace remained unchanged, but the renovations, commissioned by Bektaş, were carried out with a keen eye on local customs and environmental conditions. This resulted in several transformations, like establishing a heating system with stove tiles made by local workshops in the two largest ground floor rooms of the northern wing in the late 1590s (Figs. 12, IV–V, 18–19, 21; KERTÉSZ 2021, 555, 557, Figs. 583, 586) and creating a kitchen with an open fireplace in the room between them at the same time (Figs. 12, VI, 20; KERTÉSZ 2021, 556, Fig. 584).

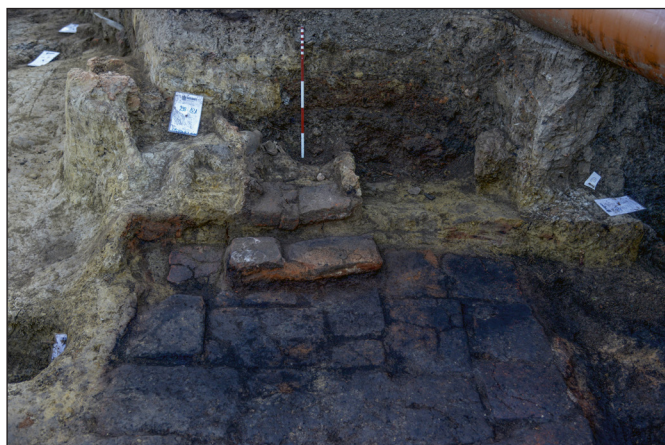
Fig. 21. Tile stove in the northwestern part of the eastern living room (*oda*) of the northern wing; its mouth opened directly to the open fireplace in the neighbouring kitchen (*mutfak*). Szolnok Castle, Trench 3, Ottoman palace, building phase: late 1590s–1685/1687 (photo by K. Kozma, 2018; after KERTÉSZ 2021, 557, Fig. 586)

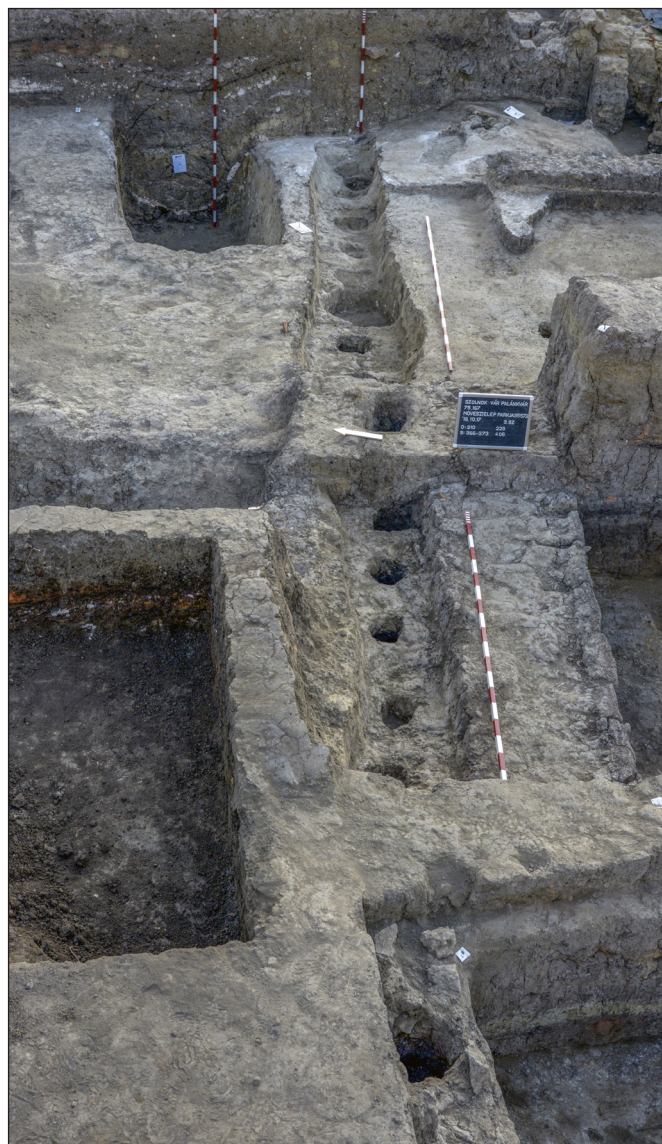
Fig. 22. Remains of the single-row palisade wall engirding the palace from the north. Szolnok Castle, Trench 3 (photo by K. Kozma, 2018; after KERTÉSZ 2021, 540, Fig. 563)

In the north, the palace was accompanied by a single-row palisade wall, the eastern end of which joined the southwestern wall of the barracks (Figs. 4, IV, 12, VII, 17, VII, 22). This protective wall certainly con-

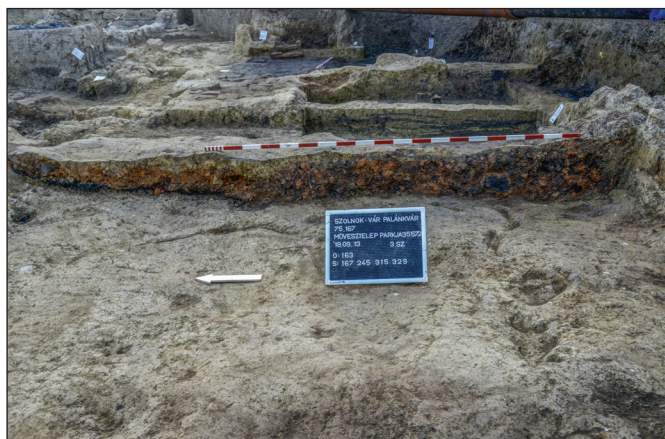
Fig. 23. Floor levels in a profile cut into the floor of the western room of the northern wing. Szolnok Castle, Trench 3, Ottoman palace (photo by K. Kozma, 2018; after KERTÉSZ 2021, 538, Fig. 560)

Based on the succession of coin-dated floor levels (Fig. 23) and other data, the palace certainly existed from the second half of the 16th century, and remained in use until short after the Christians recaptured the fort in 1685. Some evidence indicate that the building was not erected right after the Ottomans conquered the fort: the remains of a post-framed building, built after the Ottomans moved into the fort and its orientation matching that of the palace, was found under the gravel-in-clay wall foundations of the palace set on the one-time surface (Fig. 24; KERTÉSZ 2021, 537–539, Figs. 560–561).

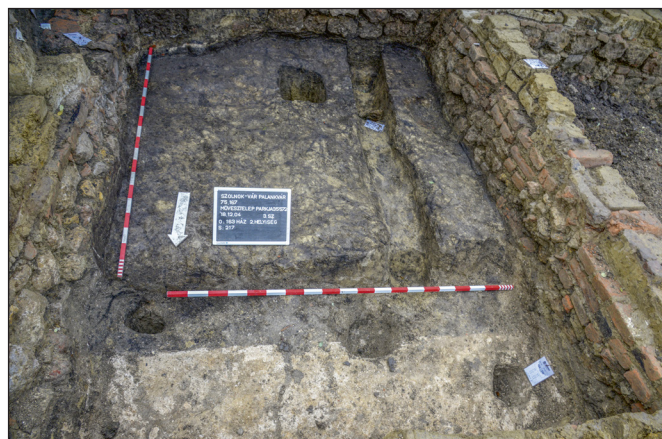
Fig. 24. Detail of the foundation trenches of the post-framed building that stood at the centre of the fort preceding the Ottoman palace. Szolnok Castle, Trench 3 (photo by K. Kozma, 2018; after KERTÉSZ 2021, 539, Fig. 561)

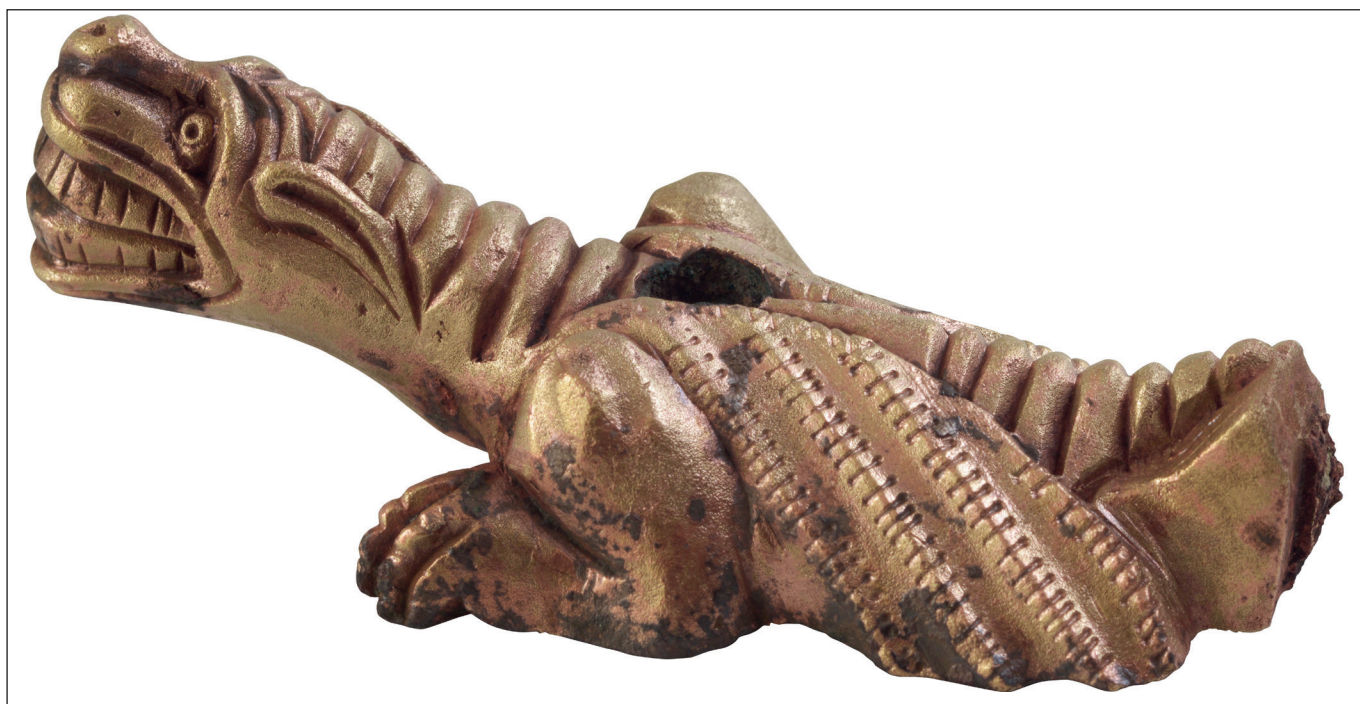
Fig. 25. Unique find with a dragon figure from the Ottoman palace. The wings on the casting were enhanced by punching. Szolnok Castle, Trench 3, second half of the 16th century; length 8.4 cm, width 1.1–3.8 cm, height 1.35–2.95 cm (photo by K. Kozma, 2018; after KERTÉSZ 2021, 564, Fig. 594)

The excavation of the building with clay brick walls yielded several interesting finds. A unique artefact, a copper alloy dragon figurine (Fig. 25), probably a scabbard ornament from a Central Asian workshop,
