## CONSERVATION OF A MEDIEVAL CHURCH AT CSÁKÁNYOSPUSZTA

GABRIELLA PÁL<sup>1</sup> – BÁLINT KELEMEN<sup>2</sup>

Hungarian Archaeology, Vol. 13 (2024), Issue 3, pp. 54–57.

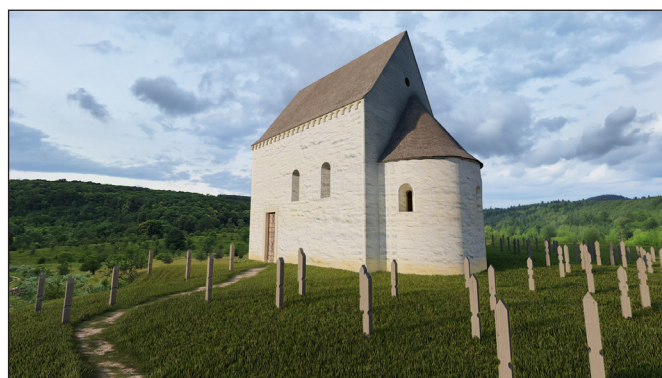
Fig. 3. Theoretical reconstruction of the church of Csákányospuszta

In the preparatory phase of the planning, a geodetic survey, architectural historical documentation, and a value inventory were created. As part of the research, the designers also made a theoretical reconstruction, followed by 3D mass modelling, with the visual design being partially enhanced using an artificial intelligence (AI) image-generating platform (Fig. 3). The basis of the restoration concept (and the *ROM Vándor* programme) was to carry out the technical restoration, preserve the aesthetic and historical values inherent in the ruin, and create a natural and harmonious relationship between the ruin and the landscape with small-scale, value-enhancing contemporary additions.

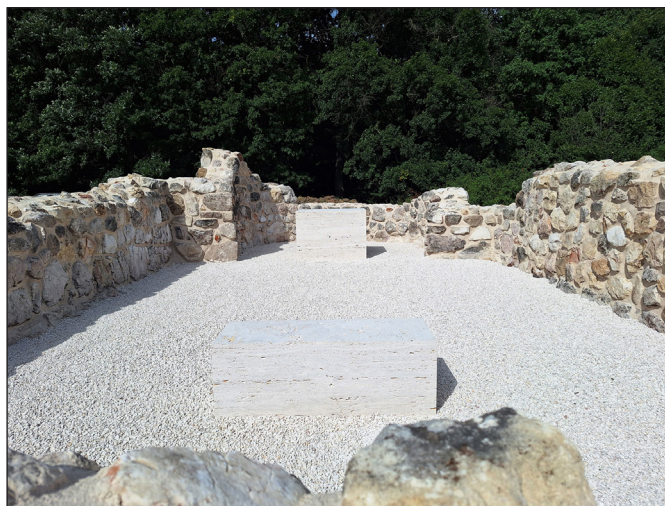
Fig. 5. The interior of the church with a limestone altar and a bench

based on excavation photos from 2005. Wall height was only increased where it was deemed necessary for interpretability. Several carved corner blocks were returned from the Tatabánya Museum to their original (or likely original) functional locations. Contemporary additions include a so-called Corten steel gate marker (which also serves as an information sign) (Fig. 4), a limestone gravel floor covering that creates an organised interior space, and an altar in its original position, though made of a single large limestone block with a modern design (Fig. 5). A new fire pit, set within steel rings, was also created for the visitors, and a limestone block bench was placed beside the church and the fire pit, serving as a place for prayer and contemplation for pilgrims and providing comfort for hikers. Another information board was installed along the dirt road at the bottom of the plot, providing valuable information on the ethics of land use, the natural and landscape values of the site, and the archaeological excavation. The opening event of the restored church ruins included a commemoration of the ancestors who once lived there: electric candles were placed at the locations of the 144 graves uncovered in the cemetery around the church, and the re-consecrated ruin church was illuminated in the night (Fig. 6).

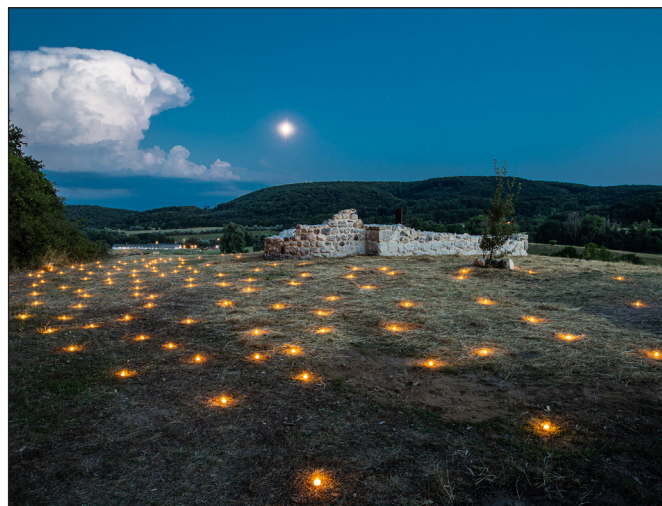
Fig. 6. Remembrance of the graveyard cemetery: candles mark the places of the one-time graves
