## ARCHAEOLOGICAL RESEARCH OF THE RUIN CHURCH OF ASZÓFŐ-KÖVESD IN THE COURSE OF RECENT CONSERVATION WORKS<sup>1</sup>

MIKLÓS RÁCZ<sup>2</sup>

Hungarian Archaeology Vol. 13. (2024) Issue 1, pp. 43–55. <https://doi.org/10.36338/ha.2024.1.6>

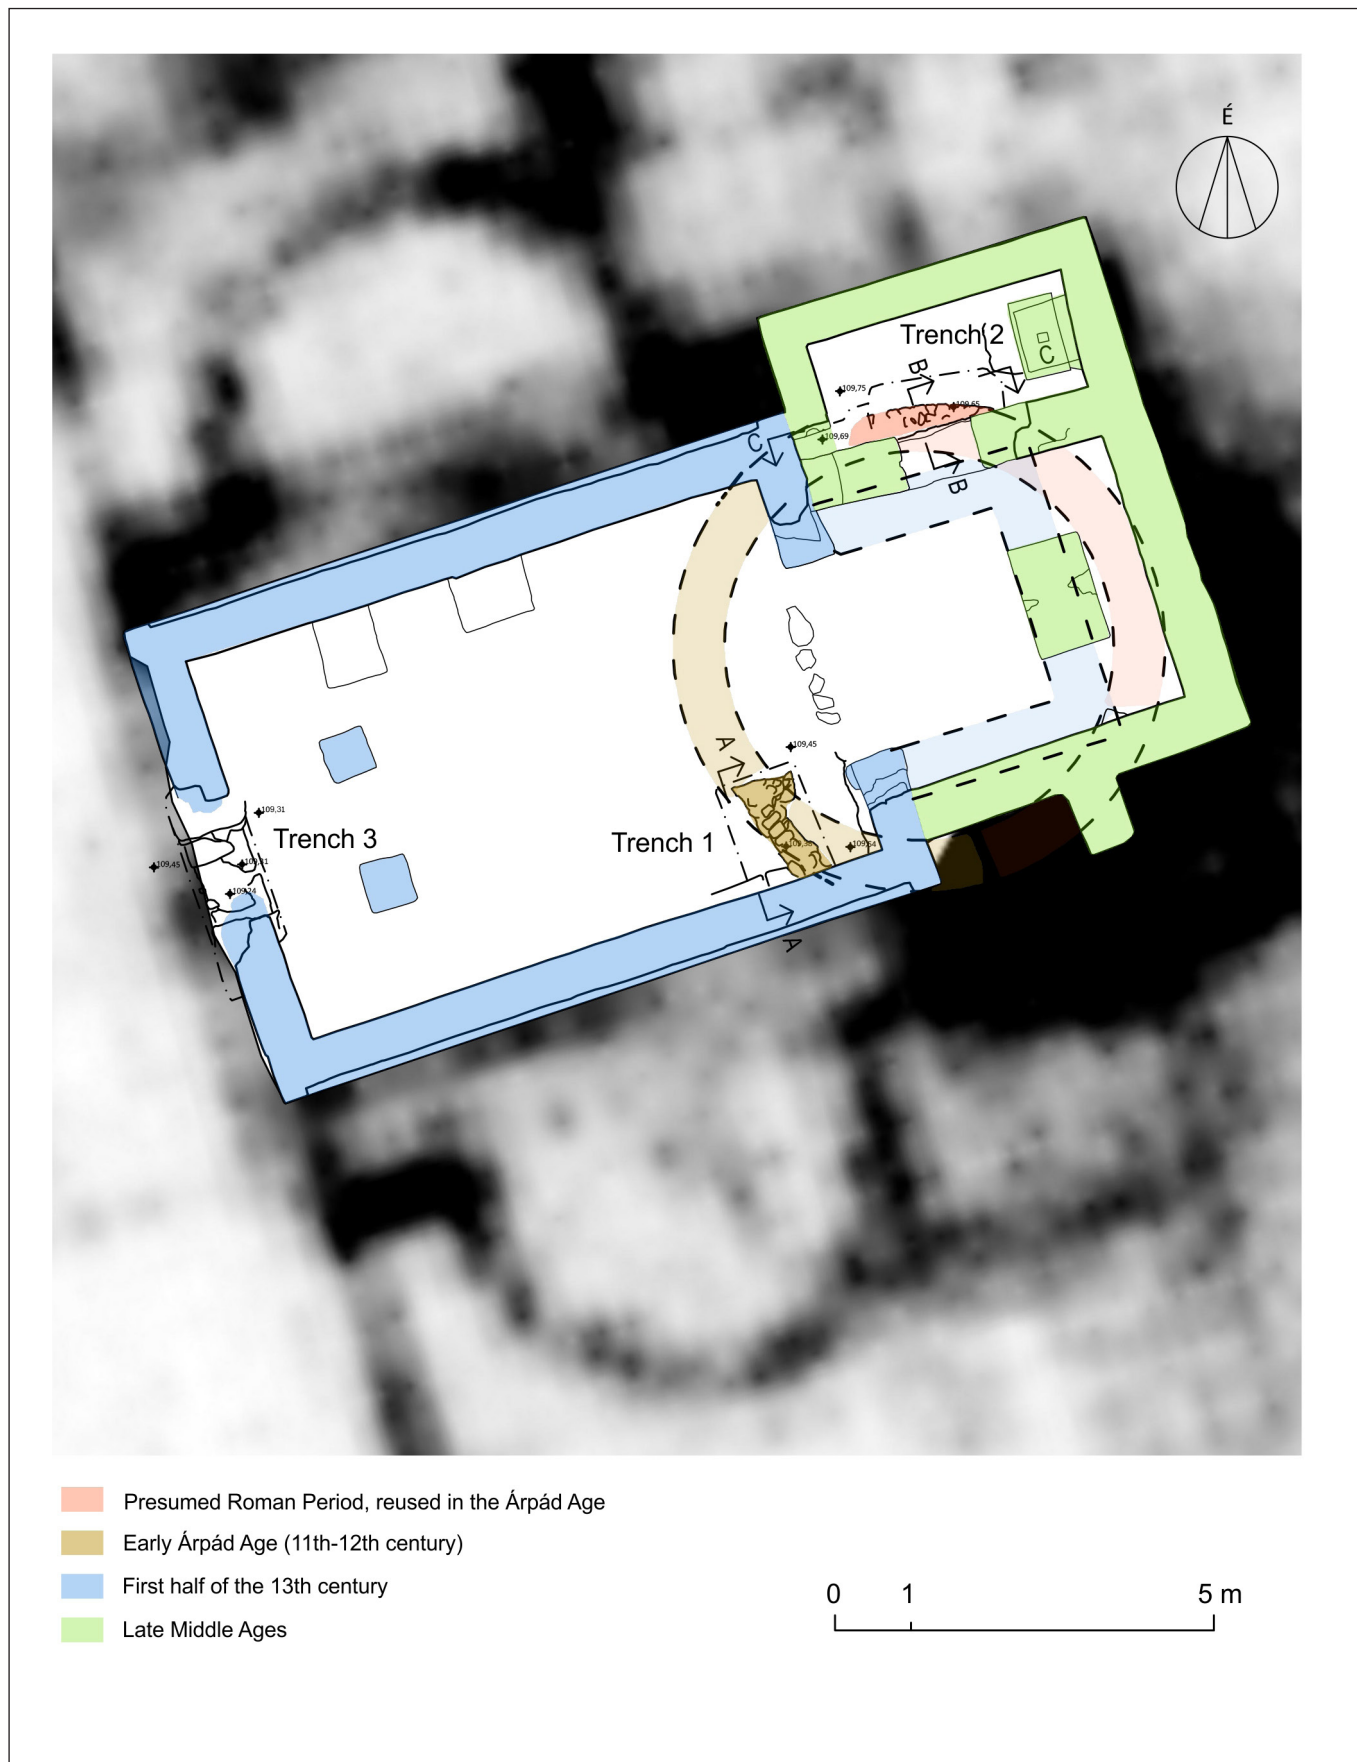
Fig. 3. Survey map with the excavated foundations and the GPR survey image of the close area.  
 (Building survey by Tibor Szappanyos, Kvalitron Ltd and Bálint Kelemen, KÖZTI. Interpretation by Miklós Rác,  
 GPR survey by STIBRÁNYI & KLEMBALA 2022, Salisbury Ltd.)

### SUMMARY OF RESEARCH RESULTS (FIG. 3)

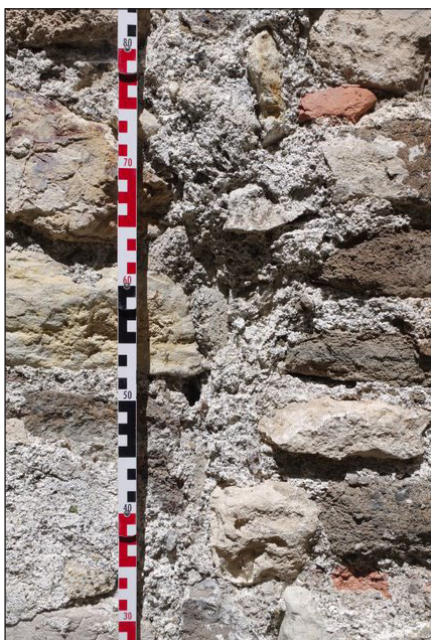
Fig. 6. The joint in the north wall of the nave with parts of an oblique surface in May 2022

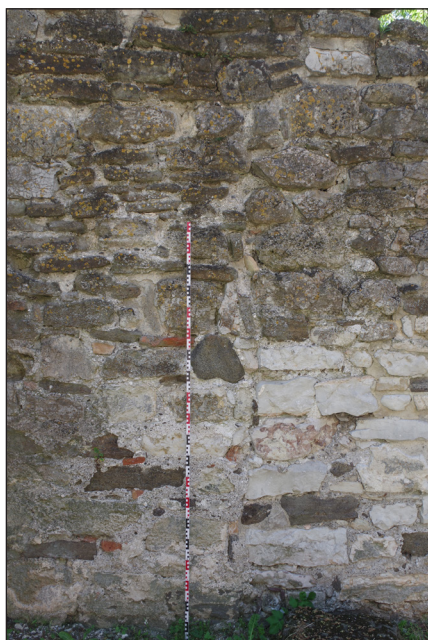
Fig. 7. Vertical wall joint in the eastern section of the south nave wall

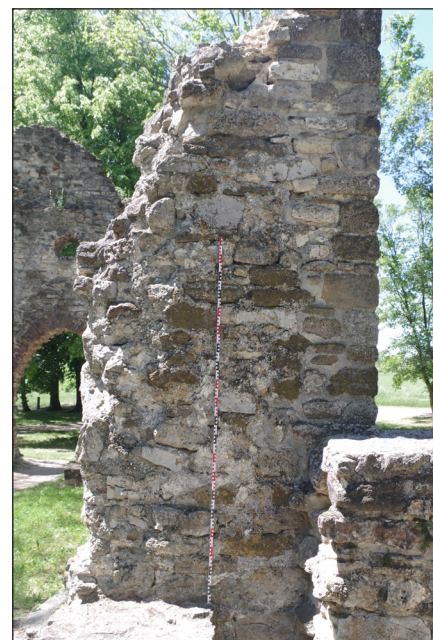
Fig. 8. The eastern wall of the nave at the sanctuary

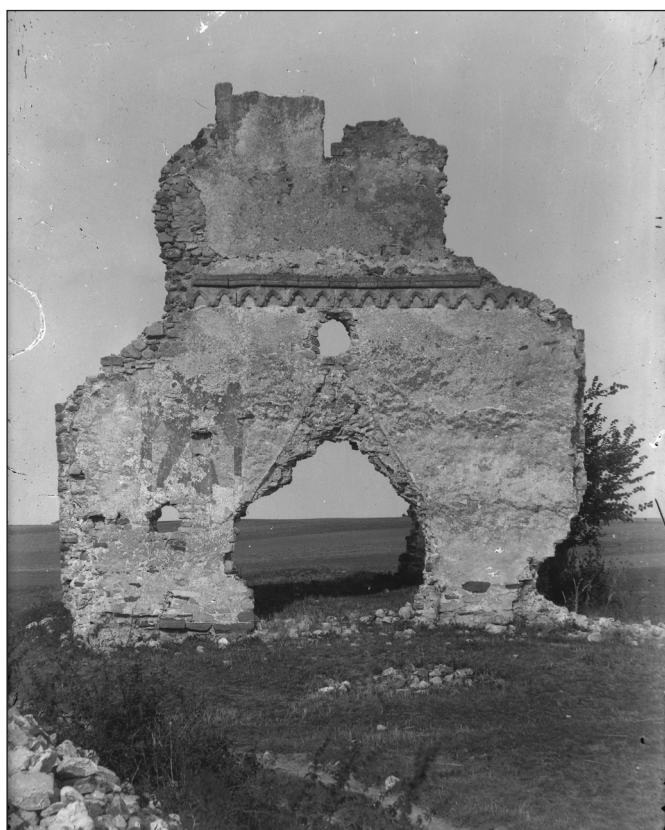
Fig. 9. The western façade on a photo from the late 19th or early 20th century with fresco remains on the northern side of the western nave wall and the stub of the tower in the upper part of the façade (Historical Monuments Photo Collection 033.500aN, GEREVICH 1938, 57. t.)

Significant details that have since disappeared can be seen in a photograph of the western facade from the late 1800s or early 1900s (Fig. 12): the remains of the fresco in the northern half of the western wall, the fragment of the tower protruding from the western gable, a part of the cornice of the gable wall, the narrow window on the tower's third floor. A photo of the church nave, taken from the east around 1957 (Fig. 13), shows the interior of the nave, including the traces and remains of the vaults, before conservation.

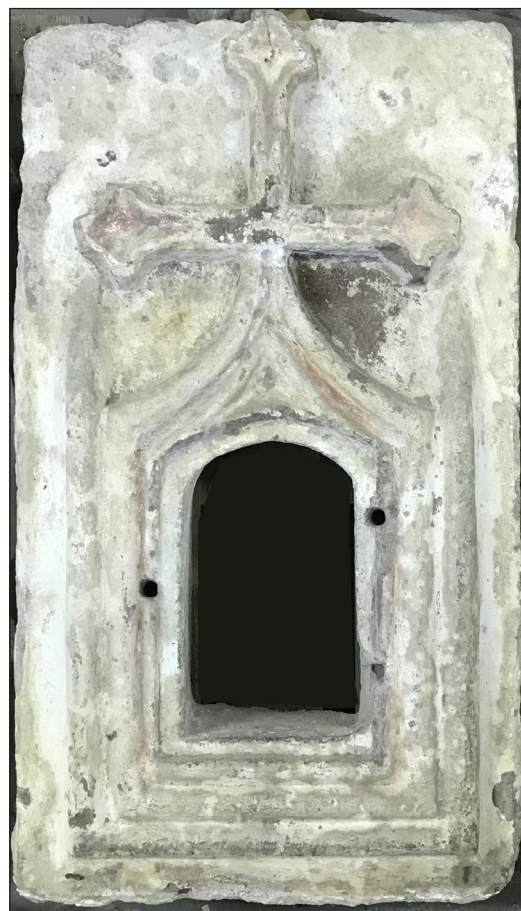
Fig. 14. The sanctuary niche unearthed in 1957  
(Laczkó Dezső Museum)

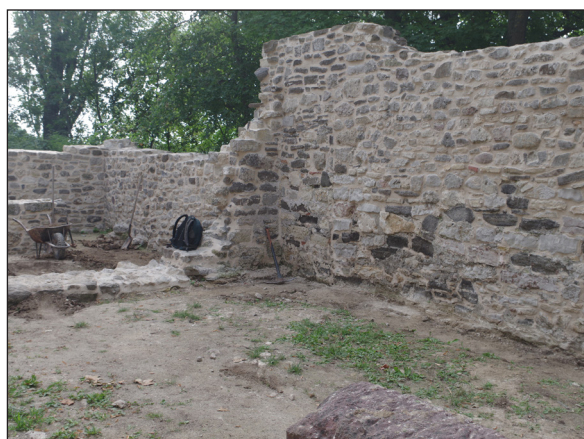
Fig. 17. The nave with the floor level deepened by builders but before excavation on 17 July 2023

In the summer of 2023, contractors excavated about 15 cm of the floor level as part of the conservation works (Fig. 17). Due to the circumstances, archaeological research was limited to examining details already discovered during previous research but lacked satisfactory documentation and a sufficiently detailed survey. In connection with the foundation wall found earlier in the southeastern corner of the nave, the main question was whether it could be connected with the wall joints observed in the rising wall section, thus contributing to understanding the two phases of the nave. It was also necessary to clarify the exact position of the wall section in the sacristy that was only included in the architecture-historical publication. We did not intend to excavate either deeper or in a larger area than previously.

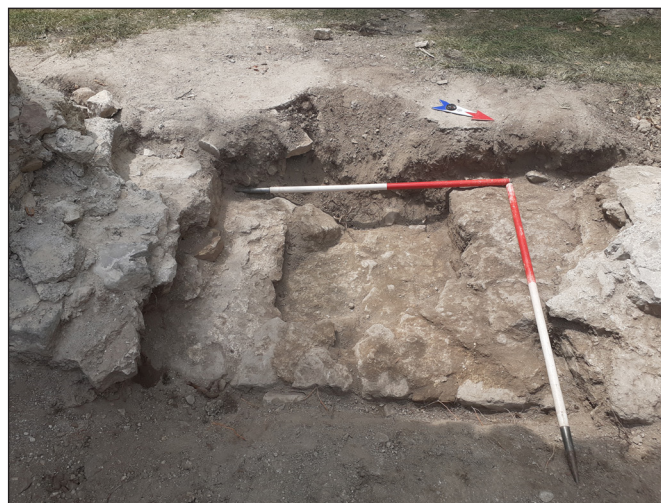
Fig. 20. Groundwall in the southeast part of the nave with wall joint on nave wall on 17 July 2023

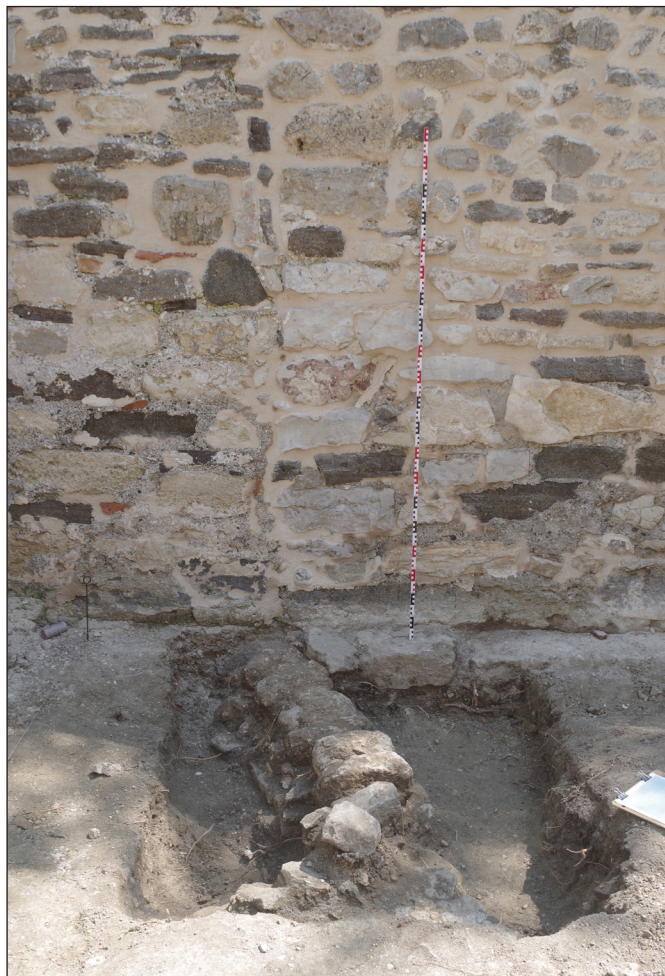
Fig. 21. Detail of the foundation wall in the sacristy on 17 July 2023

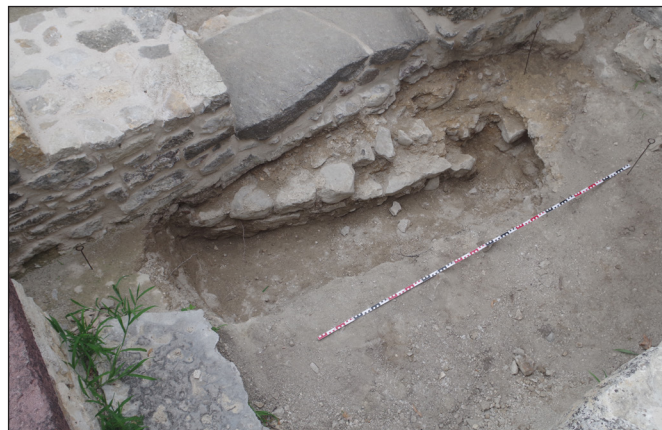
Fig. 22. Excavation at the gate, eastern view, on 18 July 2023 (by Dóra Oláh)

During the excavation on 18 July 2023, the foundations inside the gate opening were unearthed and documented (Fig. 20). The carved stone with a cross identified in 1957–58 was not found under the southern half of the opening.
