COMMUNITY ARCHAEOLOGY IN THE RESEARCH OF WORLD WAR II EVENTS The locating and interpretation of the crash site of a Consolidated B-24 Liberator bomber in the vicinity of Fehérvárcsurgó

Hungarian Archaeology Vol. 14 (2025) Issue 4, pp. 53–61. <https://doi.org/10.36338/ha.2025.4.4>

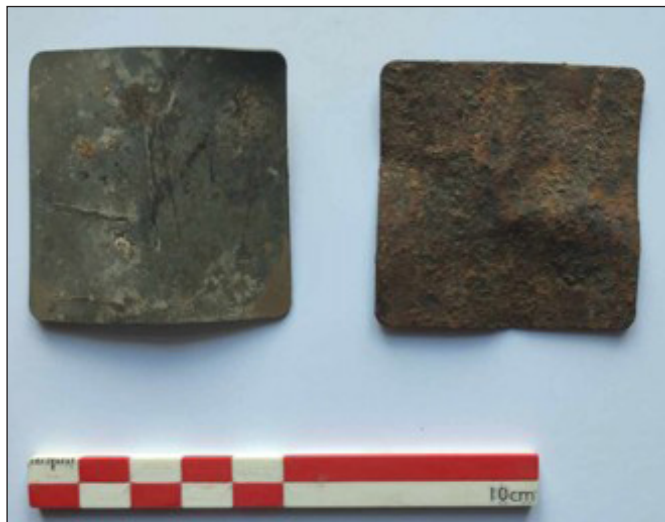
*Fig. 1. Steel plates sewn into a flak suit
(Photo: László György, Hungarian National Museum,
National Archaeological Institute)*

One classic example is the flak suit—the protective vest worn by waist gunners—which can effectively be interpreted as twentieth-century plate armor. The vest, padded with 5 × 5 cm steel plates, was intended to protect gunners positioned in the open sides of the aircraft from shrapnel from anti-aircraft shells (Fig. 1). When such items are found in the context of some other wreckage, there is a strong likelihood that the aircraft involved was a B-24 or B-17. If, however, these objects are recovered in isolation and without any contextual association, they most probably represent traces of a damaged aircraft flying low when attempting to return home—one that may have crashed in Hungary or somewhere along the route back to Italy, or that, although damaged, successfully returned to its base in the Foggia area. In such cases, identification is not possible.

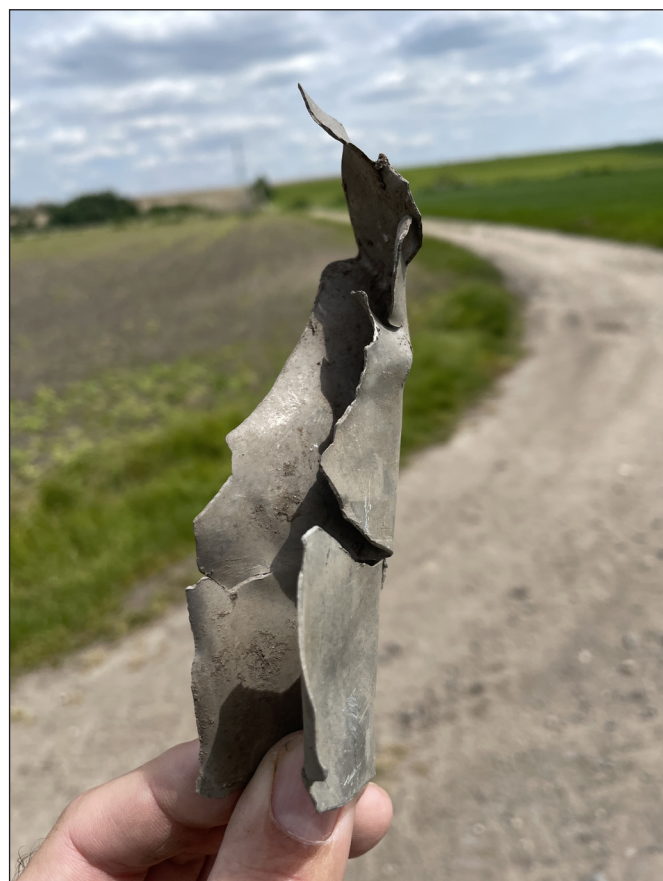
*Fig. 2. The first piece that started the research
(Photo: Csaba Dömötör)*

In the Fehérvárcsurgó case, the first recovered fragments were collected in 2023, after which a farmer cultivating the land reported additional pieces (Fig. 2). During field surveys extending to the northern side of the road, formerly known as the Papharaszti Road (KURUCZ 1989, 38), aircraft components that could be collected by visual inspection alone were encountered, sufficient to establish the first points of identification. The aluminum aircraft parts, the quality and style of the riveting, the ALCLAD marking, and the color of the zinc chromate primer clearly indicated American manufacture (Fig. 3). A stamped marking beginning with the code “GK32” on one of the components further demonstrated that it was a B-24 bomber (Fig. 4). In cooperation with the King St Stephen Museum of Székesfehérvár, we carried out a metal-detector survey on both sides of the road that were scattered with fragments of the aircraft.

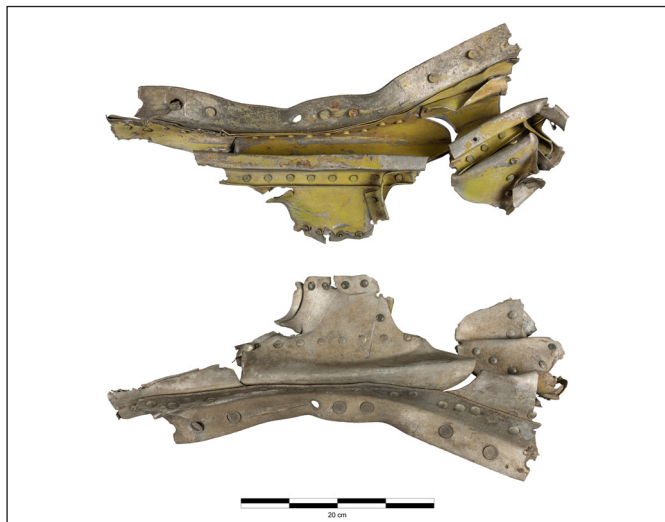
Fig. 3. A piece from the wing, clearly displaying the primer coating indicative of American manufacture (Photo: László György, Hungarian National Museum, National Archaeological Institute)

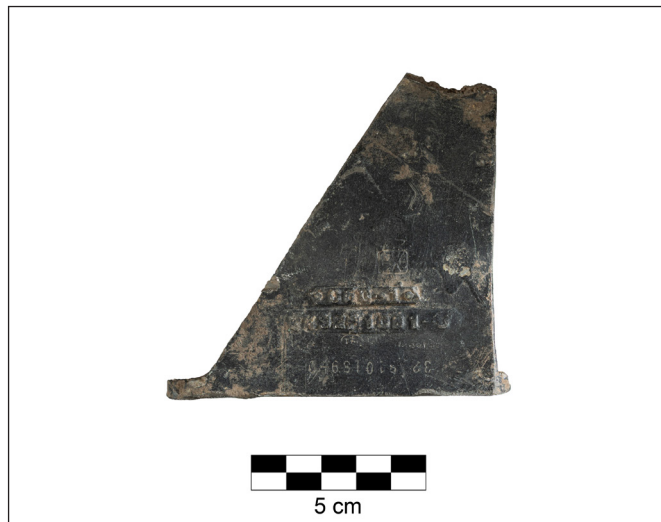
Fig. 4. This component, marked with the code GK32P1089, comes from a bracket near one of the engine controls (Photo: László György, Hungarian National Museum, National Archaeological Institute)

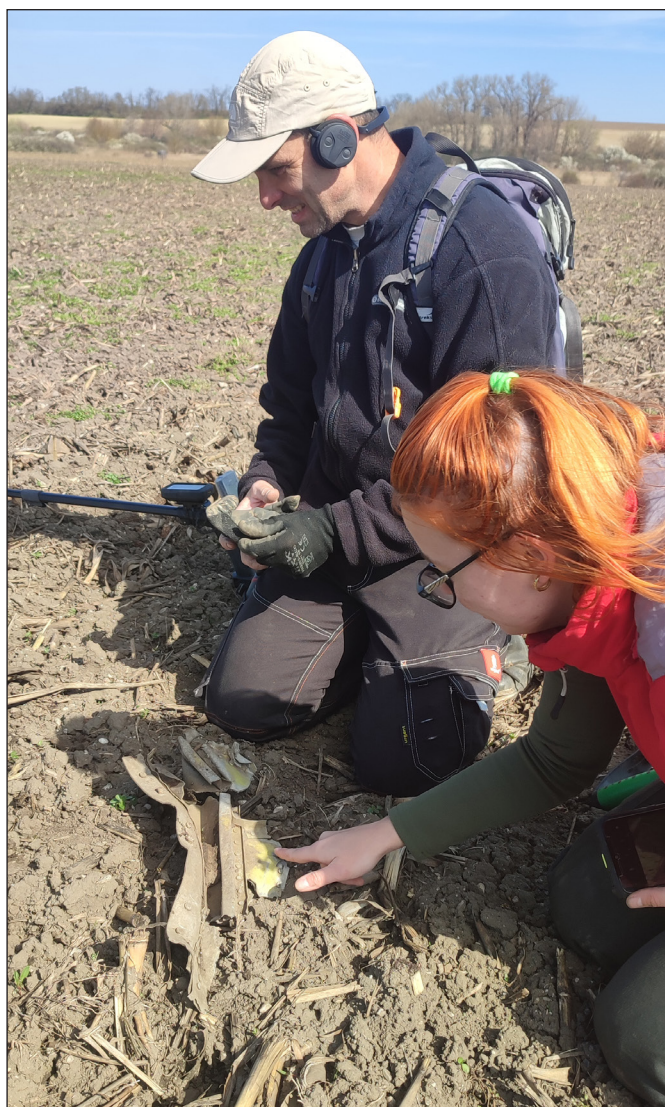
Fig. 5. Recovery of one of the larger fragments on the first day of fieldwork (Photo: Attila Papp)

Due to seasonal differences in land use, the survey was conducted on two separate occasions, during which the aircraft's debris distribution zone was delineated on both affected parcels (Fig. 5). For this purpose, we used the QField application, which is regularly employed by the museum's community archaeology program, recording each component with an on-site interpretive classification system divided into several categories (i.e., airframe, engine, armament, electronics, other), along with photographic documentation and unique coordinates (Fig. 6). Owing to local agricultural practices—in our case, prolonged stubble retention followed by disking and rapid reseeding—very short time windows were available for field work, and only a small number of metal-detecting volunteer workers could be mobilized at short notice. As a result, our primary objective was to delineate the impact and debris zone through systematic scanning.

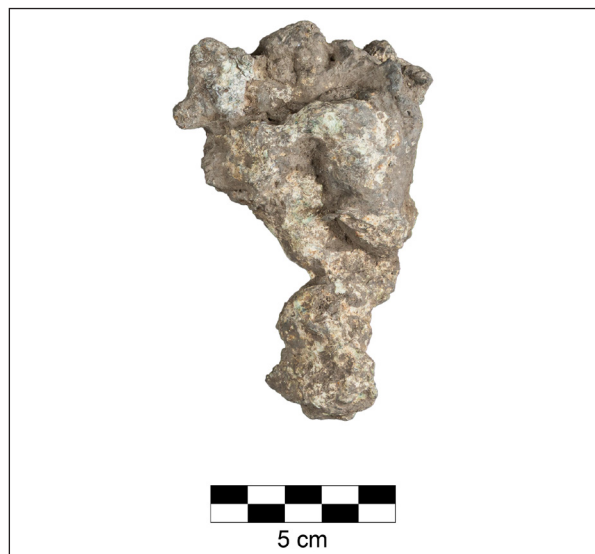
Fig. 7. The melted aluminum fragment indicates exposure to high-temperature burning (Photo: László György, Hungarian National Museum, National Institute of Archaeology)

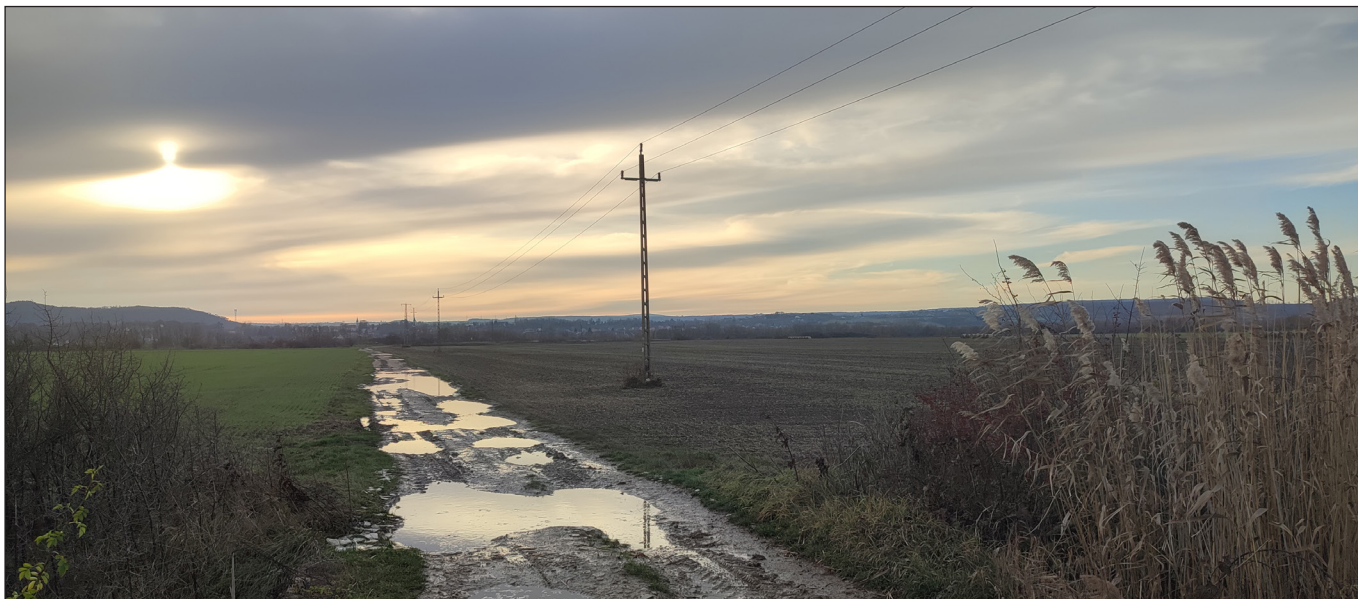
Fig. 11. Present condition of the aircraft crash site (Photo: Attila Papp)

According to eyewitness accounts, Hooper's aircraft remained controllable until the very end, and the crew almost certainly attempted to reach the nearest safe area—the territory behind the Soviet lines (*Fig. 11*). Béla Németh's memoirs indicate that they fell just a few kilometers short of this goal, as Soviet units were already positioned on the eastern side of the Móri Valley. It is also confirmed in all U.S. sources that nine of the crew parachuted from the aircraft, while one crew member, Second Lieutenant Charles A. MacDonald III, the co-pilot, died in the plane. He was initially buried in the ground near a railway guardhouse and later exhumed in the second half of 1945; this allows us to associate the specific aircraft with an identified crew member (DELANZO 1989–1990). While in this case the identification would be only indirect without a named crew member, another piece of evidence supports it: a yellow-painted skin panel, whose color matches the engine-ring color code used by the 766th Squadron to identify its aircraft (*Fig. 12*). Research regarding the fate of the nine parachuting crew members is ongoing. Their movements can be traced up to their capture and transfer to a POW camp, after which their trail is lost; they are officially recorded as missing to this day.

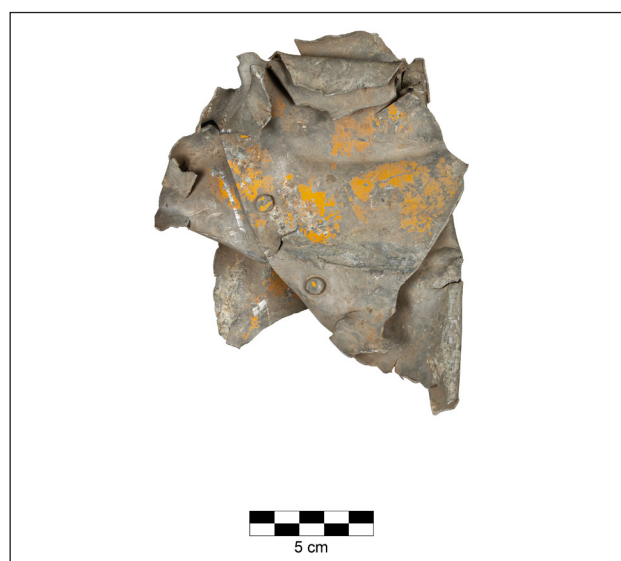
Fig. 12. The yellow marking, which identified the 766th Squadron within the Bombardment Group (Photo: László György, Hungarian National Museum, National Archaeological Institute)
