## RESEARCH AND CONSERVATION OF THE PUSZTATEMPLOM IN LAJOSMIZSE

Hungarian Archaeology Vol. 15 (2026) Issue 2, pp. 52–59.

*The conservation of the ruins of the Pusztatemplom in Lajosmizse was completed in June 2026 as the seventh project in the ROM Vándor heritage preservation programme. The church was certainly already standing in the 14th century, although little is known about the area's medieval history. Archaeological investigations at the site, however, have a considerable history, extending back to the early excavations of medieval villages in the central Great Hungarian Plain. To plan the new restoration, archaeologists from the Katona József Museum in Kecskemét conducted research under the operational leadership of Gábor Wilhelm and the technical leadership of András Kristóf Fazekas. The conservation plans were again prepared under the direction of Bálint Kelemen.*

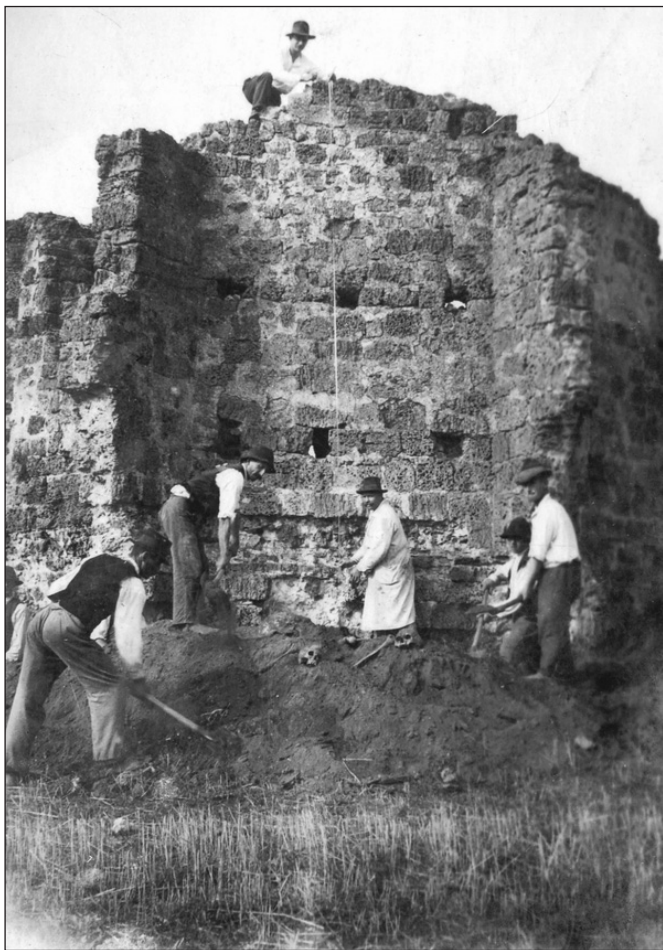
Fig. 3. A scene from the excavations in the 1930s (photo: unknown, from the collection of László Kürti)

1938, 129, 132), and described the ruins, including the location of the pastophorium, which is still visible today (Fig. 2), and the sockets for the corbels that once supported the vault ribs. We have a snapshot of the excavation itself, showing the survey of the sanctuary in progress, whilst the human bones visible on top of the mound bear witness to the excavation of the graves (Fig. 3). The aforementioned monograph contains only scant information about the cemetery and the results of the archaeological research. Szabó writes that large, raised disc-shaped earrings, characteristic of the Cumans, were found in Mizse as well as at several other sites (SZABÓ 1938, 46). We know of a further object recovered from a grave: a woman's headdress, which was a wreath made of metal wire, bent into a five-petalled flower shape and decorated with tiny beads.

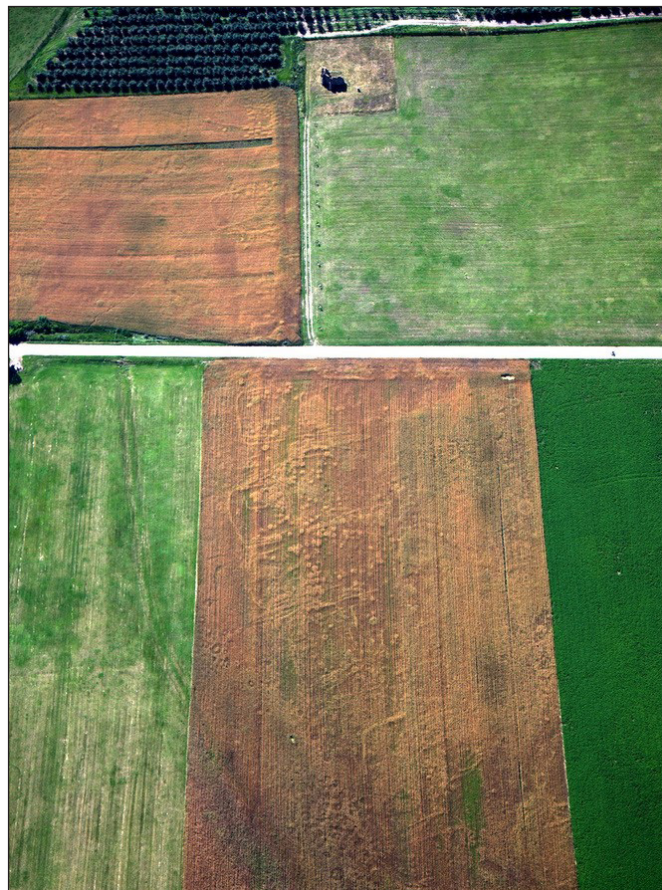
Fig. 4. Otto Braasch's aerial photograph (2008) of the church (above) and the former village – now visible as vegetation patterns (University of Pécs, Pécs Aerial Archaeology Archive – ref. no.: 034202)

In 2008, Otto Braasch carried out an aerial archaeological survey of the area. The vegetation patterns visible in the photographs provide evidence of the settlement's existence: the image reveals a settlement comprising at least two streets (Fig. 4).

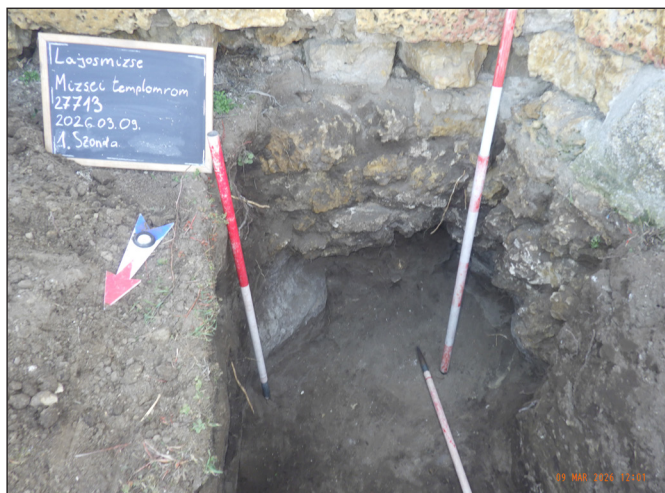
Trenches 1 and 2 are particularly significant from both architectural-historical and archaeological perspectives. In Trench 1, a grey clay foundation ran north to north-east from the sanctuary's foundation, clearly projecting beyond its line. It may represent an earlier or contemporary structure or building phase that was later demolished (Fig. 5).

Fig. 5. Trench 1 after excavation, showing the foundation extending from the sanctuary (photo: András Kristóf Fazekas)

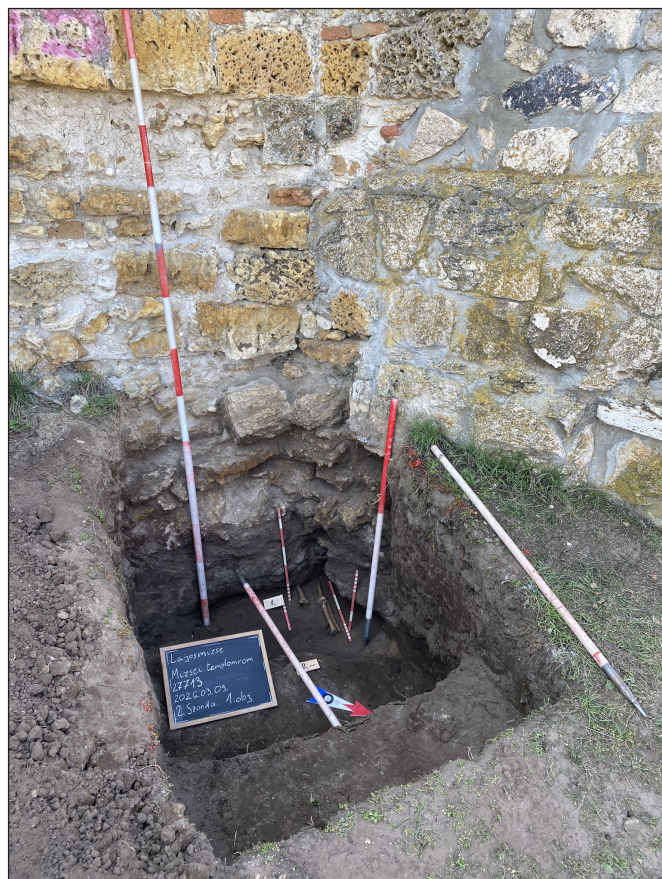
Fig. 6. After excavation of Trench 2, showing Feature 1, a burial running beneath the sanctuary (photo: András Kristóf Fazekas)

Trench 2 yielded the most important archaeological discovery: the two femurs and the left tibia (the right tibia was missing) of a young individual, lying in anatomical order with an NNE–SSW orientation (Fig. 6). The grey clay foundation of the sanctuary was clearly built over the burial, meaning that the grave is older than the construction. The grave may be a remnant of an earlier cemetery, possibly dated to the Árpád Age. As there were no datable finds associated with it, a precise dating will require scientific analysis. A 16th-century silver-plated copper counterfeit denarius was also found in a secondary position within the test trench, alongside a large quantity of pottery and fragments of human bones.

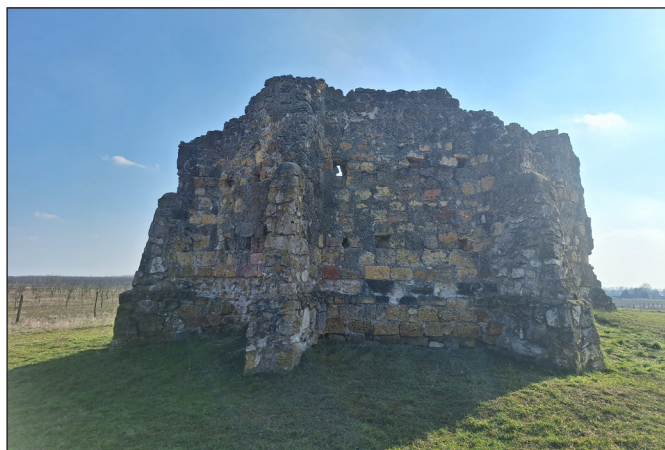
Fig. 7. The sanctuary viewed from the east before restoration (photo: Bálint Kelemen)

a sign affixed to a stone block draws attention to the historic monument. Wire fences run along two sides of the site, and security cameras powered by solar panels mounted on posts stand at two opposite corners. On the neighbouring plot, there is a bench with a table, a rubbish bin, and a fireplace (Fig. 7).

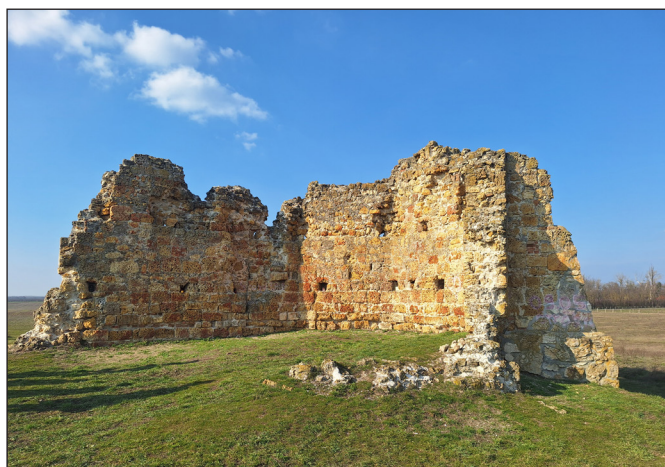
Fig. 8. The interior of the church before restoration – showing the heterogeneous infill masonry of the pillars from 1999 (photo: Bálint Kelemen)

The material of the medieval masonry (as with the vast majority of churches in the Danube–Tisza region) is porous meadow limestone quarried nearby, though brick infill can be observed in places (scattered across the vault of the tabernacle and on the pillars). The outer and inner wall facings consist of regular ashlar, whilst the core of the walls is made up of smaller, amorphous stones. Carved stone (vault ribs, decorative elements, fittings) can no longer be found on site. The pillars were reinforced in 1999 with freshwater limestone, utilising some of the original masonry stones, and the tops of the pillars were capped with a cast, arched cement covering. The medieval masonry had lost its binder at the level of the wall crown; the remaining patches of original plaster were severely crumbling, and the surface of the masonry was soiled and showed signs of biological damage (moss). Some sections of the masonry fell out, primarily at the plinth, in the middle of the wall and at the exposed ends. Structural cracks had also appeared in the masonry, mainly in the north-western wall. Unfortunately, graffiti had defaced the ruins in some places, which is why the local council installed a CCTV camera (*Fig. 8*).

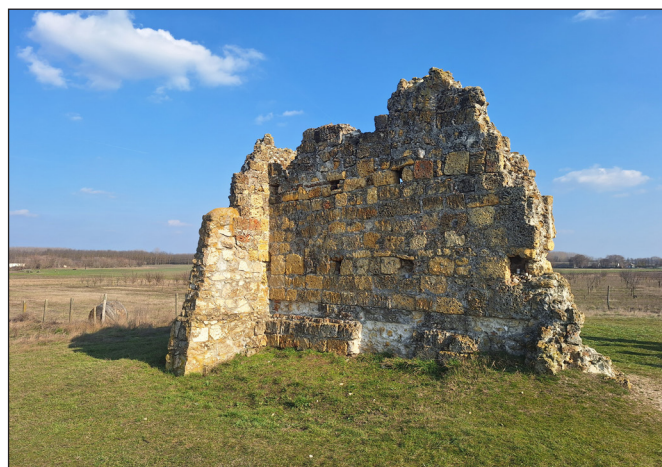
Today, the surviving remains of the former single-nave Gothic church comprise the north-west wall and the sanctuary walls, which form three sides of an octagon and stand to an average height of 5 metres, together with the sanctuary’s three pillars. The wall thickness is approximately 90 cm at the plinth and approximately 80 cm above it. The ground slopes away from the church in all directions.

Fig. 9. The north wall prior to restoration – cracks running through the wall, spalling on the plinth, crumbling wall crown, and heterogeneous pillar infill dating from 1999 (photo: Bálint Kelemen)

dismantled the loosened, crumbling wall crown and masonry only as far as necessary, down to the solid masonry, and rebuilt them using the original stones. The rebuilt wall crowns slope by 5 per cent in two directions and follow a naturalistic ruin profile. For the ashlar, we applied the programmed anastylosis method (reconstruction using existing, original pieces) during the dismantling and rebuilding process. We preserved the sockets of the former corbels and the beam sockets; at structural cracks, we used a concealed, so-called ‘dry-system wall repair’ technique with stainless steel spiral rods (Mapei Steel Dry). Interventions were localised, and damaged surfaces were repaired using specialist conservation methods. For the rendering, bricklaying and jointing mortars, we selected a cement-free trass mortar with a yellowish colour similar to the original (MAPEI-Antique Allettamento) (Fig. 10).

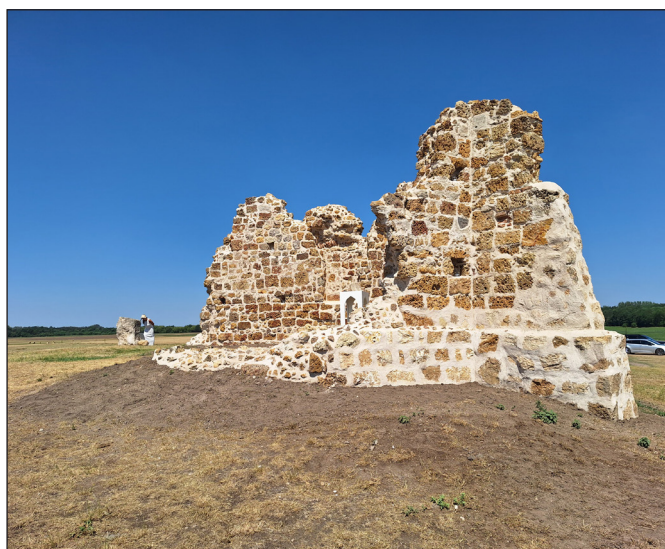
*Fig. 10. The ruins after restoration – with a thin layer of plaster applied to the surface of the previous pillar reinforcements and new infill masonry (photo: Bálint Kelemen)*

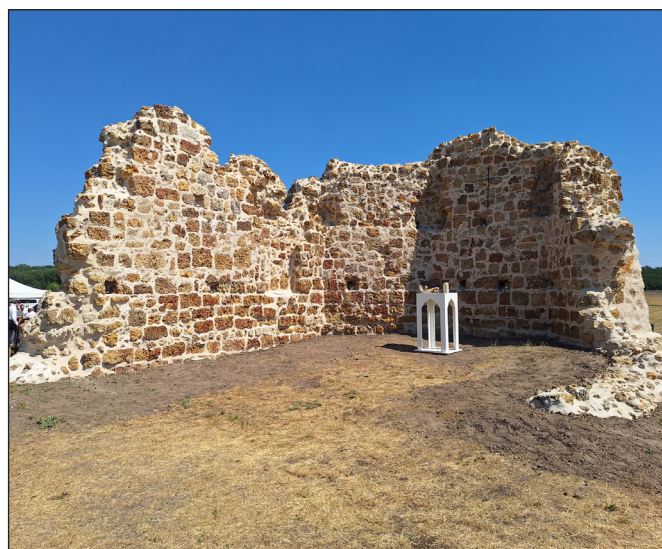
*Fig. 11. The interior of the ruins after restoration – with the wrought-iron cross on the sanctuary wall (the temporary installation in place of the altar is not part of the restoration) (photo: Bálint Kelemen)*

As at every ROM Vándor site, small-scale contemporary additions have been made here too, helping to ensure that the restored ruin can also serve as a space for spirituality, contemplation and prayer. As part of this, a slender wrought-iron cross has been placed on the inside of the sanctuary, whilst glass votive lamps with a uniform design have been put into the beam holes. Following the ‘Path of Light’ at Aszófő–Kövesd, the ‘144 Candles’ at Tatabánya–Csákányospuszta, the ‘Gate’ at Somogyszentpál–Varjaskér, the ‘Garden of Eden’ at Regöly–Somoly and the ‘Sound Tower’ at Ádánd–Hetye, the Pusztatemplom ruins at Lajosmizse have joined the series of restored sites under the name ‘Altar Wall’ (*Fig. 13*).
