THE REGÖLY-SOMOLY CHURCH RUIN AND ITS CONSERVATION IN 2025

ANDRÁS K. NÉMETH¹ – MIKLÓS RÁCZ²

Hungarian Archaeology Vol. 14 (2025) Issue 3, pp. 25–32.

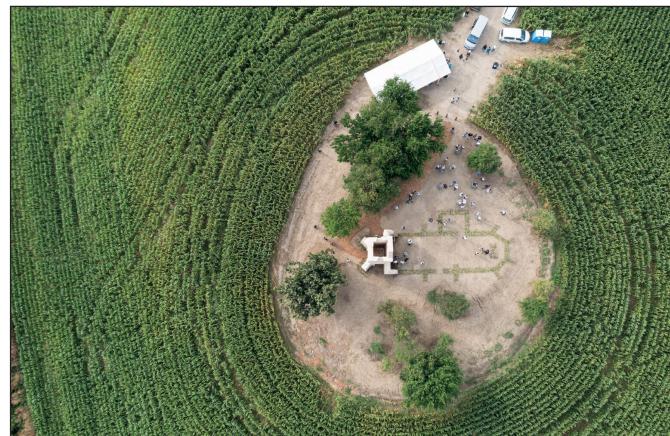
Fig. 7. The tower and its surroundings after the 2025 restoration

In addition to the conservation of the ruins, the vegetation in the area of the church was groomed, the surface of the church grounds was levelled, and the floor plan of the church, as determined by archaeological research, was marked with a flower bed (Fig. 7). As Péter Belecz, the director of the programme, put it, the basic principle of the architectural and heritage conservation programme was the technical renovation of the ruins, the preservation of the aesthetic and historical values inherent in the monument, and the preservation of the natural, harmonious relationship between the poetic ruins and the landscape. One of the special features of the ROM Váendor programme is that it not only preserves the condition of the sites involved
