THE MEDIEVAL PARISH CHURCH OF BAIÁ MARE: PRELIMINARY RESULTS OF AN ARCHAEOLOGICAL RESEARCH PROJECT

PÉTER LEVENTE SZŐCS¹

Hungarian Archaeology Vol. 11. (2022), Issue 2, pp. 29–37. <https://doi.org/10.36338/ha.2022.2.4>

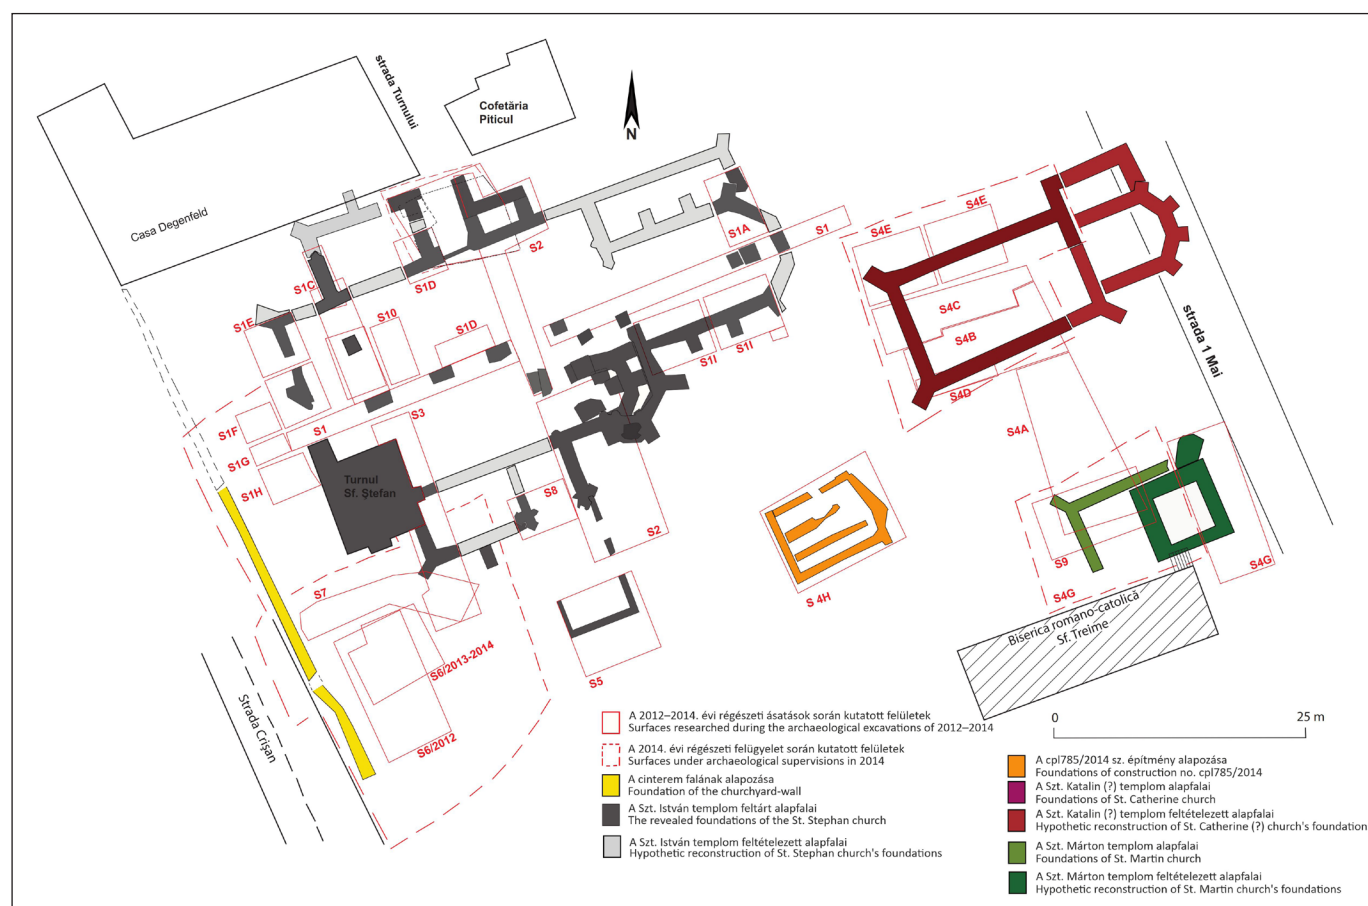
Fig. 1. Baia Mare, P-ța Cetății. Survey map of the excavated area

The site of the parish church and the surrounding park was rehabilitated, the works having been preceded by archaeological excavations between 2012 and 2014.³ The excavations revealed persisting foundations, floors, and internal details of the church building, the relics of lesser buildings, and some graves of a churchyard cemetery. However, the rescue excavation only included the areas directly endangered by reconstruction works (*Fig. 1*).⁴ The narrow timeframe and resources enabled us to unearth the archaeological layer

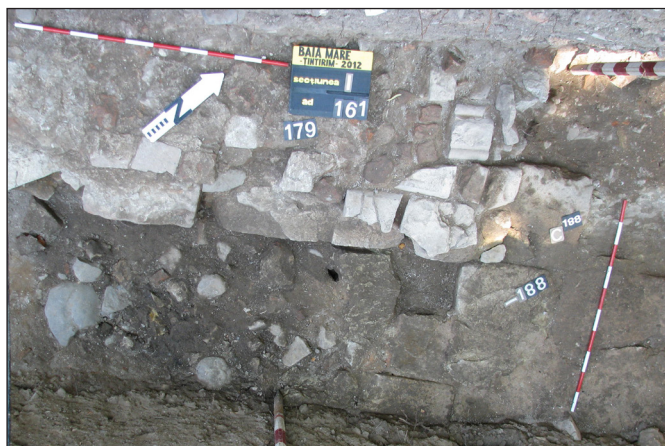
Fig. 3. Remains of the nave's and side aisles' stone floor

identified a semicircular walking surface paved with river stones in front of the western portal, 0.80–1 m below the current surface. It sloped slightly toward the Crișan (Magyar) street. In the interior of the church building, a floor made of stone slabs, also incorporating reused medieval tombstones with inscriptions, corresponded to this outdoor pavement (Fig. 3). Despite most parts of the stone slab floor had been destroyed by gas and electric pipelines and ground rods of lightning conductors, we were able to date it to the early modern period and identify as the last floor phase of the church building.

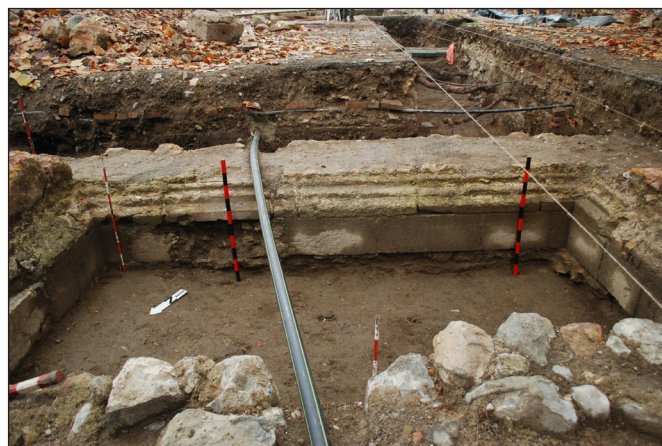
Fig. 4. Plinths of the northern side aisle's northern exterior wall

On the northern side, someplace, the elevation walls were preserved two ashlar-row high. Furthermore, parts of the plinth, compiled of nicely carved cascading oblique and cylindrical elements, connecting foundations and elevation walls, were also preserved in this section (Fig. 4). Moreover, we found the foundations of the northern portico in this zone; it was attached to the exterior walls of the parish church building, and its floor was made of brick. By the eastern side of the portico, a small chapel was created with a rather simple method: a wall was erected between two buttresses, enclosing the gap between them (Fig. 5). We also found the foundations of an additional chapel on the western side of the northern portico. This chapel was wider than the portico and stretched to the westernmost buttress of the northern side aisle's northern exterior wall.

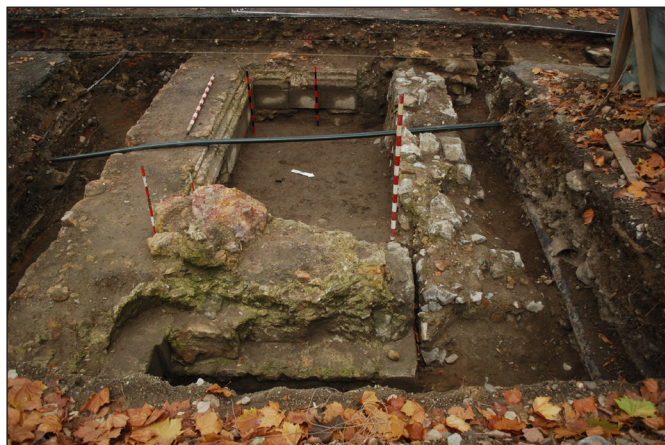
Fig. 5. The northern side-chapel, created between two buttresses

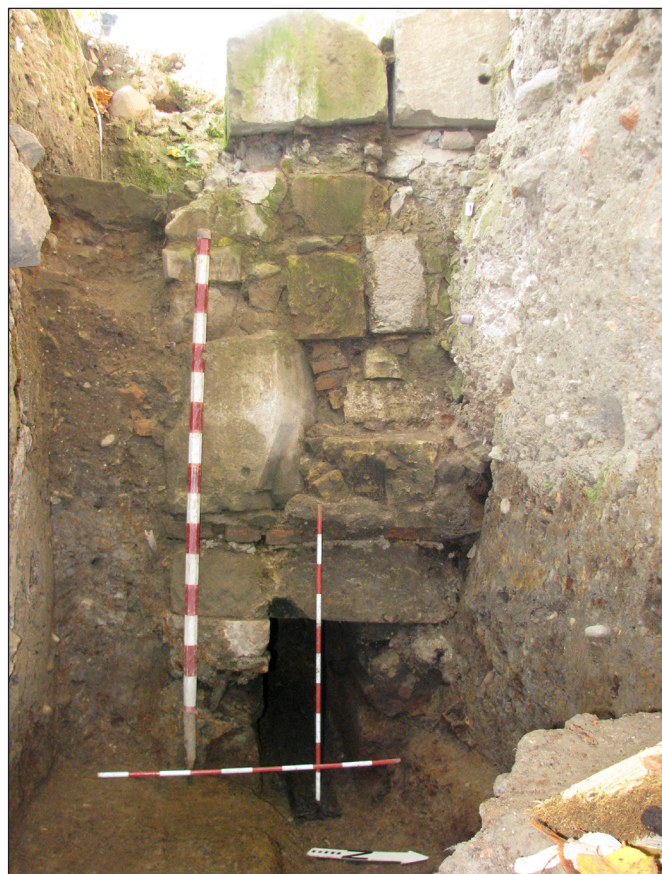
Fig. 6. Foundation of a pillar in the central row

of shafts of these pillars, and it was clarified that they belonged to the last building phase of the church building, as their foundations comprised reused bricks and stone carvings, including a tombstone with inscriptions (*Fig. 6*). Stratigraphic observations also confirmed the pillars' dating: their plinth corresponded to the latest stone floor of the church. These observations confirmed a hypothesis by Szilárd Papp about the present two-nave structure being the result of early modern transformations. The available archaeological record, however, does not enable a more precise dating (PAPP 2011, note 28). Upon checking our archaeological observations with the related written sources, it could be assumed that the transformation can be linked to the major reconstruction after a great fire in 1552 when the whole roof became destroyed and the building remained uncovered for several years. All this happened at a time when Protestantism gained support in Baia Mare (during the 1540–50s), and the local protestant congregation took over the ruined church building. All these factors might have been at work behind the radical transformations. After that, no notable structural modification took place during the building's lifetime except for some reparations after another fire in 1769 (SZÁSZ 2000, 21–33). Those works included the construction of a chapel next to the southern portico and creating stone pavements in front of the western façade and in the southern portico.

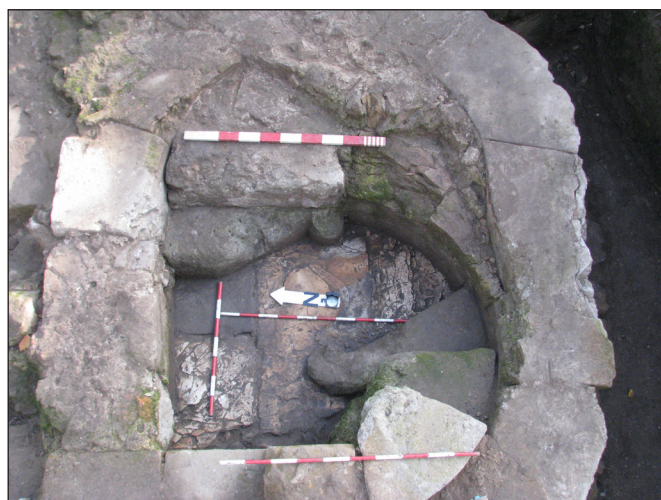
Fig. 8. Remains of a turret and spiral staircases by the south-eastern corner

In the second building phase, a turret housing a spiral staircase was also erected outside the building, attached to the south-eastern corner's exterior wall. We discovered its entrance that opened to the

interior of the southern side aisle and also that the stairs were renewed: we found the remains of two sets of steps, one starting left of the northern entrance, the other by the southern wall (Fig. 8). After the turret had been abandoned, its interior was filled up and used as a burial place.

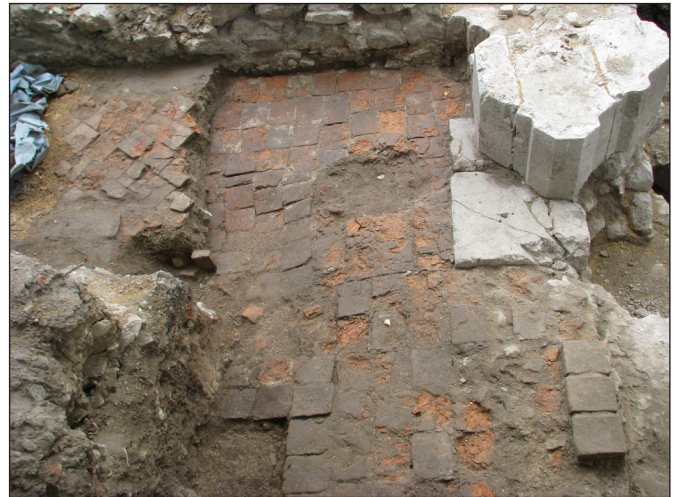
Fig. 10. Brick floors from two building periods in the choir

We have identified several floor levels in the interior of the church building, the latest one of the nave and side aisles, paved with carved stone slabs. The floor of the same period in the sanctuary was made of bricks laid oblique to the building's main axis. We also have identified a previous floor in the choir and the southern side aisle, about 30 cm below the first one (Fig. 10). The older floor was also paved with bricks but in a different pattern: they were arranged with their long sides parallel with the main axis of the building. Several features discovered in the layers between the two floors indicate that the older floor was renewed several times. Furthermore, the in-between layers contained a significant number of artefacts with everyday tools (e.g., a thimble) and coins. The oldest coins were minted during King Louis I (TÓTH 2020, no. 2.32.1.1 and 2.46.1.1), while the youngest one was issued at the time of King Mathias Corvinus (HUSZÁR 1979, no. 718–719).⁵
